# A rare cause of tube arcing artifact seen in computed tomography image of a positron emission tomography/computed tomography scanner

### Technical Note

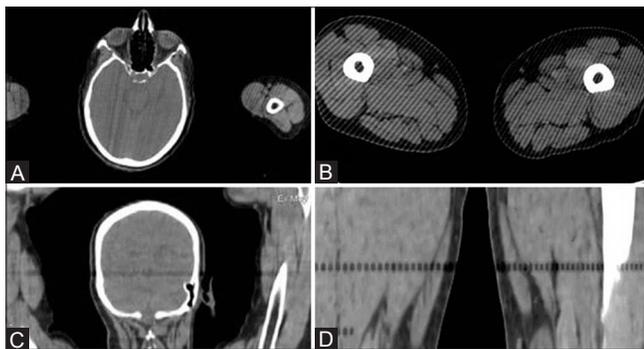
Our department has a positron emission tomography/computed tomography (PET/CT) scanner (Discovery IQ PET; GE Medical Systems, Milwaukee, USA). This equipment is used to perform PET/CT as well as routine CT procedures. On a busy afternoon, we encountered an artifact on two to three consecutive slices of the CT transaxial images of a patient, which showed near-parallel streaks across the transaxial image and a hypodense band with parallel bars on the corresponding sagittal and coronal images [Figure 1]. On careful examination and, in particular, viewing the CT images in the "lung window," it became apparent that the streaks in the transaxial slices were not parallel, but appeared to converge at a point outside the circumference of the gantry. The remaining slices did not show this kind of artifact. When we measured the HU of the tissues, we found that it was lower than that of neighboring slices. We felt that the probable reason for the artifact could be disruption of X-ray production in those slices possibly because of failure of voltage generation. Literature search suggested this could be the rarely encountered tube arcing artifact. For confirmation of the artifact, we reviewed CT series of all other PET/CT studies performed on that day. However, none of the other images had any such artifact. We immediately brought this occurrence to the vendor's support team, who also suspected voltage failure to be the possible cause. The next day, we were more vigilant and found more frequent occurrences of this artifact. We also observed something new which intrigued us. These artifacts had not occurred in any other dedicated CT images. Preliminary investigation by the vendor's support personnel revealed very short-lived, erratic drops in voltage corresponding in time with the seen artifacts. This

**Figure 1 (A-D):** Clinical image: CT tube arcing artifact seen in the head region on the transaxial image (A) and corresponding coronal image (B); in the thigh region on the transaxial image (C) and corresponding coronal image (D)

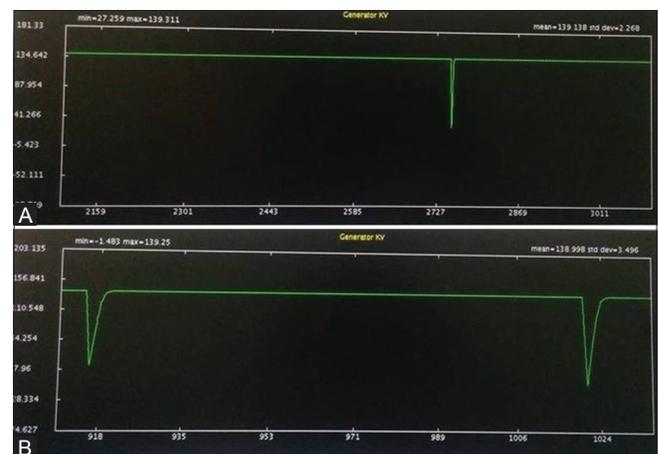
drop in voltage as seen on a graph did not touch zero at any of the instances; the voltage graph showed high standard deviations in the voltages [Figure 2], and hence, the system did not generate any error or abruptly stop scanning. However, this observation still did not explain why these artifacts were not occurring in any of the other CT images acquired. We performed repetitive phantom scan in dedicated CT protocol and did not observe such an artifact. So, we performed the phantom CT scan in PET/CT whole body protocol and streak artifact was observed [Figure 3A and B]. Thus, we decided to review the CT acquisition parameters for diagnostic CT and CT in PET/CT protocols. Our review revealed a difference in kV used in both protocols, i.e., 140 kV used in PET/CT protocol and 120 kV used in diagnostic CT protocol. Service engineer changed the HEMIT tank (which is a transformer supplying voltage to the rotor of the rotating anode), considering the faulty current supply to the CT tube. After replacement, we performed repetitive CT scans of phantom in PET/CT protocol at 140 kV and did not observe any tube arcing artifact [Figure 3C and D].

**Figure 2 (A and B):** Plot of generator kV versus time in images showing drop of voltage corresponding to appearance of tube arcing artifact (A and B)

there was no abrupt termination of the CT scan as there was no error generated by the system. This was because at no point did the drop in voltage reach the threshold (0 kV) to generate an error. The resulting artifact was seen as alternating hypodense streaks throughout the transaxial image, which corresponded with a horizontal hypodense band in sagittal and coronal images also. Tube arcing artifact can normally be corrected by applying correction algorithms. The correction algorithm could either use synthesized projections generated by using the neighboring unaffected slices or an adaptive filtering scheme or a partial data interpolation method.<sup>[6,9]</sup> However, these methods are capable of correcting only moderate streak artifacts and not to the extent mentioned here.<sup>[5]</sup> Frequent tube arcing or tube spit of this magnitude can only be resolved by replacing the tube,<sup>[5]</sup> which would have been very costly, considering that it had only been 6 months since installation of the PET/CT. However, in our case, the reason for disruption of X-ray was different. The most probable reason for disruption in X-ray production leading to the artifact was the disrupted current supply to the rotor of the rotating anode at 140 kV. Hence, simply replacing the HEMIT tank could resolve the issue. Although tube arcing artifact and its causes have

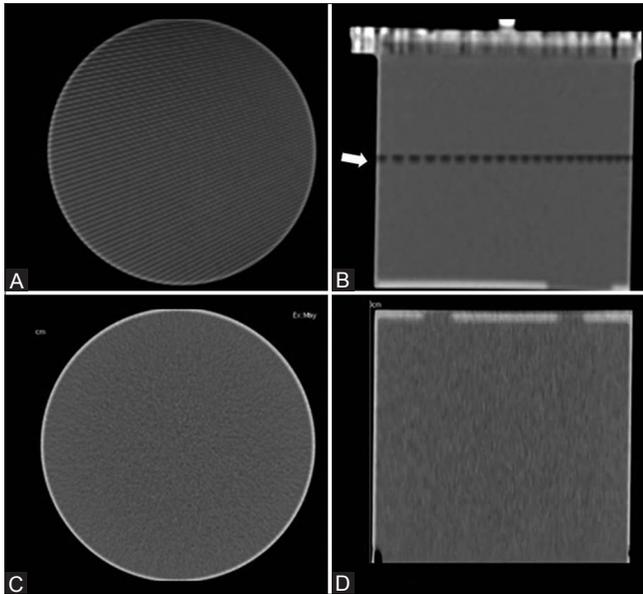
**Figure 3 (A-D):** Phantom image: CT image of uniformity phantom in PET/CT whole body protocol showing streak artifact, transaxial image (A); arrow shows alternating lucent bands seen on the coronal image (B). CT images, transaxial image (C) and corresponding coronal image (D) of uniformity phantom in PET/CT whole body protocol after replacing the HEMIT tank (no tube arcing artifact seen)

The described tube arcing artifact seen in CT images was caused by a fault with the transformer supplying voltage to the rotor connected to the anode in the X-ray tube, which involved sudden transient drops in voltage generated whenever acquisition was done at 140 kV. Using the CT at a relatively lower voltage of 120 kV could prevent such an occurrence, and in case such an artifact does occur, it would save time and cost if this reason is ruled out before proceeding to tube replacement.
