Bore Disruption: An Unusual Mechanical Failure of Two Hip Hemiarthroplasties

Joints 2017;5:51–56.

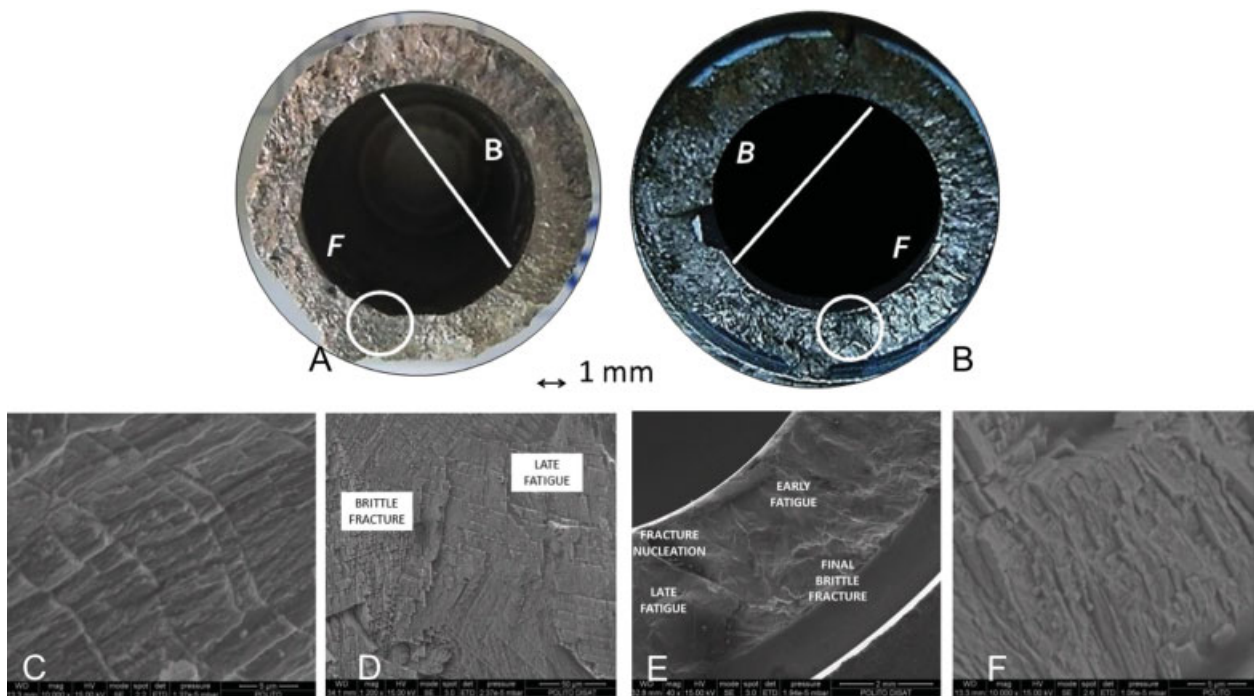
The fracture surfaces of case 1 were two annuli, with an inner diameter of 8 mm and an external diameter of 12 mm.

It was possible to observe only a single site of initiation of the fatigue fracture, with no morphological or microstructural defect near the initiation site. More than half of the fracture surface was due to a mechanism of fatigue, whereas the other half corresponded to final fracture. The mechanism of fracture observed was the so-called transgranular and not intergranular pattern. Striations appeared as relatively evenly spaced parallel lines; this pattern of fracture is often present on fatigue fracture surfaces of cobalt alloys. Each striation actually represents a shallow crack resulting from a single stress cycle of approximately 5 microns. Some zones with evidences of final fracture were observed only near the outer edge of the fracture surfaces with the presence of a lot of cleavage planes, in different directions on the different crystals, suggesting that final fracture occurs with a brittle mechanism. To check the chemical composition of the metal alloy of the prosthesis, an energy dispersive spectroscopy (EDS) analysis was performed: cobalt, chromium, and molybdenum have been identified in the ratios required for the cobalt-alloy 66Co-28Cr-6Mo (ASTM F 1537), declared by the manufacturer, without any trace of contamination (►Fig. 3).

Fig. 3 Scanning electron microscopy analysis of case 1. (A) Bore section. (B) Head side. “F” stands for “fatigue fracture” and “B” stands for “brittle fracture.” The circles correspond to the nucleation site of the fracture. (C) A magnification of the late fatigue zone on the bore. (D) A magnification of the transition area between the late fatigue and final brittle zone on the bore. (E) An overview of the nucleation site of the fracture on the head. (F) A magnification of the early fatigue zone on the head.

It can be stated that the failure of the prosthesis in case 1 has occurred for a high number of fatigue cycles. The appearance of the fracture surface of case 2 is consistent with the presence of a torsional stress and two initiation points. The second initiation point showed a macroscopic lateral groove that originated from mechanical processing by a tool. The defect, resulting from machining, was a stress concentration factor, critical for the initiation and propagation of the fracture. A responsibility of the machining
