Repair of a fractured implant overdenture gold bar: A clinical and laboratory technique report

Fahim Vohra¹, Amani Al Fawaz¹

¹Department of Prosthetic Science, SDS, College of Dentistry, King Saud University, Kingdom of Saudi Arabia

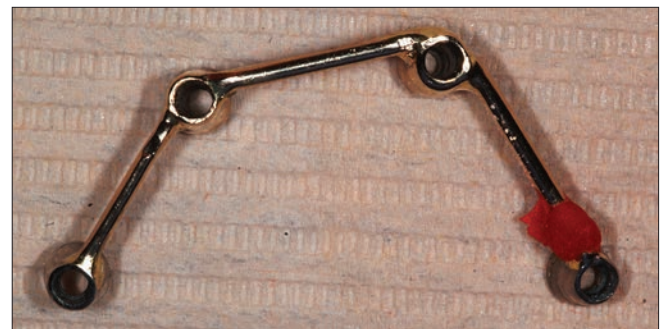
Figure 4: Splinted gold bar and coping assembly removed from the mouth to undertake laboratory procedure

3. Once the pattern resin had completely polymerized (5-7 minutes), the Dolder bar retainer was unscrewed and removed from the mouth using a SCS screw driver (Straumann, Basel, Switzerland) [Figures 4 and 5]. Regular neck healing abutments (Straumann 4.5Ø, 2 mm height)
