Differentiating spontaneous vertical root fracture in endodontically treated tooth

Myung-Jin Lim¹, Jung-Ae Kim¹, Yoorina Choi², Chan-Ui Hong³, Kyung-San Min^{1,4}

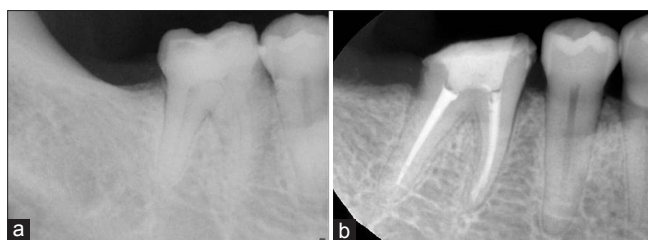
Figure 1: Radiographic features of the mandibular right first molar. (a) Diagnostic radiograph before treatment. (b) Postoperative radiograph. Symptoms were relieved after root canal treatment

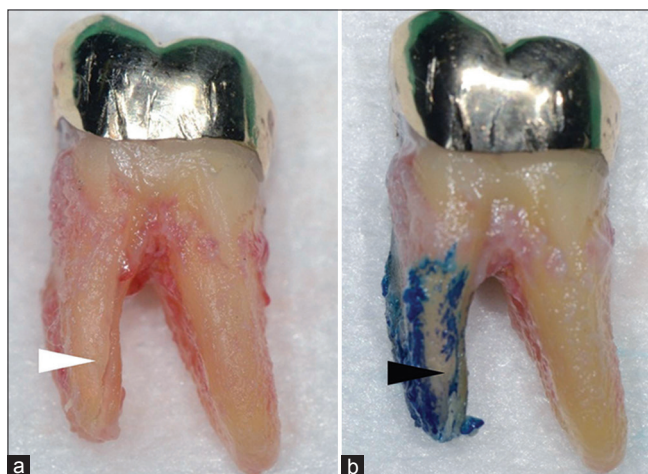
Figure 3: Clinical photographs of extracted tooth. (a) The extracted tooth showing a definite fracture line on the mesial root (white triangle). (b) The fracture line became more obvious after methylene blue staining (black triangle)

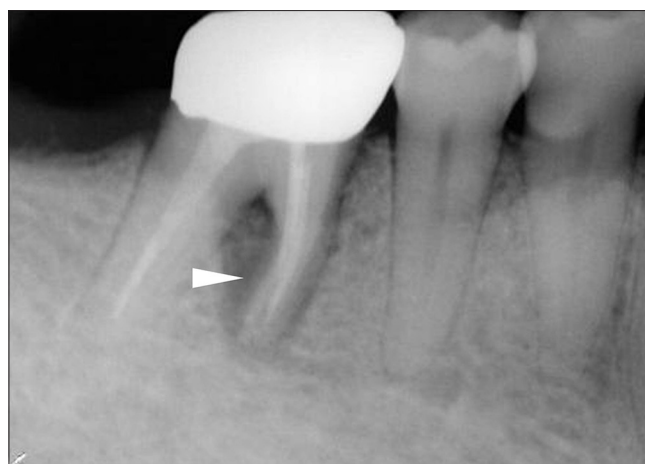
After 6 months, the patient revisited complaining of dull pain and localized swelling. We found a deep, narrow periodontal pocket on the buccal aspect of the tooth. Radiographic examination revealed extensive J-shaped periodontal bone loss around the mesial root [Figure 2]. We strongly suspected VRF and planned an extraction. When the patient noticed the problem, he asked us for the cause of the VRF. Moreover, he wondered whether the fracture could have occurred during the endodontic treatment. We explained that the fracture might have been present before the treatment or that it might have been caused by the root canal filling procedure. However, we could not give him a clear answer as to which possibility was correct. Finally, we suggested that we extract and examine the tooth in detail. The tooth was extracted under local anesthesia. We found a fracture line on the mesial root [Figure 3a]. The fracture line appeared more clearly when we stained it with 1% methylene blue solution [Figure 3b].

Figure 2: Radiograph at revisit after 6 months. Note the J-shaped periradicular radiolucency around the entire mesial root (white triangle)

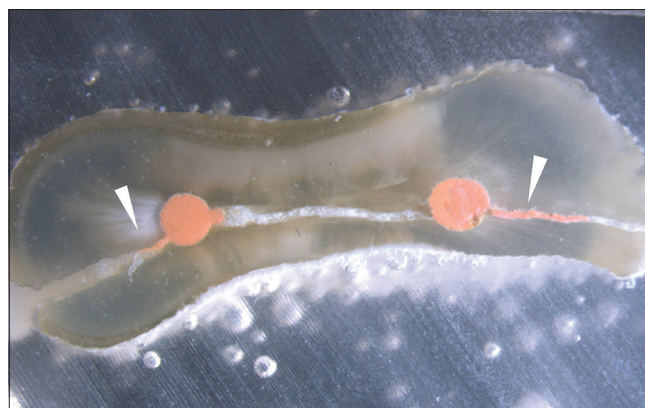
For scientific use of the tooth, we obtained informed consent from the patient. After embedding the tooth in acrylic resin, we sectioned the specimen transversely using a low-speed microtome (ISOMET; Buehler, IL, USA). We then examined the sectioned surface under a stereomicroscope (Leica MZ16FA; Leica, Wetzlar, Germany). The fracture line was along the mesial root in the buccolingual direction. Notably, we found gutta-percha in the fracture line [Figure 4]. It appeared to have been squeezed into the fracture line by the force generated during filling. It provided clear evidence that the fracture line already existed before the root canal filling procedure. We informed the patient, who agreed that the fracture occurred spontaneously before the treatment. We then planned restoration of the missing tooth with a dental implant.

Figure 4: Stereomicroscopic view of the sectioned mesial root. Note the definite crack line containing gutta-percha (white triangles) (x20)

conditions. Herein, we offer a useful tip for verifying when a VRF occurred: extract the tooth or root, then section, and examine it. If gutta-percha is present in the fracture line of the transversely sectioned root, it can be postulated that the crack line existed before the root canal filling procedure. Without a preexisting fracture line, the gutta-percha could not penetrate into the root dentin. In our case, we found obvious gutta-percha in the fracture line. It looked like the gutta-percha had been squeezed into the fracture line by the force generated during vertical compaction [Figure 4]. That clearly indicated that the fracture line already existed before the root canal filling procedure, which meant that the VRF was not iatrogenic. The patient withdrew his claim after this verification and agreed to our plans for the future restoration of the edentulous area.
