Differentiating spontaneous vertical root fracture in endodontically treated tooth

Myung-Jin Lim¹, Jung-Ae Kim¹, Yoorina Choi², Chan-Ui Hong³, Kyung-San Min^{1,4}

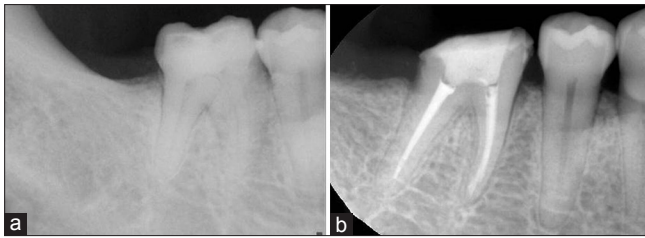
A 61-year-old man came to our dental clinic complaining of severe pain on cold stimuli. His medical history was noncontributory. When applying cold water on the right lower first molar under rubber dam isolation, the patient felt lingering pain that matched his chief complaint. The tooth showed no caries lesion or crack line. No specific problem could be seen on the diagnostic radiograph [Figure 1a]. On the basis of clinical and radiographic findings, we diagnosed irreversible pulpitis of the lower first molar and planned root canal treatment.

Figure 1: Radiographic features of the mandibular right first molar. (a) Diagnostic radiograph before treatment. (b) Postoperative radiograph. Symptoms were relieved after root canal treatment

all canals were dried and filled with gutta-percha and resin-based sealer (AHplus; Dentsply-Caulk, Konstanz, Germany) using the warm vertical compaction technique (Endo-Apex; EPdent, Seoul, Korea) [Figure 1b]. Then, we fabricated a full veneer gold crown.

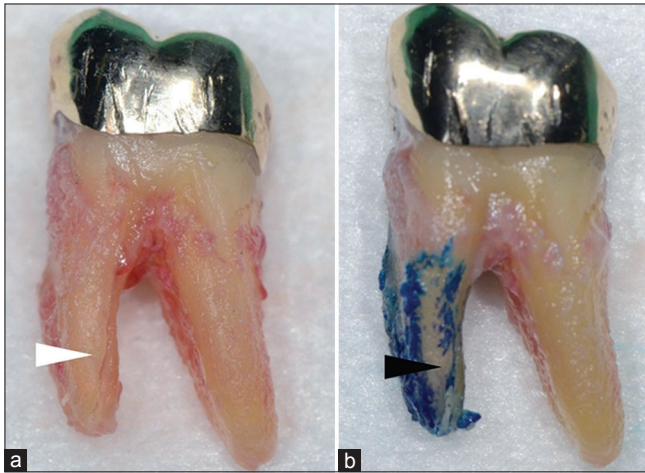
Figure 3: Clinical photographs of extracted tooth. (a) The extracted tooth showing a definite fracture line on the mesial root (white triangle). (b) The fracture line became more obvious after methylene blue staining (black triangle)

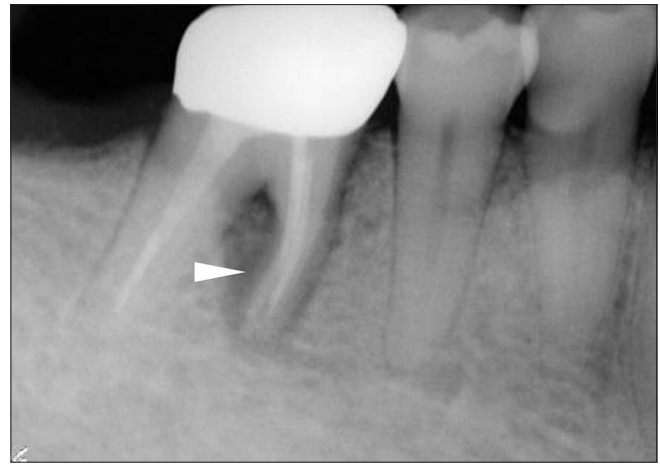
After 6 months, the patient revisited complaining of dull pain and localized swelling. We found a deep, narrow periodontal pocket on the buccal aspect of the tooth. Radiographic examination revealed extensive J-shaped periodontal bone loss around the mesial root [Figure 2]. We strongly suspected VRF and planned an extraction. When the patient noticed the problem, he asked us for the cause of the VRF. Moreover, he wondered whether the fracture could have occurred during the endodontic treatment. We explained that the fracture might have been present before the treatment or that it might have been caused by the root canal filling procedure. However, we could not give him a clear answer as to which possibility was correct. Finally, we suggested that we extract and examine the tooth in detail. The tooth was extracted under local anesthesia. We found a fracture line on the mesial root [Figure 3a]. The fracture line appeared more clearly when we stained it with 1% methylene blue solution [Figure 3b].

Figure 2: Radiograph at revisit after 6 months. Note the J-shaped periradicular radiolucency around the entire mesial root (white triangle)

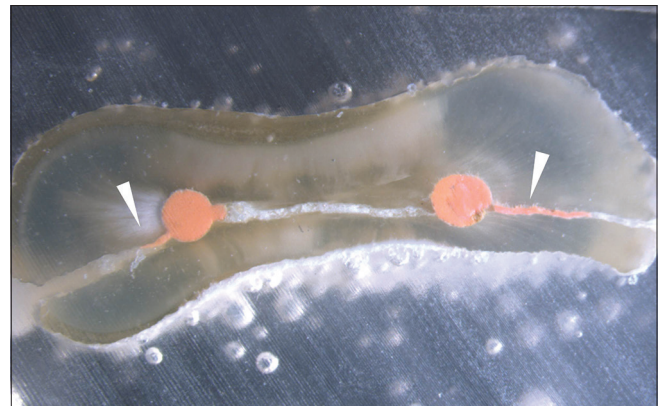
For scientific use of the tooth, we obtained informed consent from the patient. After embedding the tooth in acrylic resin, we sectioned the specimen transversely using a low-speed microtome (ISOMET; Buehler, IL, USA). We then examined the sectioned surface under a stereomicroscope (Leica MZ16FA; Leica, Wetzlar, Germany). The fracture line was along the mesial root in the buccolingual direction. Notably, we found gutta-percha in the fracture line [Figure 4]. It appeared to have been squeezed into the fracture line by the force generated during filling. It provided clear evidence that the fracture line already existed before the root canal filling procedure. We informed the patient, who agreed that the fracture occurred spontaneously before the treatment. We then planned restoration of the missing tooth with a dental implant.

Figure 4: Stereomicroscopic view of the sectioned mesial root. Note the definite crack line containing gutta-percha (white triangles) (x20)

conditions. Herein, we offer a useful tip for verifying when a VRF occurred: extract the tooth or root, then section, and examine it. If gutta-percha is present in the fracture line of the transversely sectioned root, it can be postulated that the crack line existed before the root canal filling procedure. Without a preexisting fracture line, the gutta-percha could not penetrate into the root dentin. In our case, we found obvious gutta-percha in the fracture line. It looked like the gutta-percha had been squeezed into the fracture line by the force generated during vertical compaction [Figure 4]. That clearly indicated that the fracture line already existed before the root canal filling procedure, which meant that the VRF was not iatrogenic. The patient withdrew his claim after this verification and agreed to our plans for the future restoration of the edentulous area.

There might be a possibility that the VRF occurred during the root canal filling procedure. Indeed, unless this possibility is excluded, our clinical suggestion cannot be accepted. Previous studies demonstrated that the load necessary to elicit a VRF ranges between 7 and 17 kg,^[5,13,14] and the force needed to fracture a root is much higher than that formed during filling compaction. Furthermore, VRFs result from a gradual diminution of root structures that develops from preexisting defects such as microcracks or craze lines and should not be considered an instantaneous phenomenon.^[15] Even though the VRF can be assumed to be initiated by the force generated by obturation force, the fracture might be just a craze line considered as an initial defect. Consequently, this minute fracture line could not allow the penetration of semisolid gutta-percha at the moment. In this respect, it is appropriate to presume that the VRF preexisted spontaneously and it was induced by the microcrack which elicited long before.
