Thermal Injuries during Intraoperative Magnetic Resonance Imaging: Mechanisms and Prevention

J Neuroanaesthesiol Crit Care:2021;8:66–68

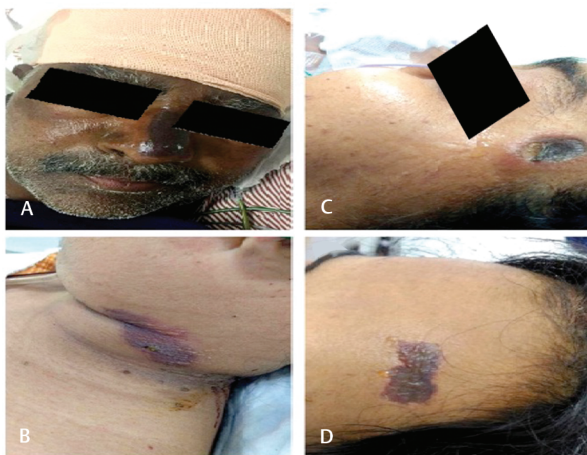
Right parieto-occipital glioma operated in the prone position postoperatively had a superficial burn on the nose (►Fig. 1A). We hypothesized that this was due to direct contact of nose with the lower MRI coil or moisture collected between the lower coil and nose in prone position. Therefore, after this case, we made sure that the lower coil is placed after surgery

Cerebellopontine angle tumor operated in left lateral position with neck rotation and lateral flexion had superficial thermal injury in flexed neck region postoperatively (►Fig. 1B). We postulated that this could be due to collection of moisture or sweat in flexed neck area leading to heat generation causing burn inside the magnetic field.

Pituitary macroadenoma for transnasal transsphenoidal resection with the use of neuronavigation had a superficial burn postoperatively under the MRI-compatible navigation tracker site or reference coil (StealthStation EM noninvasive patient tracker; Medtronic-Sofamor Danek, United States) (►Fig. 1C). We hypothesized that this could be due to improper contact between the navigation tracker and patient's skin, allowing moisture to be collected. Because the navigation tracker ideally needs to be discarded once the glue attaching it to the skin wears off, we have stopped using the same tracker for multiple cases and discard the same sooner. This prevents such burn incidents and ensures proper navigation accuracy.

Cerebellopontine angle tumor operated with bispectral index (BIS) monitoring had a superficial burn on the forehead, in the area of BIS sensor, which was removed prior to the IOMRI scan (►Fig. 1D). Our hypothesis was that this burn would be due to the moisture collected under the BIS sensor due to prolonged duration of surgery. After this case, we started cleaning and drying the site of BIS sensor before going for IOMRI.

Fig. 1 (A) Superficial burn on the nose in prone position. (B) Thermal injury between skin folds in the flexed area of neck. (C) Superficial burn under the navigation tracker. (D) Thermal injury under area of BIS sensor on the forehead. BIS, bispectral index.

just before moving in for the IOMRI scan so that moisture is not collected at the dependent sites.

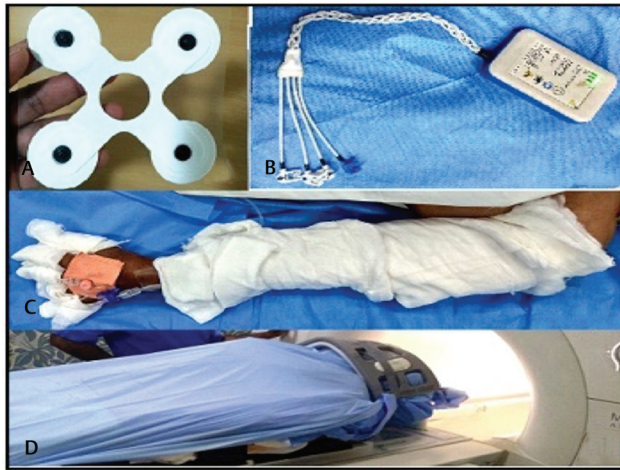
Fig. 2 (A) Closely placed MRI-compatible ECG leads made of carbon. (B) Braided MRI-compatible ECG wires with short connection ends to prevent looping. (C) Packing in areas of skin-to-skin contact (finger webs and axilla). (D) Patient under the drapes going into intraoperative MRI with upper coil visible. ECG, electrocardiogram; MRI, magnetic resonance imaging.

We should only use monitoring devices that are cleared for use with MRI during scanning. Placement of ECG leads (►Fig. 2A) should be as close as possible, and wires should be braided and cables should be of short length (►Fig. 2B). All areas that are likely to experience thermal burn injuries should be padded for thermal insulation (e.g., areas of skin-to-skin contact such as fingers, toes, axilla, and groin or skin-to-machine contact) (►Fig. 2C, D).
