Fatal upper gastrointestinal bleeding caused by a metal biliary stent despite stent shortening with APC

Endoscopy 2008; 40: E135

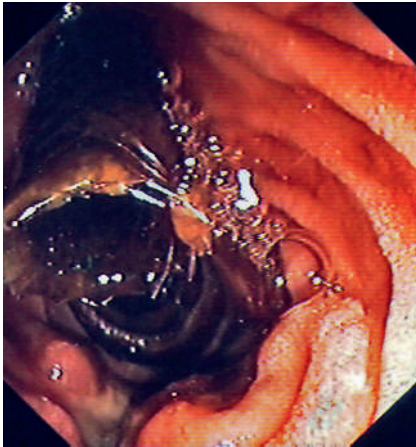
Fig. 1 The stent protruding far from the papilla. A deep ulceration is visible at the duodenal wall opposite the papilla.

Ulceration is caused by continuous mechanical irritation of the mucosa opposite the distal end of the stent. Distal migration or malpositioning are the causes of this complication. Furthermore, mucosal ulceration may be promoted by the sharp edges of metal stents [1]. To date, several cases of ulceration and bleeding caused by biliary SEMS have been reported [1–3]. In most cases, bleeding was self-limiting. When indicated, endoscopic hemostasis successfully arrested the bleeding. APC is reported to be a safe, effective, and easy way to reduce stent length [2–4]. Shortening of the stent, with or without endoscopic hemostasis, was enough to permanently correct the complication in the published cases. Fatal bleeding

Upper endoscopy revealed a normal esophagus, stomach, and duodenal bulb. At the duodenal wall opposite the papilla, a large ulceration with hematin spot (◻ Fig. 1) had formed as a result of SEMS impaction. We decided to shorten the stent with argon plasma coagulation (APC). For this procedure we used a duo-

Metal stents are a valuable means of restoring the continuity of the biliary tract. Choosing the correct size and accurate positioning are key factors to reducing complications. Furthermore, metal stents with rounded edges could reduce the risk of ulceration. Finally, longer hospitalization may be advisable when treating SEMS-induced bleeding ulcers.

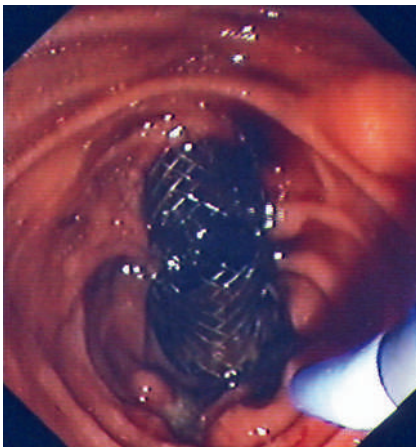
Fig. 2 Half-way through cutting the stent. The ulceration is also visible as is the argon plasma coagulation catheter.

denoscope and an ERBE generator (APC settings: power 80 W, flow rate 1.8 l/minute). The section was done circumferentially 1 cm from the papilla (◻ Fig. 2), and the stent was shortened by 1.5 cm (◻ Fig. 3). During his hospitalization the patient was making progress and his hematocrit was stable. He was discharged 4 days later.

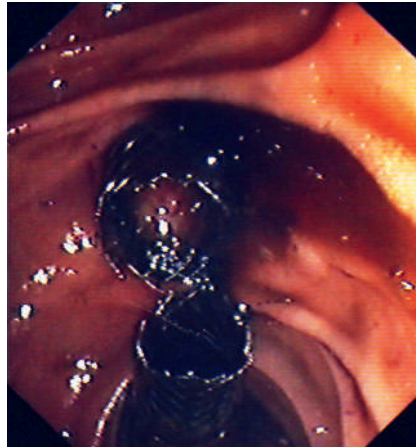
Fig. 3 Final result of cutting the stent. The fragmented piece is afterwards withdrawn along with the scope.
