Differentiating spontaneous vertical root fracture in endodontically treated tooth

Myung-Jin Lim¹, Jung-Ae Kim¹, Yoorina Choi², Chan-Ui Hong³, Kyung-San Min^{1,4}

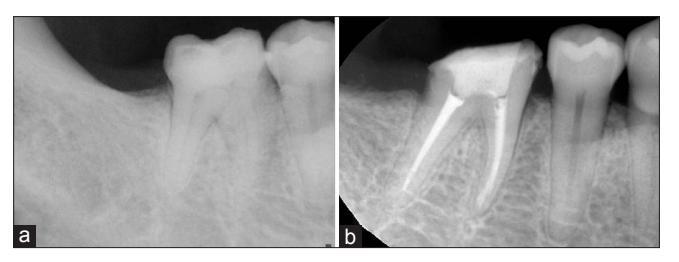
all canals were dried and filled with gutta-percha and resin-based sealer (AHplus; Dentsply-Caulk, Konstanz, Germany) using the warm vertical compaction technique (Endo-Apex; EPdent, Seoul, Korea) [Figure 1b]. Then, we fabricated a full veneer gold crown.

Figure 1: Radiographic features of the mandibular right first molar. (a) Diagnostic radiograph before treatment. (b) Postoperative radiograph. Symptoms were relieved after root canal treatment

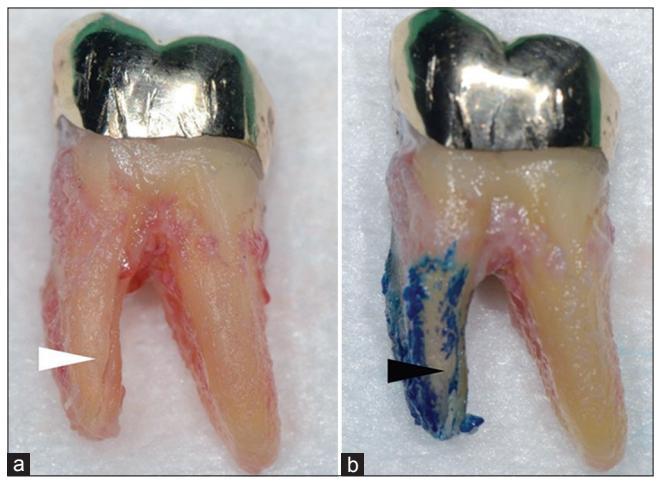
Figure 3: Clinical photographs of extracted tooth. (a) The extracted tooth showing a definite fracture line on the mesial root (white triangle). (b) The fracture line became more obvious after methylene blue staining (black triangle)

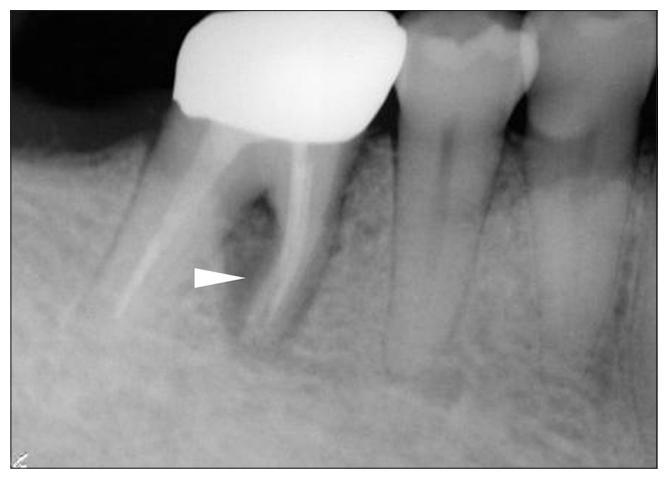
After 6 months, the patient revisited complaining of dull pain and localized swelling. We found a deep, narrow periodontal pocket on the buccal aspect of the tooth. Radiographic examination revealed extensive J-shaped periodontal bone loss around the mesial root [Figure 2]. We strongly suspected VRF and planned an extraction. When the patient noticed the problem, he asked us for the cause of the VRF. Moreover, he wondered whether the fracture could have occurred during the endodontic treatment. We explained that the fracture might have been present before the treatment or that it might have been caused by the root canal filling procedure. However, we could not give him a clear answer as to which possibility was correct. Finally, we suggested that we extract and examine the tooth in detail. The tooth was extracted under local anesthesia. We found a fracture line on the mesial root [Figure 3a]. The fracture line appeared more clearly when we stained it with 1% methylene blue solution [Figure 3b].

Figure 2: Radiograph at revisit after 6 months. Note the J-shaped periradicular radiolucency around the entire mesial root (white triangle)

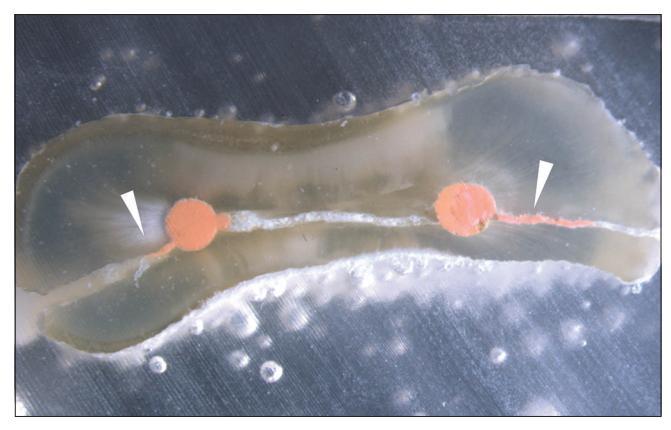
For scientific use of the tooth, we obtained informed consent from the patient. After embedding the tooth in acrylic resin, we sectioned the specimen transversely using a low-speed microtome (ISOMET; Buehler, IL, USA). We then examined the sectioned surface under a stereomicroscope (Leica MZ16FA; Leica, Wezler, Germany). The fracture line was along the mesial root in the buccolingual direction. Notably, we found gutta-percha in the fracture line [Figure 4]. It appeared to have been squeezed into the fracture line by the force generated during filling. It provided clear evidence that the fracture line already existed before the root canal filling procedure. We informed the patient, who agreed that the fracture occurred spontaneously before the treatment. We then planned restoration of the missing tooth with a dental implant.

Figure 4: Stereomicroscopic view of the sectioned mesial root. Note the definite crack line containing gutta-percha (white triangles) (×20)

conditions. Herein, we offer a useful tip for verifying when a VRF occurred: extract the tooth or root, then section, and examine it. If gutta-percha is present in the fracture line of the transversely sectioned root, it can be postulated that the crack line existed before the root canal filling procedure. Without a preexisting fracture line, the gutta-percha could not penetrate into the root dentin. In our case, we found obvious gutta-percha in the fracture line. It looked like the gutta-percha had been squeezed into the fracture line by the force generated during vertical compaction [Figure 4]. That clearly indicated that the fracture line already existed before the root canal filling procedure, which meant that the VRF was not iatrogenic. The patient withdrew his claim after this verification and agreed to our plans for the future restoration of the edentulous area.

There might be a possibility that the VRF occurred during the root canal filling procedure. Indeed, unless this possibility is excluded, our clinical suggestion cannot be accepted. Previous studies demonstrated that the load necessary to elicit a VRF ranges between 7 and 17 kg^[5,13,14] and the force needed to fracture a root is much higher than that formed during filling compaction. Furthermore, VRFs result from a gradual diminution of root structures that develops from preexisting defects such as microcracks or craze lines and should not be considered an instantaneous phenomenon.^[15] Even though the VRF can be assumed to be initiated by the force generated by obturation force, the fracture might be just a craze line considered as an initial defect. Consequently, this minute fracture line could not allow the penetration of semisolid gutta-percha at the moment. In this respect, it is appropriate to presume that the VRF preexisted spontaneously and it was induced by the microcrack which elicited long before.
