Dual-scan technique for the customization of zirconia computer-aided design/computer-aided manufacturing frameworks

Key words: Computer-aided design/computer-aided manufacturing, dual-scan technique, zirconia

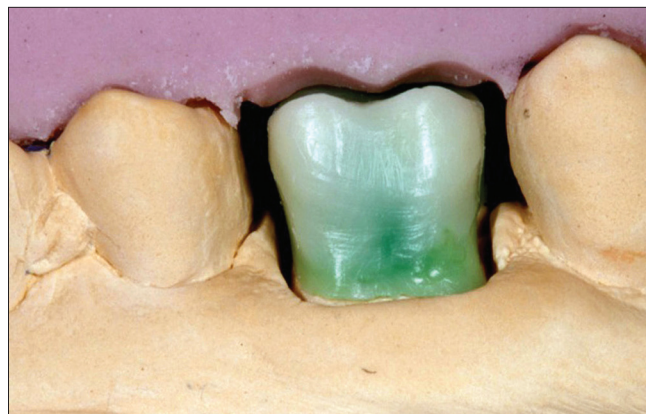
Figure 2: Waxed substructure

A dual-scan procedure was used to combine the datasets from the die with and without the waxed
