The effect of resistance grooves on the fracture toughness of zirconia-based crowns from mono and cyclic loading

Tarek Q. Qasim¹, Billal M. El-Masoud², Ahmed M. Abu Laban²

ABSTRACT

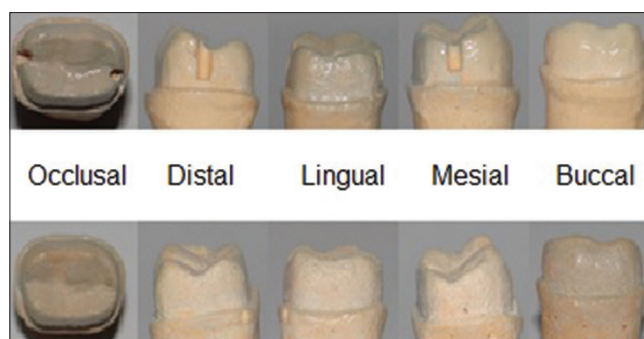
Figure 2: Different views of the abutments used in this study after duplication and the addition of grooves in one of the abutments to insure standardization of the abutment and to minimize the variables to only the grooves addition

[Figure 2]. The direction of the chewing was placed buccolingually, to mimic the chewing forces applied by the human jaws. Both stone dies were scanned using computer-aided design/computer-aided manufacturing CAD/CAM machine (NEO CAD 7.7). The Zirconia copings have overall thickness of 0.5 mm with the exception of the groove area. The CAD/CAM method is widely used in dental prostheses.^[13] Two groups of eight zirconia copings were made for each abutment, zirconia compatible porcelain (Noritake-Japan) then veneered to all samples with 1 mm porcelain thickness. To hold the fabricated crowns in testing chamber, abutments for the crowns made from hybrid composite (Prime dent - USA). The composite built inside the crown and extended 8 mm below the crown edge, i.e., gum line. All specimens were subjected to thermal aging using a thermal cyclic machine for 6000 cycles (5°C-55°C); the duration of each cycle was 60 s to simulate 5 years in oral service. Before testing, the samples fixed in the specimens holder using dental acrylic (Metropair- England) and left to cure slowly for 24 h at room temperature. According to manufacturer specifications, materials properties used in this study are summarized in Table 1.
