# Pseudotumor in Large Diameter Head Metal-on-metal Total Hip Replacement\*

Rev Bras Ortop 2019;54:87–89.

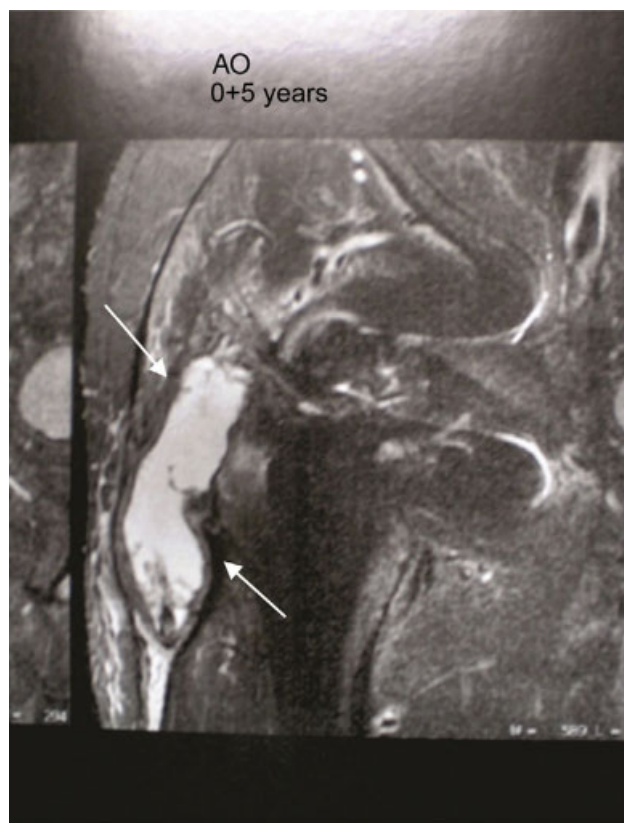
**Fig. 2** T2-weighted magnetic resonance imaging showing the pseudotumor mass.

Male, former athlete, 60 years old, primary osteoarthritis of the hip (Tonnis III), submitted to an uncemented total hip replacement with metal-on-metal tribological pair, 50 mm head, and femoral stem with interchangeable neck. The patient presented a normal evolution for 5 years, until the onset of groin pain, sudden limping, and trochanteric region swelling. The patient had no fever, and his motion range was preserved. Radiographs show the implant in normal position, cup inclination at 40°, with no demarcation lines and/or osteolysis (►Fig. 1). Normal C-reactive protein, erythrocyte sedimentation rate = 35/45; chromium = 2.1; cobalt = 4.1 µg/L. Joint puncture fluid with café au lait color and sterile cultures. A magnetic resonance imaging (MRI) exam with suppression of the metal artifact showed a large soft tissue mass involving the peritrochanteric region and communicating with the joint capsule (►Fig. 2). The patient underwent a total hip replacement revision via the lateral route with the resection of the tumor mass involving part of the abductor mechanism and joint capsule (►Fig. 3). The fixed acetabular component, with no wear signs, was removed and replaced with another implant with a cross-linked polyethylene insert and a 32 mm ceramic head (►Fig. 4). The interchangeable neck and its connections showed signs of tribocorrosion and were replaced (►Fig. 5). At the 12-month post revision follow-up, the patient was asymptomatic and presented normal clinical, radiological, and laboratorial parameters.

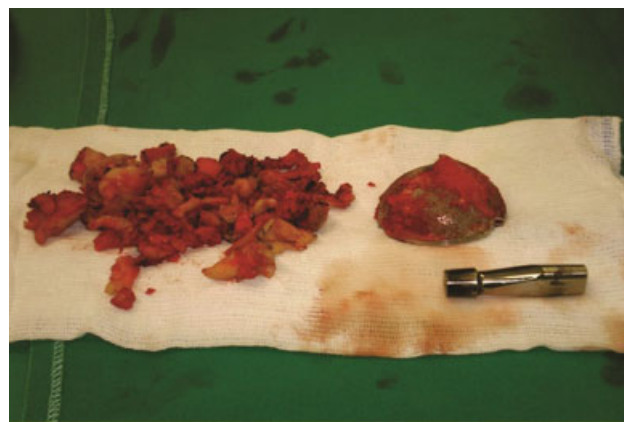
**Fig. 3** Extensive mass of resected tissues.

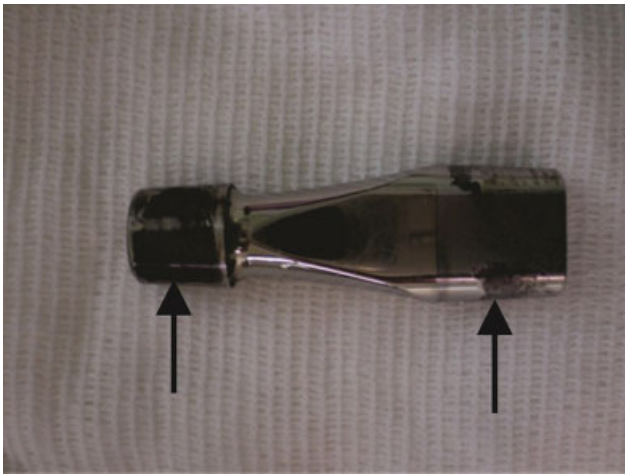
**Fig. 5** Typical tribocorrosion signs.

The frictional torque and the micromovements at the modular connection produce an additional amount of metallic debris caused by damage at the superficial layer of the cone, which is summed up to the particles formed at the joint surface.<sup>9</sup> The diagnostic value of the increased serum levels of chromium and cobalt ions is debatable. The clinical picture and the MRI with metallic artifact suppression are considered the basis for the diagnosis. The recommended treatment is the revision of the total hip replacement with resection of the abnormal tissue and implant exchange to achieve the maximum reduction of metallic interfaces.<sup>10</sup>
