Endoscopic removal of a broken self-expandable metal stent using the stent-in-stent technique

DOI <http://dx.doi.org/10.1055/s-0032-1306795>
Endoscopy 2012; 44: E232
 © Georg Thieme Verlag KG
 Stuttgart · New York
 ISSN 0013-726X

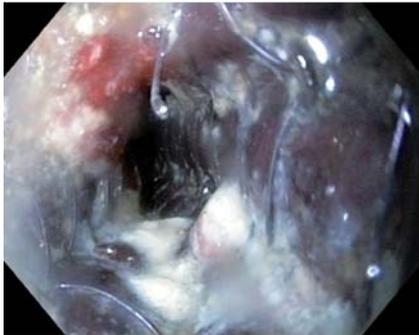
Fig. 1 Endoscopic image of one of the broken wires which resulted in collapse of the self-expandable metal stent (SEMS).

A 55-year-old man with dysphagia due to an unresectable distal esophageal adenocarcinoma underwent placement of a 15-cm partially covered self-expandable metal stent (SEMS), diameter 18 mm (Ultraflex; Boston Scientific, Natick, Massachusetts, USA). After 3 months, he presented with recurrent dysphagia. At endoscopy, the meshes of the SEMS had broken, leading to collapse of the SEMS and obstruction of the lumen (Fig. 1). Because the patient's clinical condition had improved and further treatment with chemotherapy or radiotherapy was considered, we decided to remove the SEMS using the stent-in-stent technique. A second SEMS, 17-cm long, fully covered, diameter 20 mm (Hanaro, M.I.Tech, Korea) was inserted, overlapping the full length of the first SEMS. After 2 weeks, on endoscopic examination, the loose struts of the disrupted SEMS had perfora-

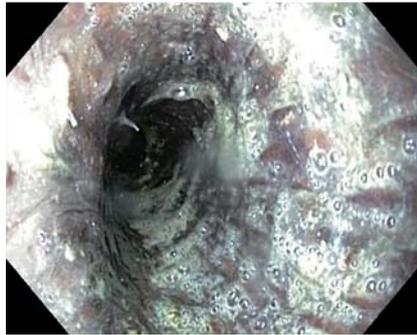
Fig. 2 The broken wires of the first self-expandable metal stent (SEMS) have perforated the covering of the second SEMS.

ted the covering of the fully covered SEMS, and the radial pressure of the fully covered SEMS had succeeded in detaching the partially covered SEMS from the esophageal wall and tumor (Fig. 2). By pulling the proximal retrieval lasso of the fully covered SEMS, both SEMSs were extracted simultaneously without the need to exert much force. Examination of the retrieved stents showed they were strongly attached to each other, indeed with loose struts of the first stent perforating the covering of the fully covered SEMS (Fig. 3). Immediately after removal of both stents, no esophageal stenosis was observed. The post-procedural course was uneventful, and the patient is currently without dysphagia. Spontaneous fracture with collapse of an esophageal SEMS is a rare complication [1,2]. However, if a SEMS is extracted by

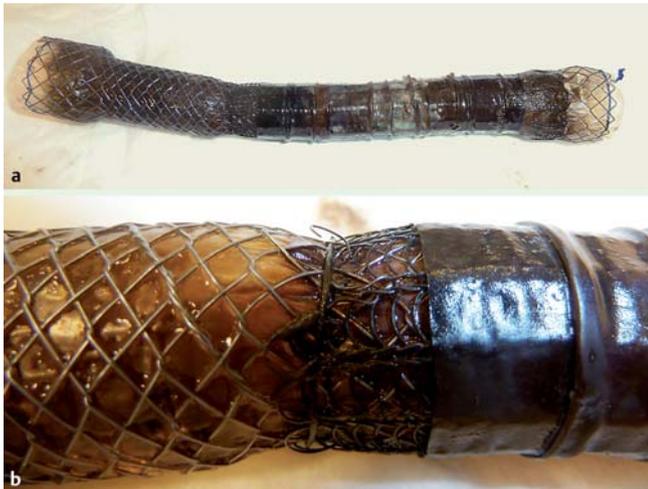
Fig. 3 **a** Fully covered self-expandable metal stent (SEMS) strongly attached to the partially covered SEMS. **b** Close-up of the end of the partially covered SEMS with a loose wire.
