# Fistula Formation 6 Years after Removal of Infected Pacemaker Leads

Thorac Cardiovasc Surg Rep 2015;4:49–51.

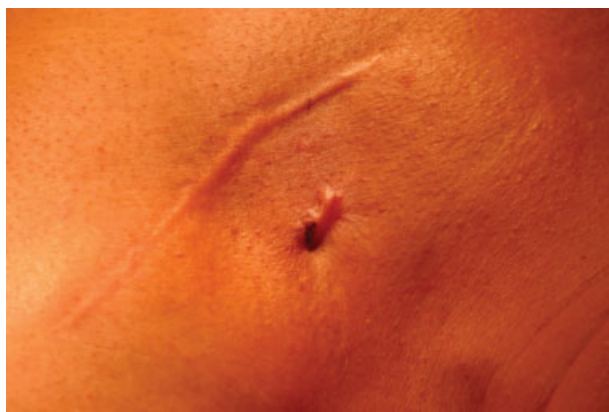
**Fig. 1** In addition to the scar of the old permanent pacemaker pocket the ulceration of the fistula is obvious.

In early 2013, the patient was readmitted to the hospital with same complaints. There were local swelling, tenderness, and purulent secretion. Signs of systemic infection could not be detected. We suspected an 8-cm-long fistula between the lead remnant under the left collarbone, seen 6 years ago, and the skin surface (▶ Fig. 1). Based on this assumption, we decided to resect the fistula and remove the fragment.

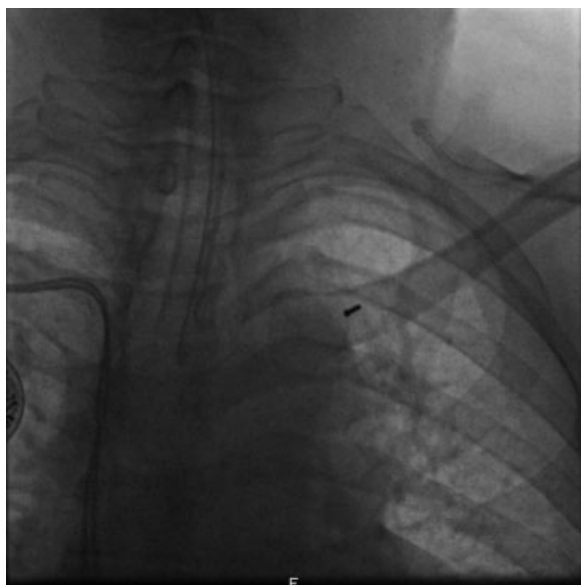
**Fig. 2** Chest X-ray: Under the left clavicle, the remaining electrode tip is visible. In addition, the endotracheal tube and the right-side permanent pacemakers are shown.

The procedure was performed under general anesthesia. In the first step, the lead tip was localized by fluoroscopy and the area in which the fragment was projected was marked on the skin surface (▶ Fig. 2). We used Siemens Artis Zeego multiaxis system (Siemens Healthcare, Erlangen, Germany) for screening to permit localization in several angulations. The next step was to explore the fistula by a small probe, followed by spindle-shaped cutting of the same. Because of severe

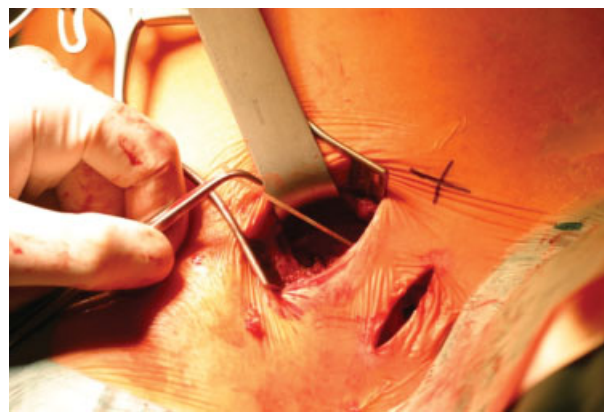
**Fig. 3** The image shows the infraclavicular and the supraclavicular access and the remaining lead. The fistula was removed.

adhesions, a further supraclavicular incision was necessary to reach the fragment (→**Fig. 3**). Another advantage of the additional supraclavicular incision was facilitated access to the lead remnant and better control in case of hemorrhagic complications. In addition, the strong connective tissue of the fistula served as a guidance structure to reach and mobilize the fistula and the lead fragment. We were able to rescue a 10 cm lead isolation fragment, the anchor, and the electrode tip of the pacemaker lead explanted 6 years ago (→**Fig. 4**). This finding was unexpected, because the silicone insulation of the pacing lead was invisible under fluoroscopy and we had assumed only a lead tip or a small fragment. The fistula ended right on the subclavian vein. To prevent oozing, we placed a Tabotamp hemostat (TABOTAMP, Ethicon Biosurgery, Johnson & Johnson Medical GmbH, Norderstedt, Germany), a densely woven knit of oxidized regenerated cellulose, inside

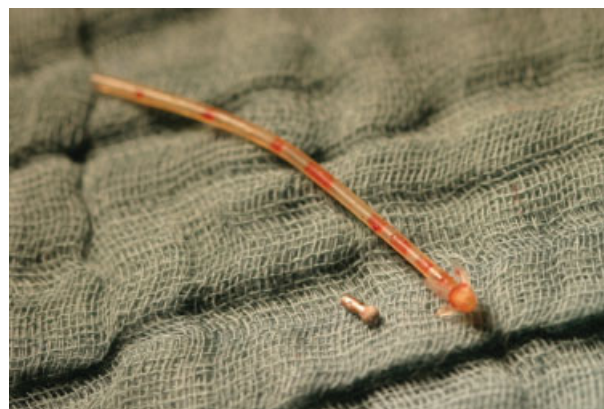
**Fig. 4** The removed lead remnant and electrode tip.
