Polyethylene Tibial Post Fracture in a Posterior Stabilized (Genesis II) Total Knee Arthroplasty

J Knee Surg Rep 2015;1:60–63.

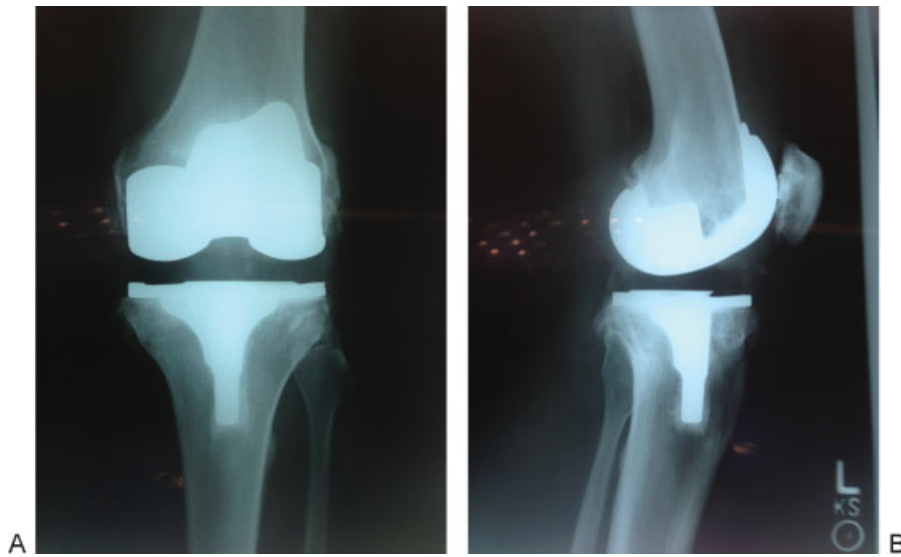
Fig. 1 (A) Anteroposterior radiograph of knee after injury. (B) Lateral radiograph of knee after injury.

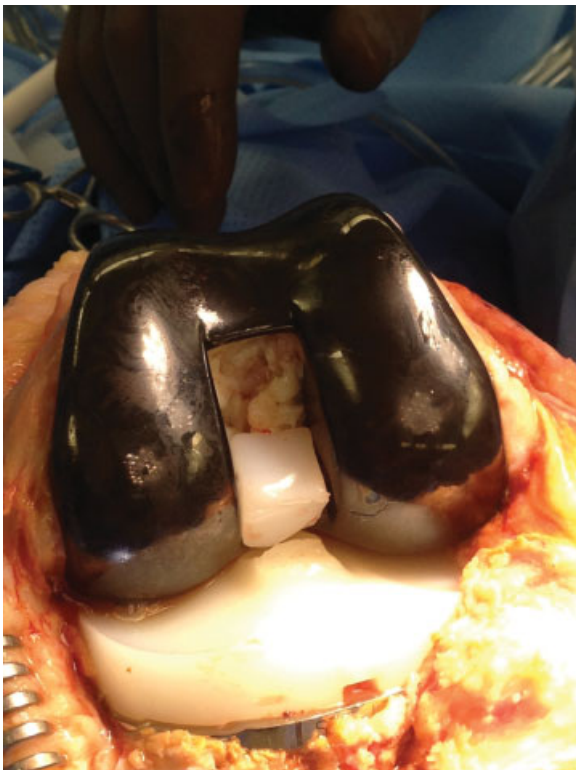
The patient's previous midline incision and medial parapatellar arthrotomy were utilized. Immediately upon exposing the joint, the fractured post was found sitting anterior to the polyethylene insert and tibial component (▶ Fig. 2). The femoral, tibial, and patellar components were inspected and found to be stable and well fixed. The insert was then

Fig. 2 Photograph of fractured polyethylene tibial post discovered during surgical exposure.

Posterior stabilized knee prostheses have the design feature of a cam and post to replicate native kinematics. The cam engages the post during flexion and results in femoral rollback. However, this mechanism increases the potential for higher wear and failure especially in the setting of anterior post impingement. This can be the result of placing the

femoral component in flexion, cutting the tibia with increased posterior slope, knee hyperextension, posterior placement of the femoral component, or anterior tibial tray placement.³ The post is also at risk with deep flexion as this can place significant shear stress across the post.⁵ Multiple reports of post fracture have been published, and anterior impingement and deep flexion mechanisms have been consistently described.⁴⁻⁹

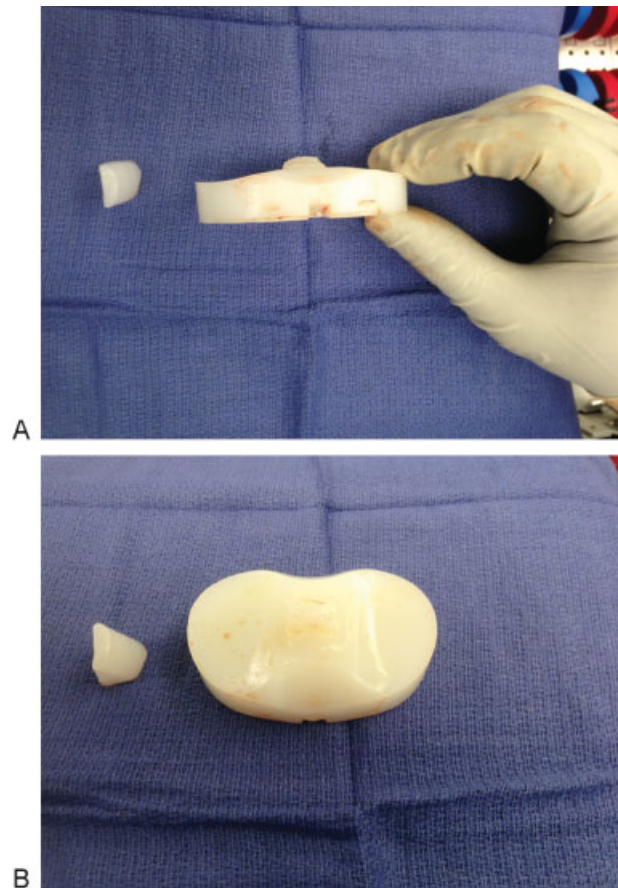
removed from the knee and examined. There were no signs of significant wear along the medial or lateral compartments. The post also showed no signs of increased wear (►Fig. 3A, B). A size 18 posterior stabilized polyethylene insert was then inserted into the knee (►Fig. 4). The knee was examined for varus/valgus, anterior/posterior, and midflexion stability and

Fig. 3 (A) Anterior aspect of the polyethylene insert showing the post fracture. (B) Superior view of the polyethylene insert with fractured post.

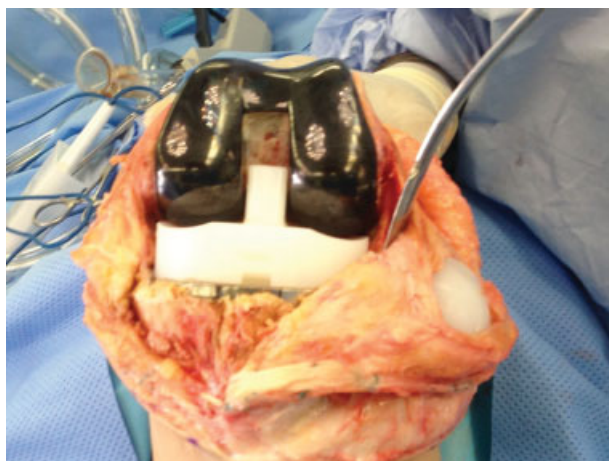
Fig. 4 Photograph of knee after polyethylene exchange.

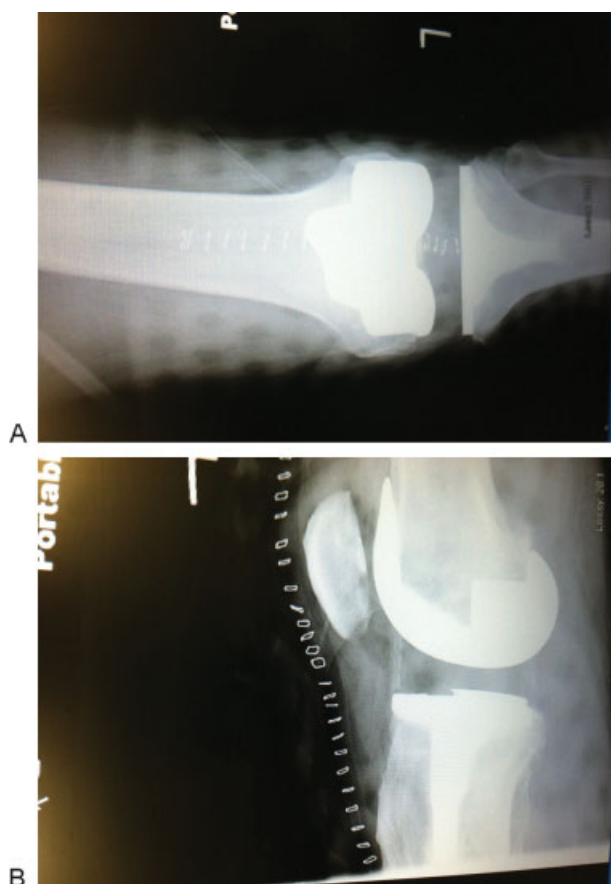
Fig. 5 (A) Anteroposterior radiograph after revision surgery. (B) Lateral radiograph after revision surgery.

was found to be stable. Patellar tracking was midline. At follow-up, patient was doing well with significantly improved pain and function of his left knee (►Fig. 5A, B).
