# Unusually High Rate of Early Failure of Tibial Component in ATTUNE Total Knee Arthroplasty System at Implant–Cement Interface

J Knee Surg 2017;30:435–439.

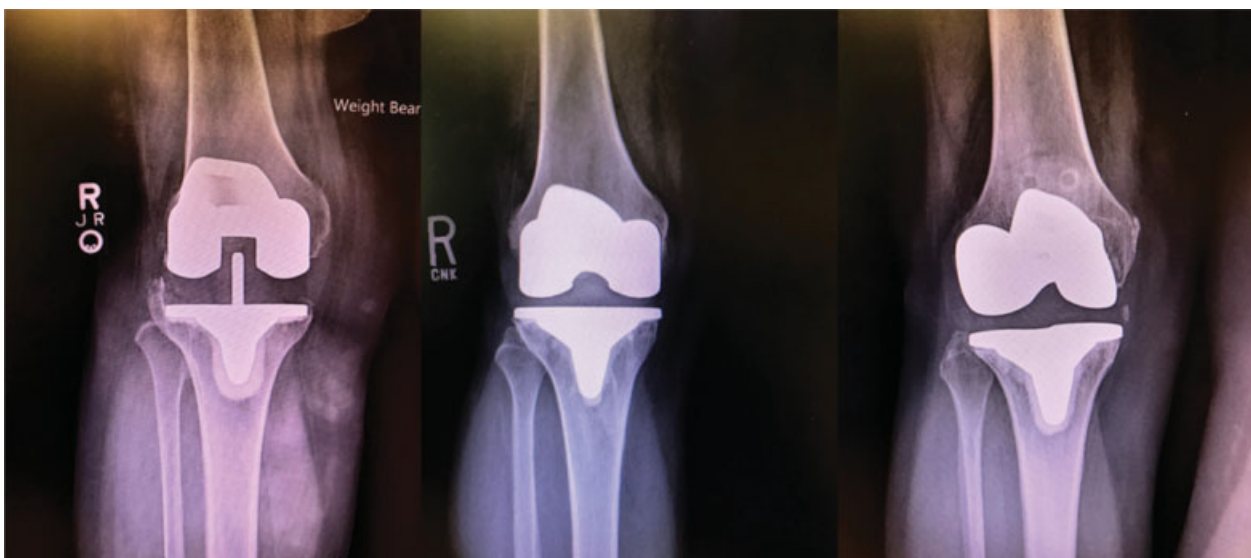
Radiographic evaluation of the 15 knees that received this implant demonstrated only 2 (13%) to have evidence of radiolucencies. In the first case, on the AP radiograph, there was evidence of radiolucency in zones 1 and 2. On the lateral radiograph, there was evidence of radiolucency in zone 3A. For the second case, there was evidence of radiolucencies in zones 1, 2, and 3L on AP radiograph, and zones 1, 2, and 3A on lateral view (→ Fig. 1).

**Fig. 1** Anteroposterior radiographs prior to revision surgery.

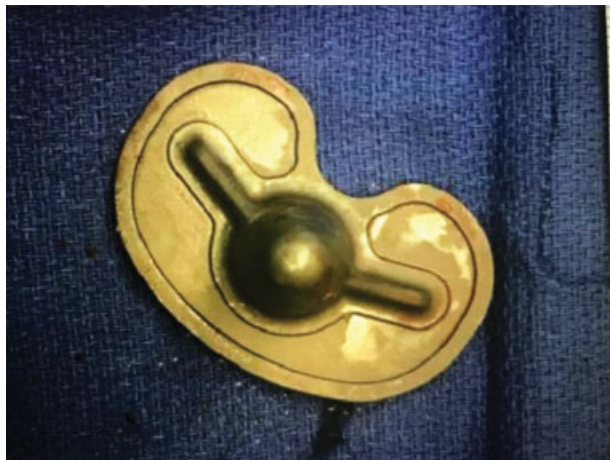
In all revision cases described in this study, there was an apparent loosening of the tibial component with gross implant motion between the tibial tray and tibial bone cement. In one patient, the tibial tray would piston 4 mm as the knee was brought from flexion to extension, and would lift off from the tibial bone cement when the leg was manually distracted intraoperatively. All patients underwent revision of both tibial and femoral components. In all tibial cases, the tibial tray would piston 4 mm as the knee was brought from flexion to extension, and would lift off from the tibial bone cement when the leg was manually distracted intraoperatively. All patients underwent revision of both tibial and femoral components. In all tibial cases, the tibial component had debonded and was easily separated from the cement mantle. Upon removal of the tibial baseplate, the inferior surface of the tibial baseplate was clear of cement (→ Fig. 2), while all the cement was strongly adherent to the tibial bone (→ Fig. 3). The femoral components were securely attached to the femoral bone with no apparent loosening. Upon explantation of the femoral components, the cement was strongly adherent to the implant surface in all cases (→ Fig. 4).

**Fig. 2** Inferior surface of the tibial component immediately after explantation.

cement–bone interfaces, which may contribute to the loosening. The design of the inferior surface of the tibial component appears to have rounded edges and less insets for cement interdigitation relative to the prior designs. In addition, the tibial keel appears to have less rotational phalanges which may lead to less rotational stability and less macro-interdigitation. Furthermore, according to the manufacturing literature, the backside surface of the tibial component has markedly different surface roughness when compared with the femoral component (60 vs. 220 grit blasts). All of these factors may contribute to the propensity of this implant for early loosening through higher loads and less stability at the tibial implant–cement interface.

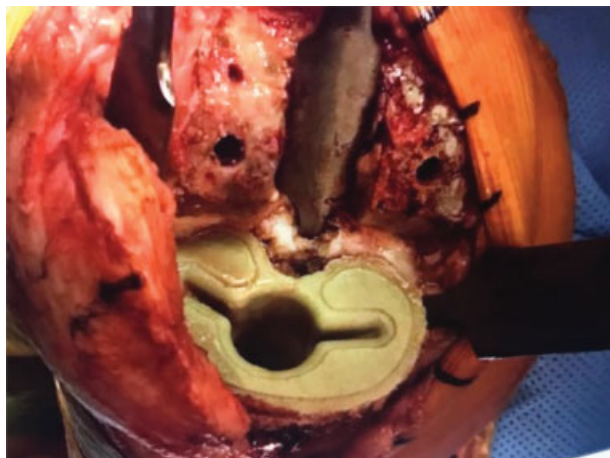
**Fig. 3** Cement adherent to the tibial bone after explantation of tibial component.

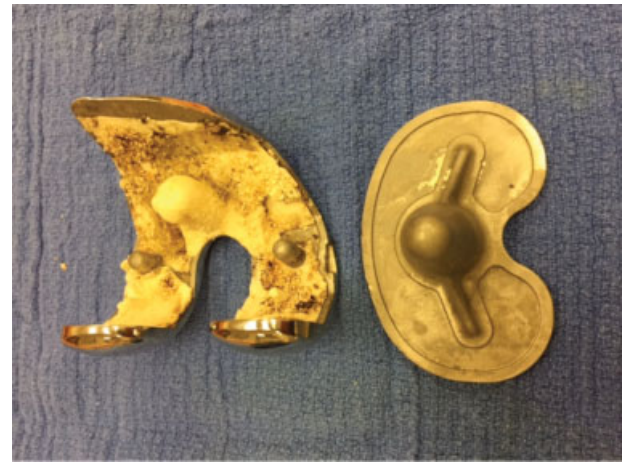
**Fig. 4** Cement adherent to femoral component but not tibial component.
