Stress Fracture of Proximal Femur after Hip Resurfacing Treated with Cannulated Screw

We describe a case illustrating a femoral neck stress fracture in a patient operated with hip resurfacing (HR), surgically treated with osteosynthesis.

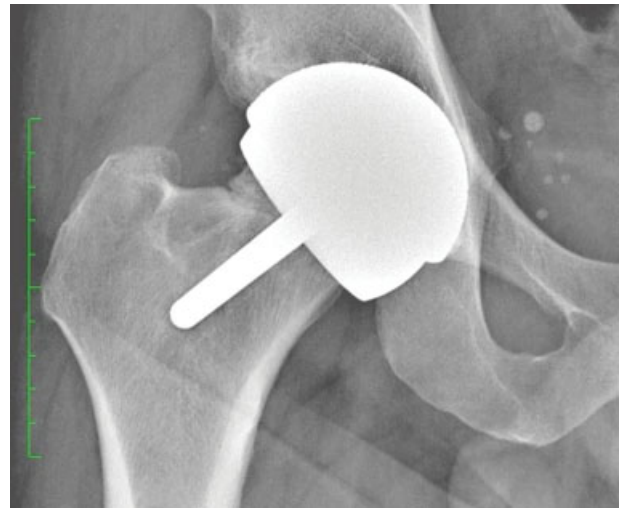
The anteroposterior X-ray showed a stress fracture of the femoral neck with a slight variation (4 degrees) of the prosthetic component compared with the postoperative X-rays (▶ Fig. 2). No magnetic resonance imaging was required

Fig. 2 Anteroposterior X-ray at 2-year follow-up after hip resurfacing showing a stress fracture of the femoral neck.

Femoral neck fractures are a well-documented complication of HR and occur within the 9th week after surgery.² To prevent this event, it is recommended a careful patient selection and careful surgical technique. In our case, fracture occurred many years after surgery, despite correct implantation of the femoral component and normal BMI of the patient. This scenario and patient history led us to diagnose a stress fracture.

in favor of osteoclasts. The result is the appearance of microfractures which, in some cases, may lead to complete fractures.^{1,3} For this reason, we chose not to weaken the lower part of the femoral neck and tried to stabilize the fracture. In our opinion, factors associated with the occurrence of the fracture were prolonged downhill running and the hard training on a hard-on-hard prostheses.

The day after, the patient underwent surgery under spinal anesthesia in the supine position. As the fracture was incomplete, it was treated like undisplaced femoral neck fracture, with reduction maneuver. A lateral incision was made and under observation from the image intensifier a guidewire was passed superior to the stem of the femoral component of the BHR. One 6.5 mm cannulated screw 75-mm long was placed into the superior neck. The image intensifier was used to confirm that the threads were beyond the fracture line and that the fracture was compressed (**Fig. 3**).
