Revision of a Press Fit Biological Fixation Stem Fracture in a Dog

VCOT Open 2019;2:e19–e26.

This report describes a clinical case of a press fit biological fixation femoral implant neck fracture (fatigue failure) and its revisions in a dog. A total hip arthroplasty revision was performed. The stem was replaced with a bigger one through a V-shape osteotomy of the proximal–lateral aspect of the femur. Stabilization was accomplished using a locking plate and two over-the-plate cerclage wires. Subsidence of the femoral stem occurred following revision and was revised with a second revision in which a collared stem was used. Two revision surgeries were necessary to have a stable functional prosthesis with successful bone integration at 7 months postoperative reevaluation. Major errors encountered in this case were placement of an undersized stem and an inadequate femoral canal stability/press-fit. Fracture of a BFX femoral stem neck has not been previously reported.

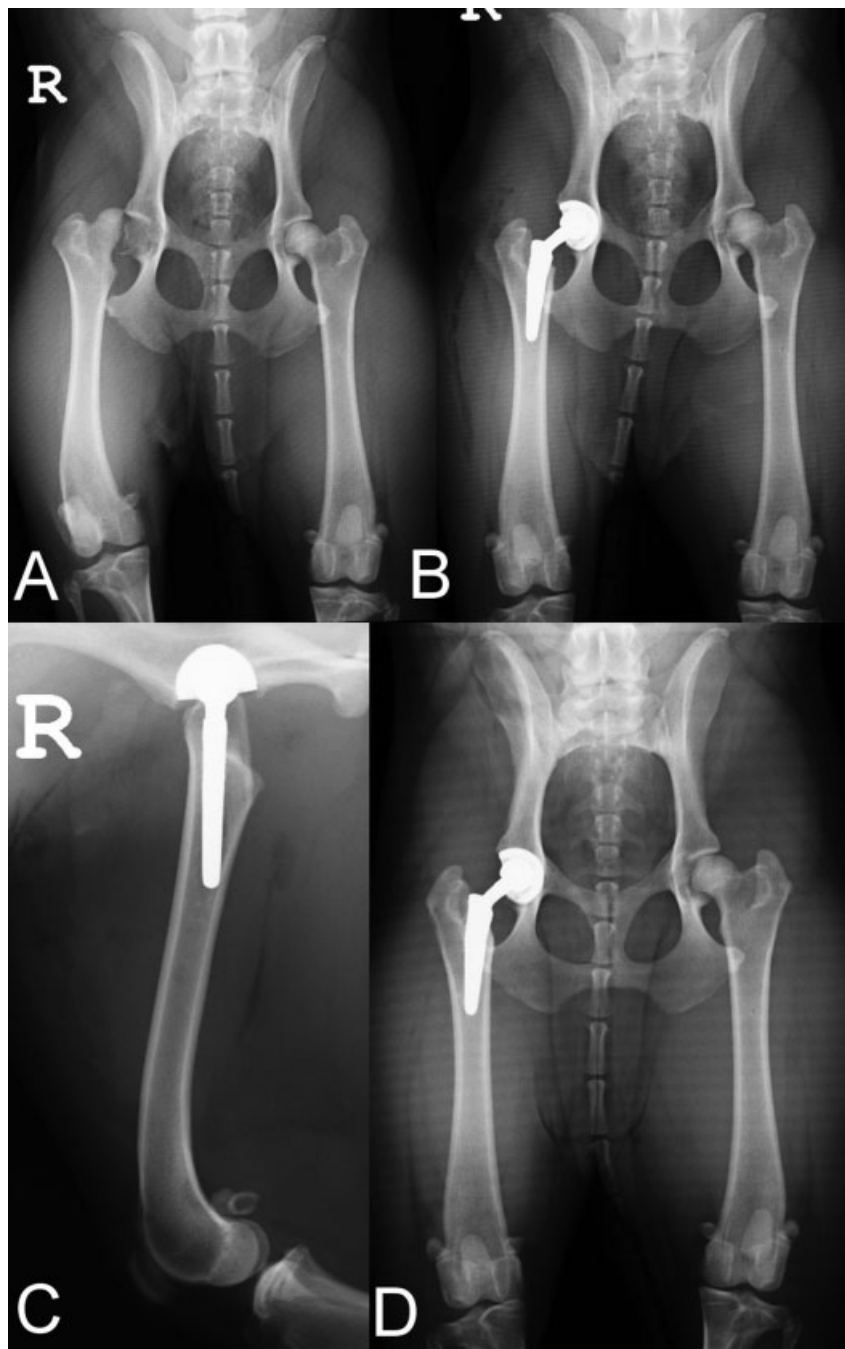
Fig. 1 Preoperative ventrodorsal hip extended, pelvic radiographic view (A) showing an articular non-reducible multifragmentary femoral head fracture of the right femur. Postoperative ventrodorsal hip extended, pelvic radiographic view (B) and mediolateral femoral view (C). A cementless total hip has been implanted. The stem is size number 4, the prosthetic cup is 20-mm with a +3, 12 mm diameter prosthetic head. A ventrodorsal hip extended, pelvic radiographic view acquired 2 months after surgery (D) shows osseointegration of the cup and stem.

A 1-year-old female American Staffordshire Terrier weighing 19 kg was referred to our clinic for a non-weight bearing right hindlimb lameness after a fall from a balcony. A non-reducible multifragmentary right femoral head fracture was identified radiographically. A total hip replacement was planned. A 20-mm BFX acetabular cup, number BFX stem and a +3 mm, 12-mm-diameter head (BioMedtrix; Whippany, New Jersey, United States) were implanted. Radiographs performed 2 months after surgery showed stable bony ingrowth (–Fig. 1).

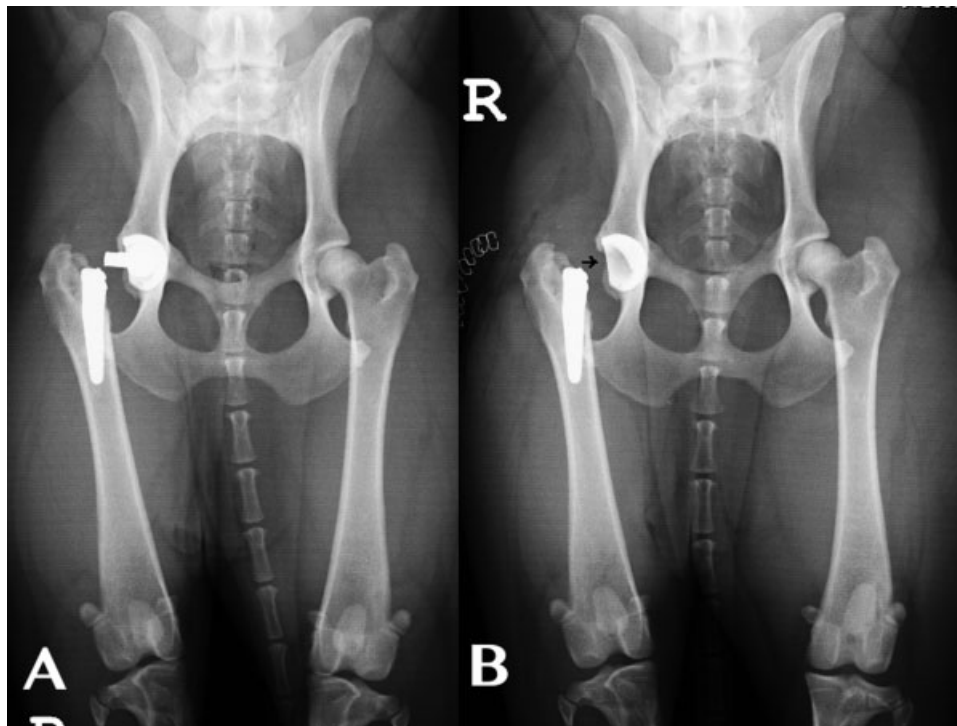
Four years after surgery, a right hind limb non-weight-bearing lameness occurred acutely while the dog was running. A fatigue failure at the junction of the stem neck and shaft was seen on radiographs. Implant loosening, bone resorption or fracture of the femur was not observed. Eccentric position of the prosthetic head in the cup suggested severe cup liner wear (►Fig. 2).

Fig. 2 (A) Ventrodorsal hip extended, pelvic radiographic view showing the fatigue failure of femoral stem 4 years after total hip replacement. (B) Postoperative ventrodorsal view of the pelvis after prosthetic neck and head removal. Bone damage on the dorsal acetabular rim is visible (arrow).

The prosthetic head and fractured neck were removed using a craniolateral approach.¹⁸ Radiographic signs of dorsal acetabular rim wearing were noticed after surgery, see-

ingly due to impingement of the prosthetic neck on the lateral aspect of the cup and adjacent bone. One month later, the lameness had not improved and a stem revision surgery was planned. An extended trochanteric osteotomy was performed (►Fig. 3), and the stem was removed. The osteotomized segment was reduced and secured using a six-hole, 139-mm-long, 2.5-mm-thick locking stainless steel plate (V3304 Fixin Intrauma; Rivoli (TO), Italy) placed on the lateral surface of the proximal portion of the femur. Three monocortical titanium alloy 3.0 mm locking screws were

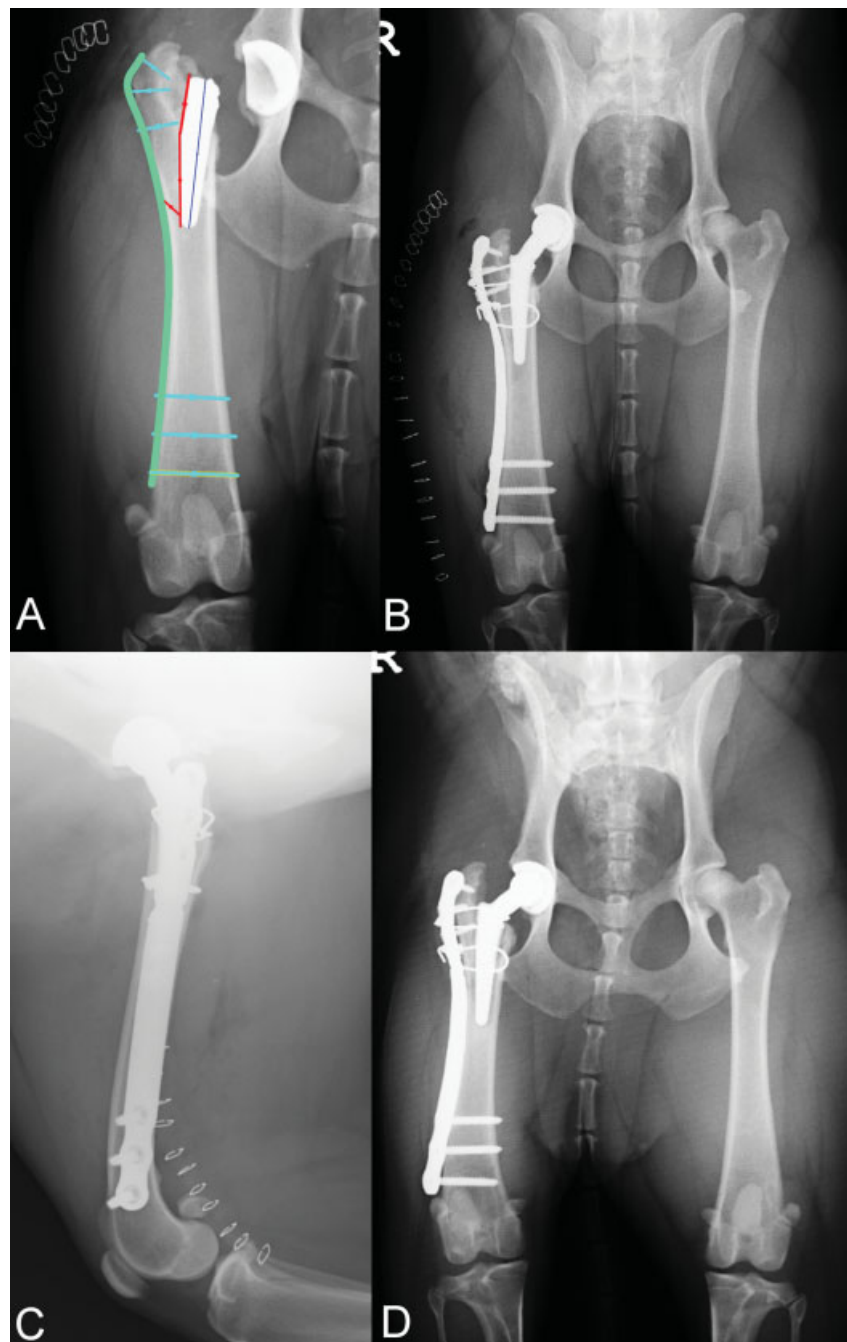
Fig. 3 (A) Preoperative revision planning. The green line represents the plate and pale blue lines the screws. The red lines outline the osteotomy. The blue line measures the stem length. (B) Ventrodorsal hip extended, pelvic radiographic view after prosthesis revision surgery. (C) Postoperative mediolateral view of the right femur. (D) Twelve weeks after surgery, radiographic follow-up shows 4 mm of stem subsidence and a lack of osseointegration, with a radiolucent zone surrounding the stem, and femoral medullary sclerosis distal to the stem tip.

inserted proximally and three bicortical 3.5 mm locking screws were inserted distally. Two 1.25-mm-diameter single-loop cerclage wires (DePuy Synthes; West Chester, Pennsylvania, United States) were applied over the plate to provide additional stability. Polyethylene wear was confirmed intraoperatively and the polyethylene liner was removed. A new 20 mm polyethylene liner with 13 mm internal diameter (ID) to accommodate the femoral head diameter of the larger stem was impacted into place.¹⁹ The femoral canal was broached for the insertion of a new femoral stem using a number 5 broach (BioMedtrix). A number 5 BFX stem (BioMedtrix) was inserted. A 13-mm-diameter +5 mm prosthetic head (BioMedtrix) was impacted on the trunnion.¹⁷ Postoperative radiographs were acquired. Follow-up clinical examination and radiographs of the pelvis were performed at 12 weeks after surgery. The femoral stem had subsided by 4 mm. A weight-bearing lameness was visible. One month later, radiographic re-evaluation demonstrated lack of bone ingrowth and a loose stem (►Fig. 4). A revision surgery was scheduled. The two cerclage wires and the locking bone plate were removed. The femoral stem was loose and manually extracted. The femoral canal was broached using a number 6 and a number 7 broach (BioMedtrix). A number 7 BFX collared stem (BioMedtrix) was inserted. A 13mm + 5 head was applied. Stem alignment was considered adequate on postoperative radiographs. Follow-up clinical examination and radiographs of the pelvis were performed at 8 weeks (►Fig. 5) and at 7 months after the second revision. The dog was pain-free upon palpation or hip manipulation without visible lameness at a walk or trot. The stem was well

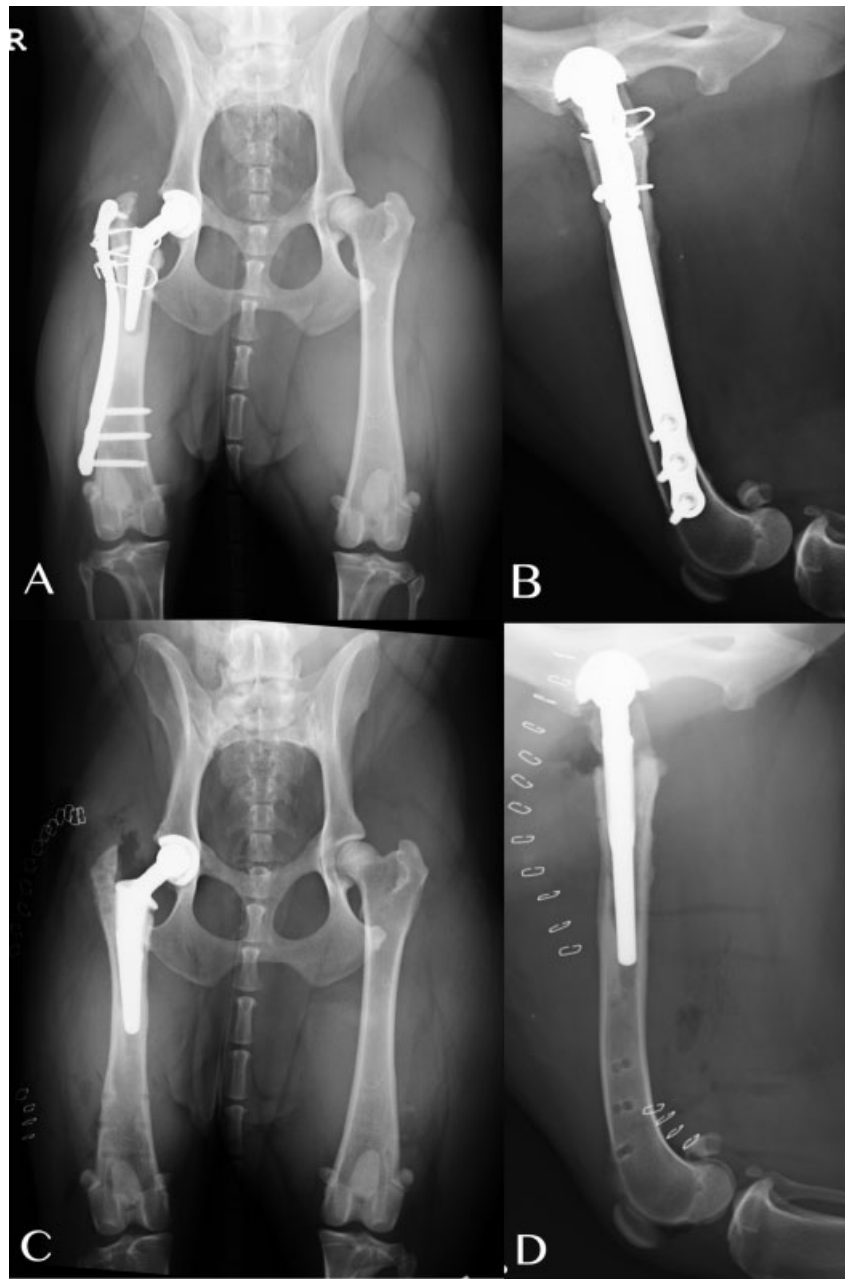
Fig. 4 (A) Ventrodorsal hip extended, pelvic radiographic view acquired 4 months after the revision showing further distal stem subsidence, osteolysis around the stem and lack of osseointegration with femoral medullary sclerosis distal to the stem tip. (B) Mediolateral view of the right femur 4 months after revision surgery. (C) Ventrodorsal hip extended, pelvic radiographic view after second revision surgery. A size number 5 biological fixation (BFX) stem was replaced with a collared size number 7 BFX stem. To prevent varus orientation of the broaches, a 1 mm slice of bone was excised from the medial aspect of the greater trochanter. (D) Postoperative mediolateral view of the right femur after second revision surgery.

Minor subsidence < 5 mm may occur in the first post-operative weeks before bone ingrowth takes place and it often does not have clinical consequences.²⁰ One of the causes of major clinical subsidence is poor femur canal preparation³² however, weak cancellous bone and/or an undersized stem can also be contributing factors. The stem selected to fit the femoral canal at the time of the first revision appeared suitable, and a press fit was achieved; however, 12 weeks after revision surgery, signs of severe subsidence were present. Stability provided was not enough to allow osseointegration. The stem had subsided by 4 mm and was loose. Failure of ingrowth may have been due to the lack of compression of the lateral cortical segment onto the stem. Using double loop cerclage wires directly on the bone, in addition to single loop cerclage wires over the locking plate, may have provided more stability and improved press fit.³³ Also, the stem used in the first revision was relatively small (number 5), and the cancellous bone may have been of poor (weak) quality. By comparison, the stem used in the second revision was two sizes larger (number 7) and had a medial collar. The subsidence of the number 5 stem probably compacted the endosteal bone and facilitated the placement of a larger stem at the time of the second revision.

In conclusion, placement of an undersized stem in the first surgery and an inadequate femoral canal stability/press fit following the first revision surgery were errors encountered in this case.

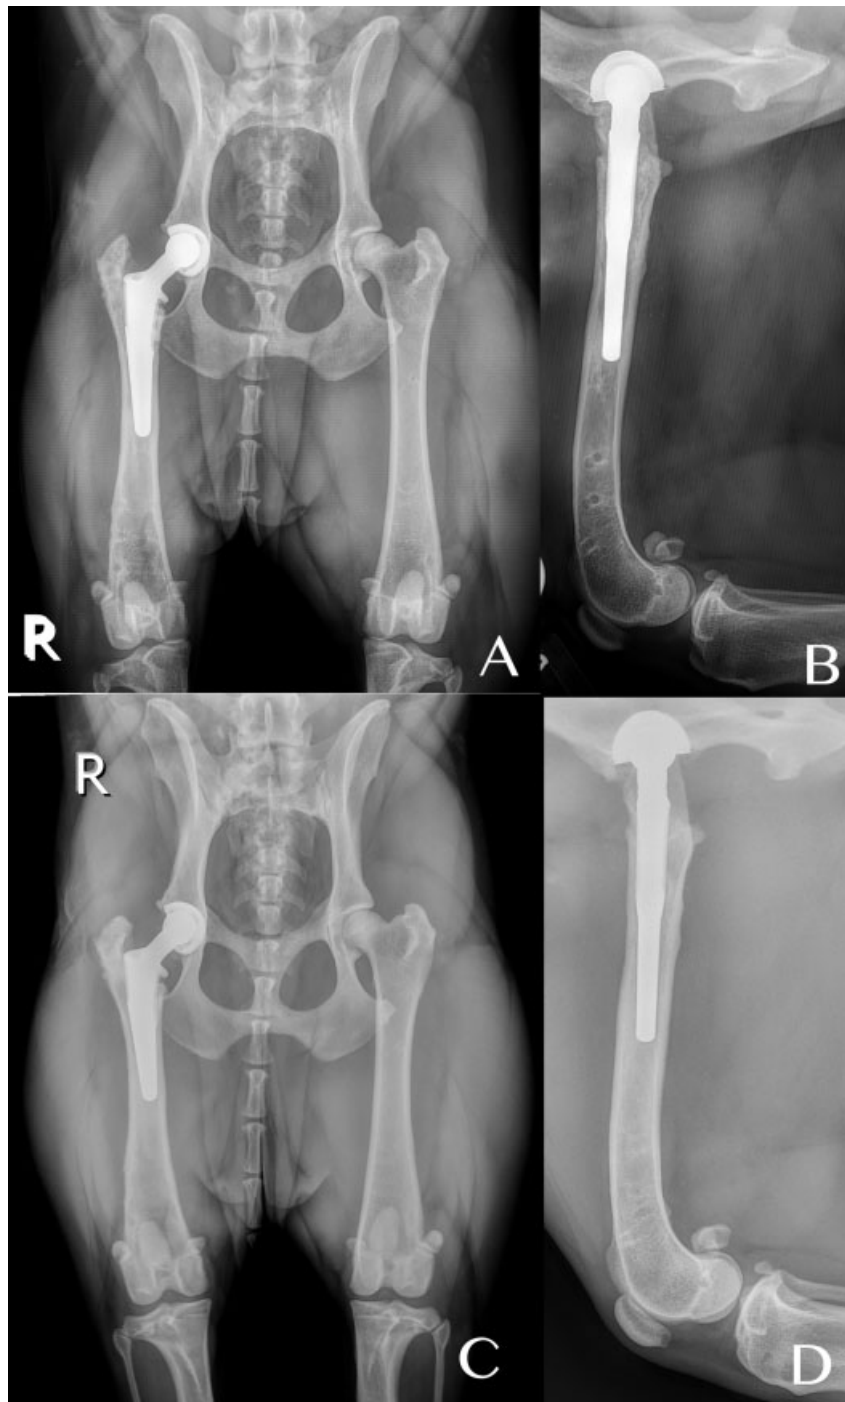
Fig. 5 Ventrodorsal hip extended, pelvic radiographic view (A) and mediolateral (B) radiographic view acquired 8 weeks after the second revision surgery (implantation of the number 7 stem). The stem is stable and appears well osseointegrated. (C) Ventrodorsal hip extended, pelvic radiographic view 7 months after the second revision surgery. No subsidence has occurred, and the stem appears well osseointegrated. (D) Mediolateral view of the right femur after 7 months from the second revision surgery. Right thigh muscle mass was improved compared with postoperative radiographs.
