# An Intraoral Repair Method for Chipping Fracture of a Multi-unit Fixed Zirconia Reconstruction: A Direct Dental Technique

Alfredo Mikail Melo Mesquita<sup>1</sup> Nadin Al-Haj Husain<sup>2</sup> Pedro Molinero-Mourelle<sup>2</sup> Mutlu Özcan<sup>3</sup>

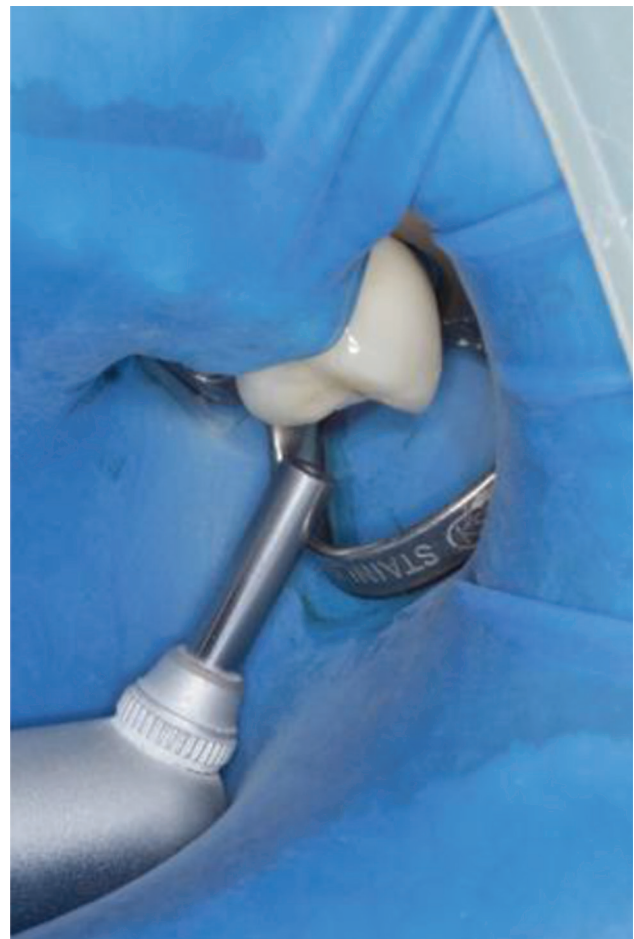
**Fig. 2** Air abrasion using a chairside device with silica-coated alumina particles (30 µm, 2.5 bar for 20 seconds).

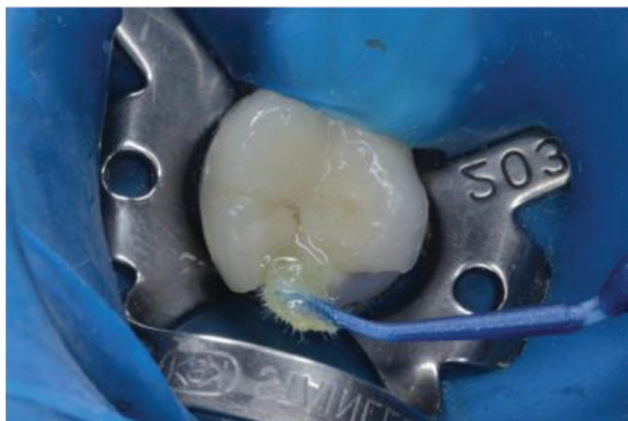
**Fig. 4** Application of adhesive resin.

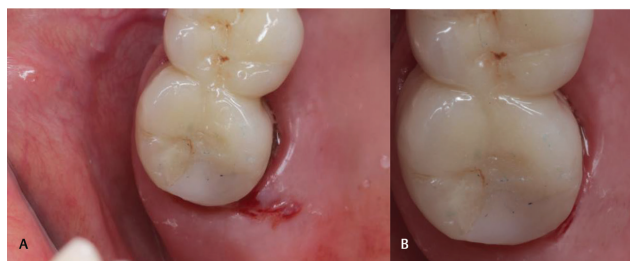
**Fig. 7** Final (A) over and (B) closeup view of repaired distal palatal veneering and core fracture.
