Early Intraprosthetic Dislocation of Total Hip Arthroplasty with Double Mobility Implant: Case Report*

Rev Bras Ortop

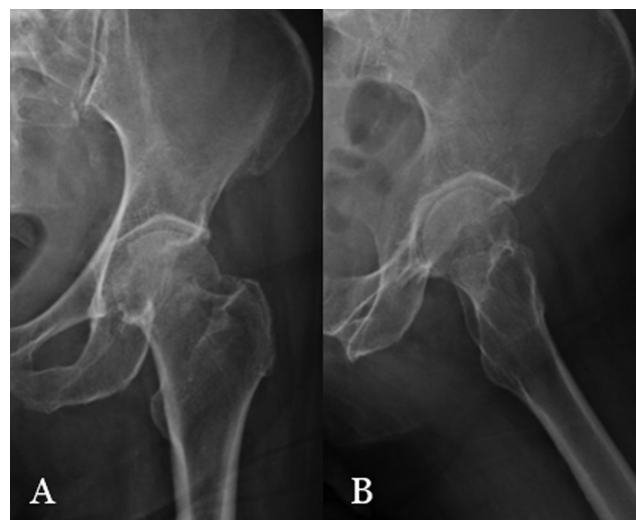
The radiographic examination revealed the diagnosis of fracture of the neck of the left femur, AO 31B1.1 (► **Figure 1a-b**).

Fig. 1 Fracture of the neck of the left femur impacted in valgus, in AP (A) and profile (B).

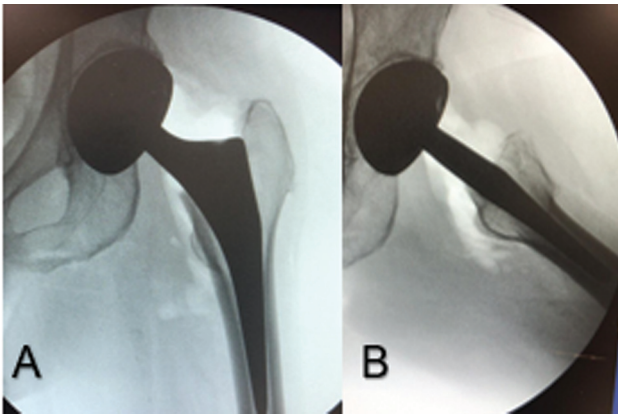
The polyethylene liner was properly coupled to the metal head with specific material and tested before being deployed. Stability tests and intraoperative control radiographs were performed, confirming good implant positioning and hip stability (► **Figure 2a-b**).

Fig. 2 Radiographic control in the immediate postoperative period showing reduction of components and concentricity of the metallic head (A) in AP and profile (B).

The patient underwent total arthroplasty of the left hip with double mobility implant (Medacta). A 48/28 double mobility polyethylene liner, size 1 uncemented femoral stem, a 28 mm metallic femoral head, and a 48 mm non-cemented acetabular dome were used. Posterolateral access was performed with capsular repair and short rotators.

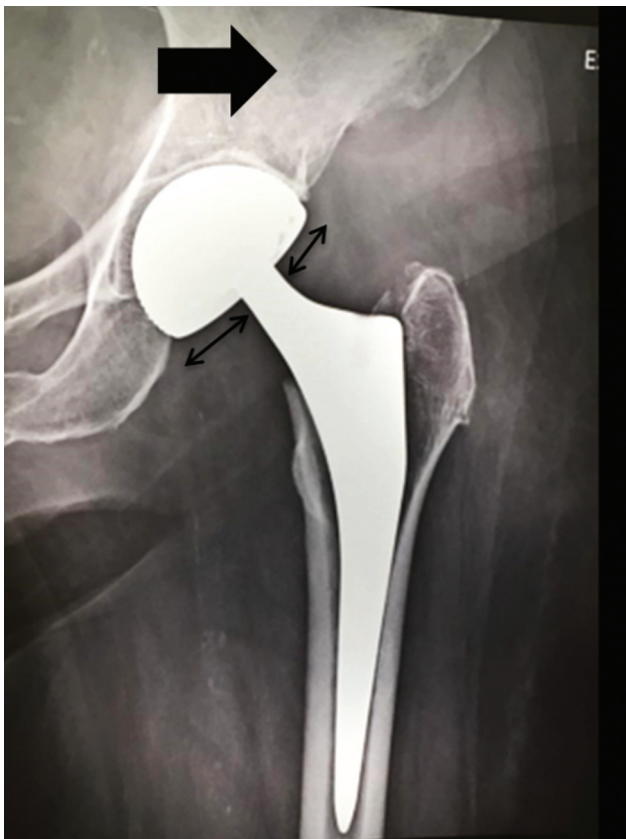
Fig. 4 X-ray 7 days after reduction. The larger arrow shows the "bubble sign", the polyethylene displaced in the soft parts. The smaller arrows show the eccentricity of the metal head in the acetabular dome.

condition, without functional limitation, complaining only of crackling in the posterior region of the left hip. Radiographs after reduction show congruence between the femoral head and the acetabular dome, but femoral head eccentricity is observed in the acetabular metallic dome (→**Figure 4**). A superolateral circular opacity (bubble sign) is also observed. Computed tomography (CT) reveals a polyethylene component in the posterosuperior aspect of the hip (→**Figure 5**).

In our case, the patient presented complications after a single attempt at closed reduction, in which the maneuver strength resulted in intraoperative displacement of the polyethylene. This complication occurs when the polyethylene coating fits into the edge of the acetabular component, and the subsequent traction of the limb results in the dissociation of the

metal head from the polyethylene coating, similar to a "bottle opener" effect, and polyethylene can migrate out of the acetabulum.

The reduction in these patients should be performed with general anesthesia or subarachnoid block, in order to facilitate it. The maneuver should be performed carefully and without axial traction to avoid or attenuate the "bottle opener" effect. Instead of applying direct axial traction, internal rotation should be coupled to axial traction, allowing the polyethylene coating to move away from the acetabulum, avoiding the collision of the acetabular component. Fluoroscopic imaging should be used to guide the reduction maneuver. Postreduction radiographs should be carefully evaluated for femoral head eccentricity and the presence of a bubble sign. Intraprosthetic dislocation requires surgical intervention, and anesthesia should be used for open reduction and eventual component replacement. Computed tomography may be requested in case of doubt. The suggestion would be to place a metallic marker on the polyethylene that would facilitate its detection on radiographs.

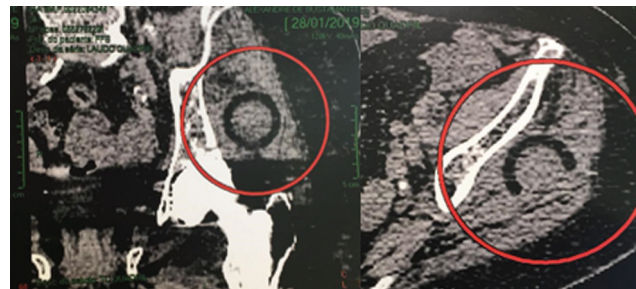
Fig. 5 (A) Coronal section of computed tomography. The red circle shows polyethylene component in soft tissues, (B) In the axial cut, a red circle evidencing polyethylene.

The patient underwent outpatient follow-up. She can perform all daily activities without functional limitation. The only complaint was polyethylene crackling which improved with ~ 60 days. She did not present other episodes of dislocation. Due to the absence of symptoms and high surgical risk (chronic renal failure and severe heart disease), both the patient and the responsible physician chose not to perform revision surgery.
