Early Intraprosthetic Dislocation of Total Hip Arthroplasty with Double Mobility Implant: Case Report

Rev Bras Ortop 2024;59(3):475–478.

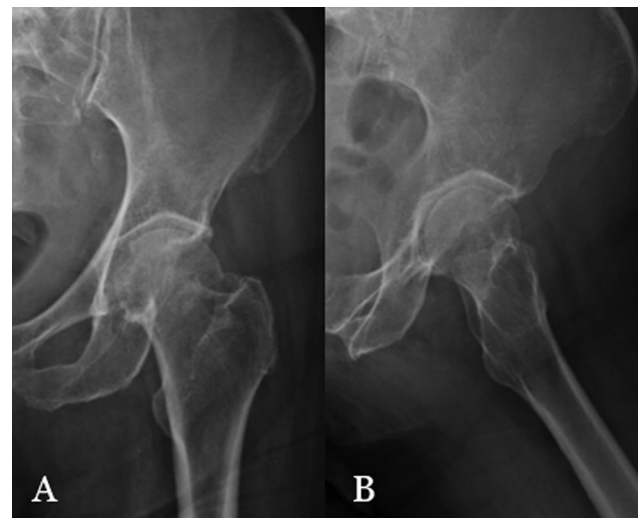
The radiographic examination revealed the diagnosis of fracture of the neck of the left femur, AO 31B1.1 (► Fig. 1a-b).

Fig. 1 Fracture of the neck of the left femur impacted in valgus, in AP (A) and profile (B).

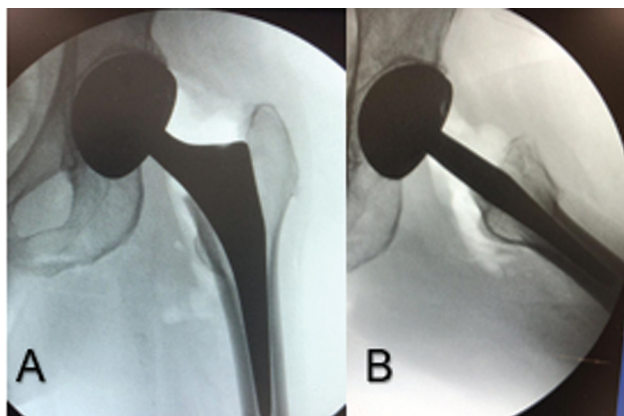
The polyethylene liner was properly coupled to the metal head with specific material and tested before being deployed. Stability tests and intraoperative control radiographs were performed, confirming good implant positioning and hip stability (► Fig. 2a-b).

Fig. 2 Radiographic control in the immediate postoperative period showing reduction of components and concentricity of the metallic head (A) in AP and profile (B).

The patient underwent total arthroplasty of the left hip with double mobility implant (Medacta). A 48/28 double mobility polyethylene liner, size 1 uncemented femoral stem, a 28 mm metallic femoral head, and a 48 mm non-cemented acetabular dome were used. Posterolateral access was performed with capsular repair and short rotators.

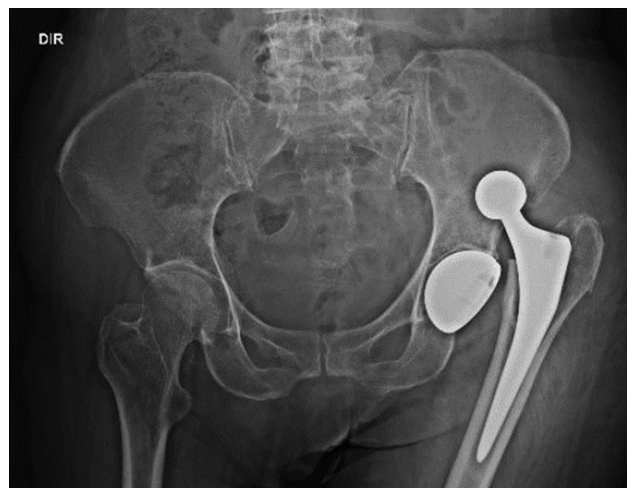
On the 18th postoperative day, after a fall to the ground, the patient was treated in the emergency room, complaining of pain in her left hip. Radiographs of the hip showed upper posterior dislocation of the prosthesis (►Fig. 3).

Fig. 3 Panoramic radiography of the basin showing posterosuperior dislocation of the left hip prosthesis.

The closed reduction was performed with sedation (propofol), using the reduction maneuver of Allis apud Waddell et al.⁶ and radiographic control. She returned to the outpatient clinic on the 7th day after reduction in good general

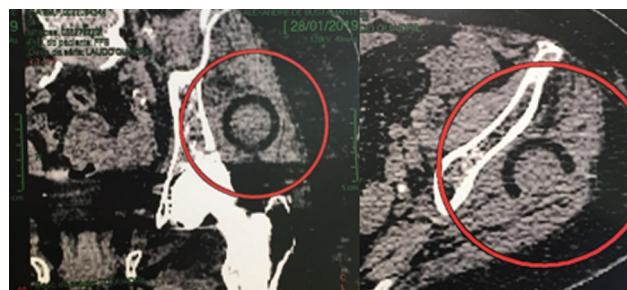
condition, without functional limitation, complaining only of crackling in the posterior region of the left hip. Radiographs after reduction show congruence between the femoral head and the acetabular dome, but femoral head eccentricity is observed in the acetabular metallic dome (►Fig. 4). A superolateral circular opacity (bubble sign) is also observed. Computed tomography (CT) reveals a polyethylene component in the posterosuperior aspect of the hip (►Fig. 5).

Fig. 5 (A) Coronal section of computed tomography. The red circle shows polyethylene component in soft tissues, (B) In the axial cut, a red circle evidencing polyethylene.

The patient underwent outpatient follow-up. She can perform all daily activities without functional limitation. The only complaint was polyethylene crackling which improved with ~ 60 days. She did not present other episodes of dislocation. Due to the absence of symptoms and high surgical risk (chronic renal failure and severe heart disease), both the patient and the responsible physician chose not to perform revision surgery.
