Influence of the Connector Area on the Chipping Rate of the VM9 Veneering Ceramic in a Posterior Four-Unit Yttria-Stabilized Tetragonal Zirconia Polycrystal Fixed Dental Prostheses: A Pilot Study

Eur J Gen Dent 2021;10:144–150.

Objective The purpose of this study was to evaluate the influence of the connector area on the chipping rate of the VM9 veneering ceramic in a 4-unit yttria-stabilized tetragonal zirconia polycrystal (Y-TZP) framework, using a novel sonographic technique.

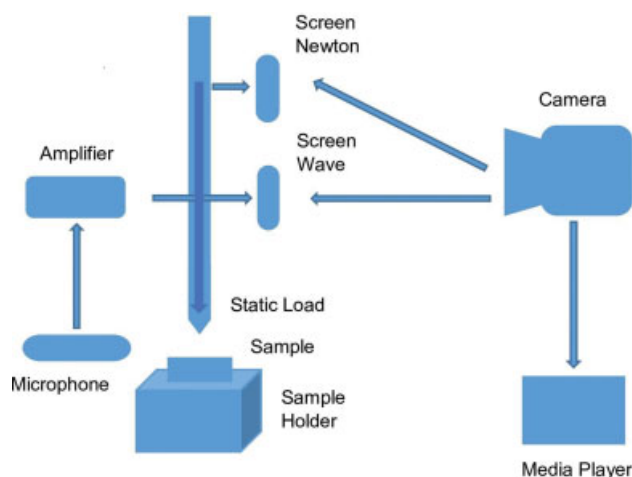
Fig. 1 Representation of the testing system 24.

An audio-visual system including a high-sensitivity microphone, a sound amplifier, a sound analysis software, a movie camera, and a Windows Media Player software were needed for this purpose.

The microphone (Earthquake) was connected to a sound amplifier and held one centimeter away from the sample to allow the capture of the slightest noise. The amplifier itself was connected to a sound software (Protools), converting the sounds emitted by the specimens to a visual signal, called "wave," displayed on the computer screen. During the test, silence was assured to prevent external sound interferences.

Perpendicular to the screen, a digital video camera (Sony) mounted on a tripod was positioned 2 meters away from the computer screen. It filmed simultaneously, the peak movement of the wave displayed on the computer screen and the load value (Newton) displayed on the screen of the testing machine (→ Fig. 1).

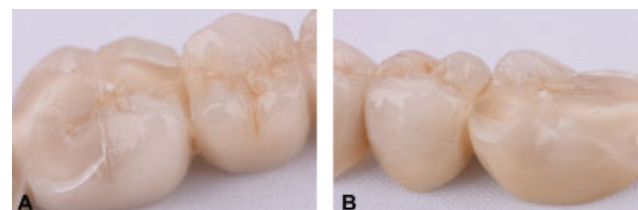
Fig. 2 Cohesive failures 24.

Three modes of failure were observed: cohesive failures (fractures or cracks within the veneering layer) (→ Fig. 2), adhesive failures (fractures or cracks separating the veneering layer from the zirconia core) (→ Fig. 3), and core failures (fractures or cracks in the zirconia core) (→ Fig. 4).

The first group (ZrO_2 ; 7.5 mm^2) demonstrated predominantly cohesive failures (3 cohesive failures), whereas the second group (ZrO_2 ; 8 mm^2) demonstrated predominantly core failures (3 core failures), and the third group (ZrO_2 ; 9 mm^2) demonstrated predominantly adhesive failures (3 adhesive failures). (► **Table 1**)

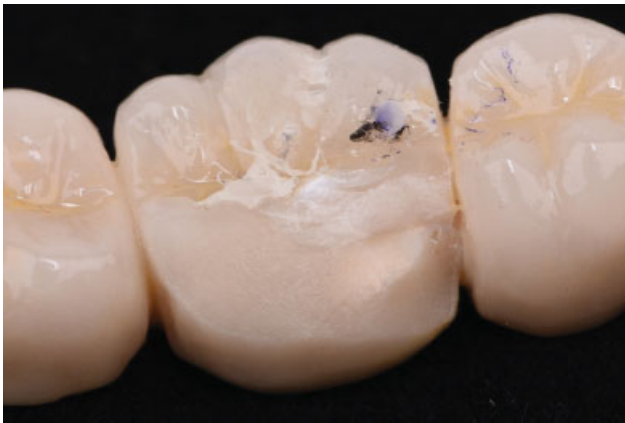
Fig. 3 Adhesive failure 25.

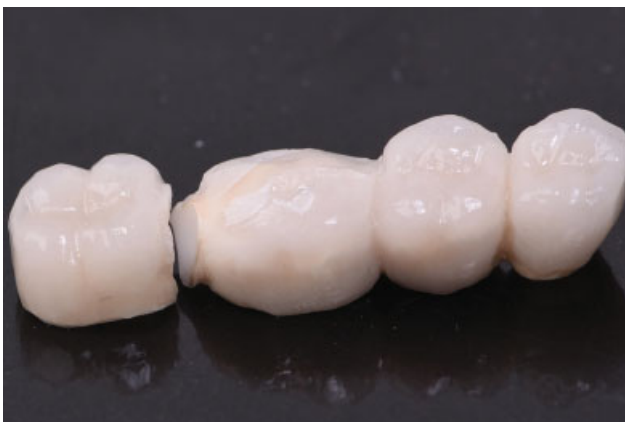
Fig. 4 Core failure 25.

Moreover, catastrophic failure (core failure), which occurred in five frameworks, could be due to a high-loading speed, a defect in the zirconia core, or a stiff veneered ceramic. Analysis of catastrophic failure revealed that the distal connector was the site of fracture. This finding is similar to that in the report by Lüthy et al¹⁸ and Larsson et al.³⁷ This may have been because the distance from the center of the distal abutment to the middle of the pontic was larger than the distance from the center of the mesial abutment to the middle of the pontic, as pointed out by Tsumita et al.³⁸
