## Fracture of a self-expanding metal stent used to manage a post-vertical sleeve gastrectomy stenosis

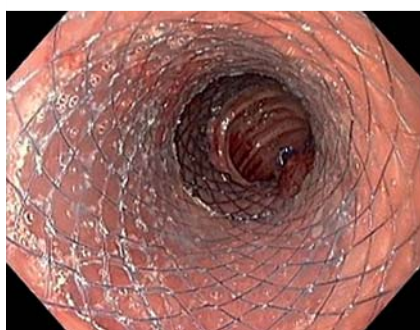
**Fig. 2** Upper gastrointestinal endoscopy showing the distal portion of the opened self-expanding stent in the duodenum.

tula (● Fig. 1). An upper gastrointestinal endoscopy (UGE) confirmed a 5-cm stenosis of the gastric tube and a covered self-expanding metal stent (SEMS; Hana-rostent Esophagus Benign BS; 22/28×120 mm) was deployed across the stenosis (● Fig. 2).

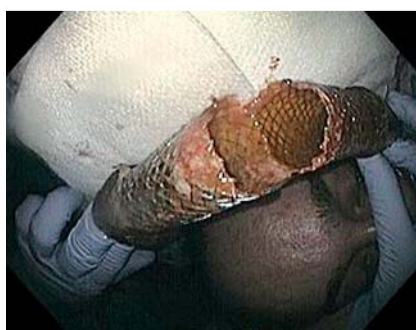
**Fig. 4** The fractured self-expanding metal stent following its successful endoscopic removal.

SEMS had fractured (● Fig. 3) and this was confirmed by computed tomography (CT) scanning. The SEMS was removed uneventfully during a further UGE (● Fig. 4). The gastric stenosis was adequately dilated and the patient was again discharged 3 days later.
