Migrated Peripherally Inserted Central Catheter in the Right Ventricle and Bilateral Pulmonary Arteries: A Case Report

Indian J Radiol Imaging

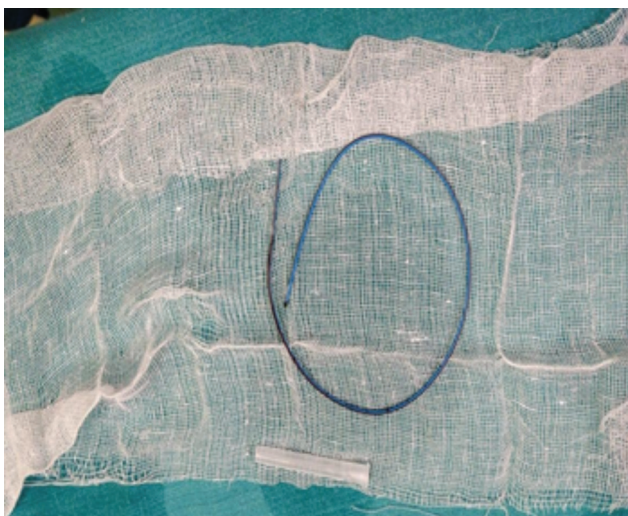
Fig. 5 Retrieved PICC line. PICC, peripherally inserted central catheter.

using an ultrasound-guided percutaneous right femoral venous approach, a 9-F catheter sheath and snare taken, positioned in right atrium (RA), and the free end in RA is grasped in snare and pulled out through the sheath (**Fig. 5**). Whole of the broken segment of PICC retrieved.
