Post-TAVI Follow-Up with MDCT of the Valve Prosthesis: Technical Application, Regular Findings and Typical Local Post-Interventional Complications

Martin Soschynski¹, Fabio Capilli¹, Philipp Ruile², Franz-Josef Neumann², Mathias Langer¹, Tobias Krauss¹

Fortschr Röntgenstr 2018; 190: 521–530

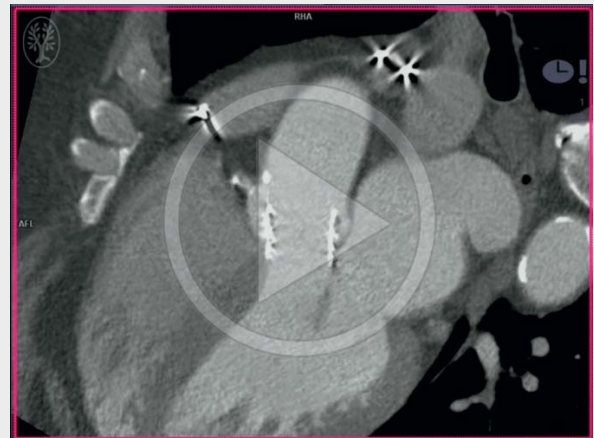
► **Video 1** Normal valve leaflet movement of an Edwards SAPIEN 3-Prosthesis.

which the individual phases can be viewed in the desired angulation as a video is suitable for this purpose. Valve leaflet movement can thus be evaluated dynamically (4D) ► **Video 1**.

The multi-phase reconstruction from the ECG-triggered CT dataset allows evaluation not only of the morphology of the prosthesis leaflets but also of valve movement. In particular, in areas with a thickened valve leaflet, hypokinesia, i. e., reduced movement between diastole and systole, must be evaluated. Dedicated image reporting software can be used to visualize leaflet movement as a video sequence ► **Video 1**.
