Post-TAVI Follow-Up with MDCT of the Valve Prosthesis: Technical Application, Regular Findings and Typical Local Post-Interventional Complications

Martin Soschynski¹, Fabio Capilli¹, Philipp Ruile², Franz-Josef Neumann², Mathias Langer¹, Tobias Krauss¹

Fortschr Röntgenstr 2018; 190: 521–530

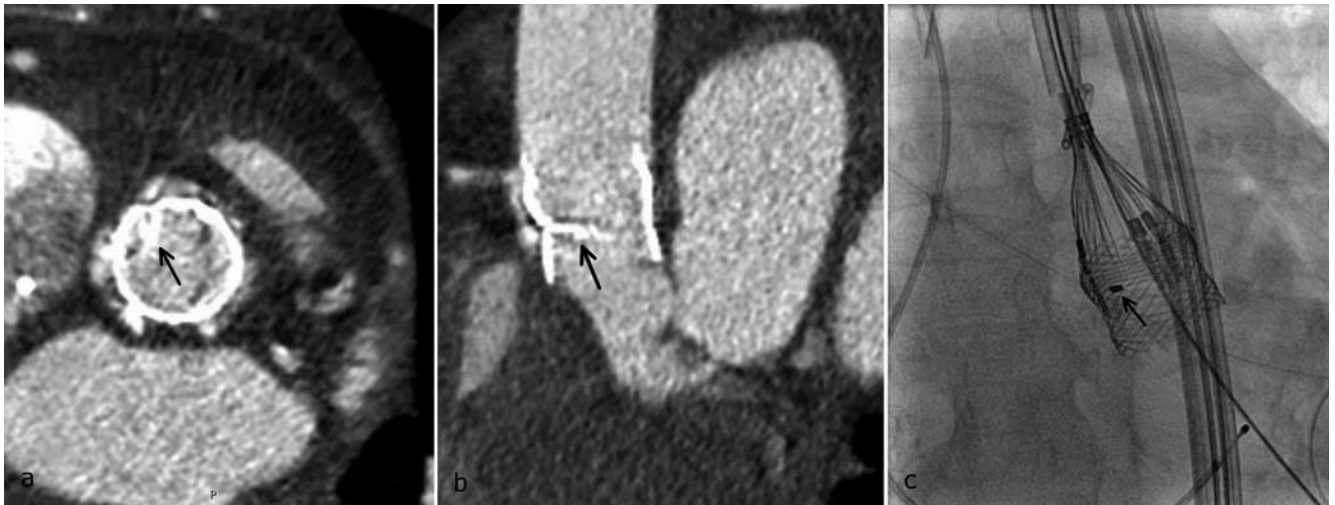
► **Fig. 3** Normal CT findings of a Lotus-prosthesis in **a** axial and **b** parasagittal angulation as well as **c** fluoroscopy during implantation. Note the radiopaque marker which causes beam hardening artifacts on CT (arrows). After deployment, the correct position of the marker is at the level of the sinus of Valsalva, about 5 mm distal to the native annulus.

frame facilitates positioning of the valve [9]. During expansion of the stent, the stent frame shortens and the marker moves in the direction of the annulus until it reaches the correct position at the level of the sinus of Valsalva, approx. 5 mm distal to the annulus [10]. The marker can cause beam-hardening artifacts on CT and must not be confused with a para- or intravalvular foreign object (► **Fig. 3a-c**).
