Post-TAVI Follow-Up with MDCT of the Valve Prosthesis: Technical Application, Regular Findings and Typical Local Post-Interventional Complications

Authors

Martin Soschynski¹, Fabio Capilli¹, Philipp Ruile², Franz-Josef Neumann², Mathias Langer¹, Tobias Krauss¹

Fortschr Röntgenstr 2018; 190: 521–530

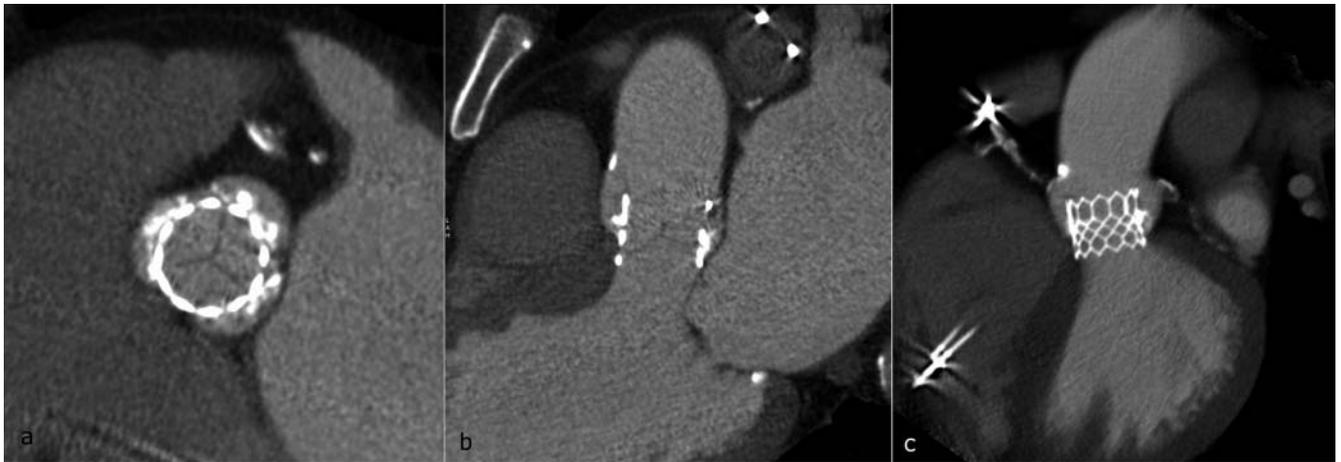
► **Fig. 1** Typical post-interventional MDCT of an Edwards SAPIEN 3-prosthesis in **a** axial and **b, c** parasagittal angulation to the prosthetic valve. **a** In the axial view the native valve leaflets can be seen as fine linear hypodensities at the level of the aortic bulbus. At this level the prosthesis is usually not fully attached to the aortic wall. **b** Parasagittal reconstruction shows the correct craniocaudal position of the prosthesis and complete attachment of the stent to the aortic wall at the level of the aortic annulus. **c** Thick-slab multiplanar reconstruction (MPR) illustrates the stent geometry and the exact implantation position.

The typical post-interventional CT finding for an Edwards SAPIEN 3 prosthesis is shown in ► **Fig. 1a-c**. In the case of balloon-expandable aortic valve prostheses like the Edwards SAPIEN prosthesis, the stent frame is designed to expand fully in a circular fashion so that it presses the calcified original valve against the wall of the aortic root [4].

The entire circumference of the stent should lie against the left ventricular outflow tract (LVOT) (► **Fig. 1b, c**). Massive, asymmetrical calcifications can result in incomplete conformation of the stent to the wall of the LVOT [4].

The prosthesis leaflets of the newly implanted aortic valve are visible on CT as fine, symmetrical, hypodense, arched structures within the lumen (► **Fig. 1a, b**). Thickening of one or more leaflets is to be categorized as pathological.

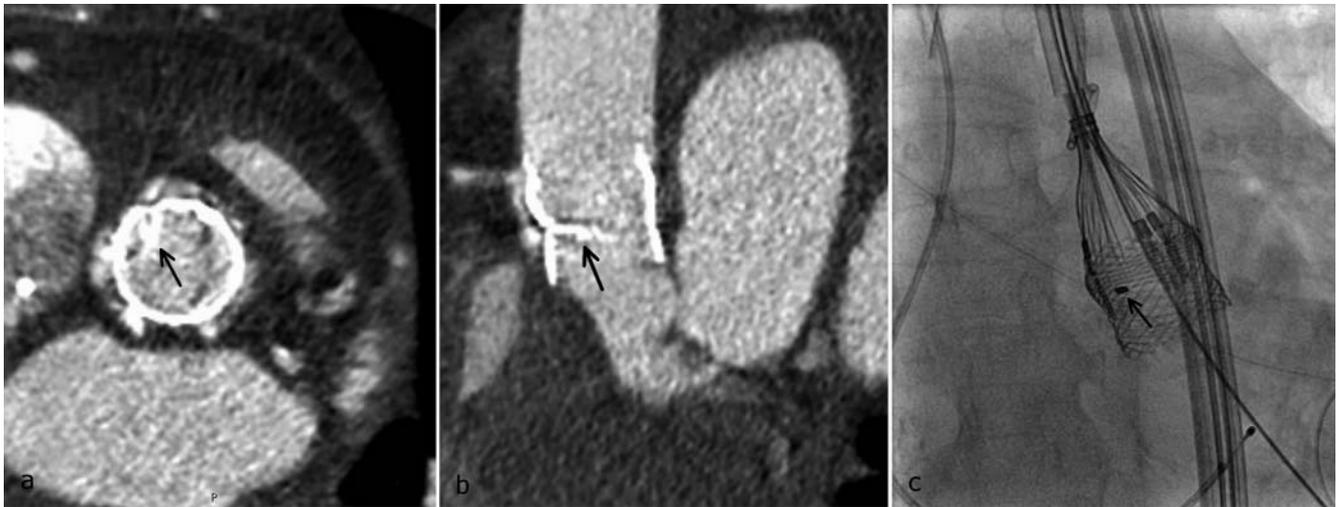
► **Fig. 3** Normal CT findings of a Lotus-prosthesis in **a** axial and **b** parasagittal angulation as well as **c** fluoroscopy during implantation. Note the radiopaque marker which causes beam hardening artifacts on CT (arrows). After deployment, the correct position of the marker is at the level of the sinus of Valsalva, about 5 mm distal to the native annulus.

frame facilitates positioning of the valve [9]. During expansion of the stent, the stent frame shortens and the marker moves in the direction of the annulus until it reaches the correct position at the level of the sinus of Valsalva, approx. 5 mm distal to the annulus [10]. The marker can cause beam-hardening artifacts on CT and must not be confused with a para- or intravalvular foreign object (► **Fig. 3a-c**).

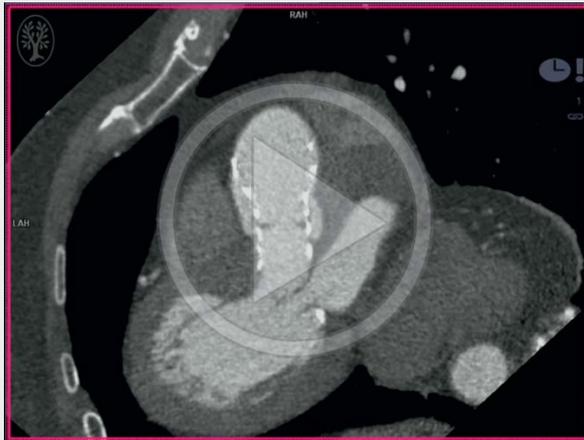
▶ **Video 2** Same patient as in ▶ **Fig. 4**. Thrombotic apposition of right and non-coronary leaflet. There is hypokinesia at the thickened areas.

the cardiac cycle (► **Fig. 5a, b, 6a, b**) [2, 3]. Thrombosis of the valve leaflet can be but is not necessarily associated with hypokinesia of the corresponding valve leaflet. One of more leaflets can be affected ► **Video 2**.

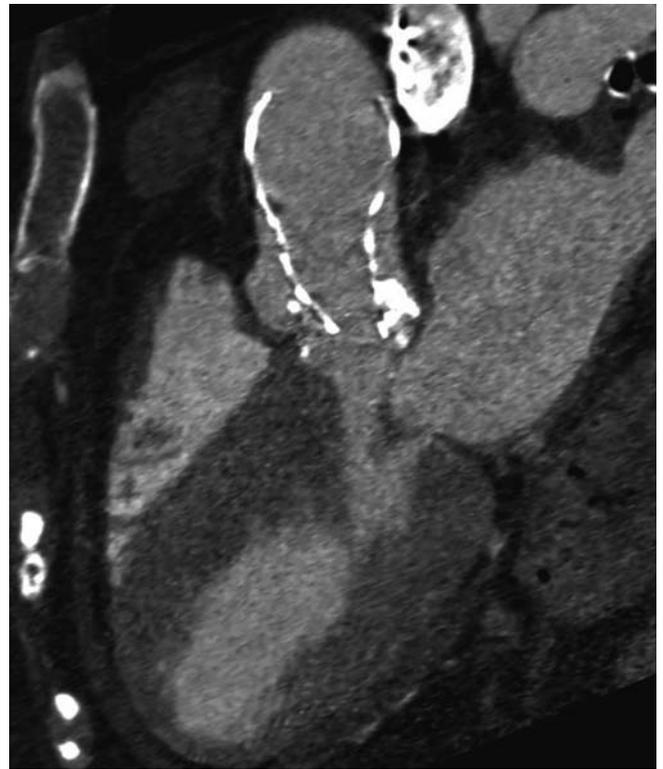
▶ **Fig. 8** Position of a CoreValve-prosthesis that is too high in the aortic root. Due to pronounced confluent calcifications of the original valve, the prosthesis could not be placed deeply enough. Consequently, the caudal end of the stent frame only barely extends to the annulus. The stent wire is not fully unfolded. The risk of secondary dislocation into the ascending aorta is increased.

As explained in the section „Normal findings“, the prosthesis should ideally be positioned so that the covered portion of the stent fully covers the original valve. If this is not the case, the original valve leaflets project into the lumen, resulting in an obstruction (► **Fig. 7**). Moreover, the incorrect stent position can present an increased risk for secondary dislocation (► **Fig. 8**).
