A 30-year-old woman underwent capsule endoscopy (Given® M2A, Given Imaging Ltd., Yoqneam, Israel) to investigate melena. Her medical history was significant for neurofibromatosis, portal and mesenteric vein thrombosis, portorenal shunt surgery, and antrectomy. On examination, her abdomen was slightly protuberant, with multiple surgical scars. A reducible, golf ball-sized, ventral hernia in the epigastric region was noted when performing a Valsalva maneuver. After swallowing the capsule, the patient left the clinic wearing a white T-shirt covering the capsule endoscopy (CE) belt pack. The next 7 h were uneventful, and no discomfort was experienced.

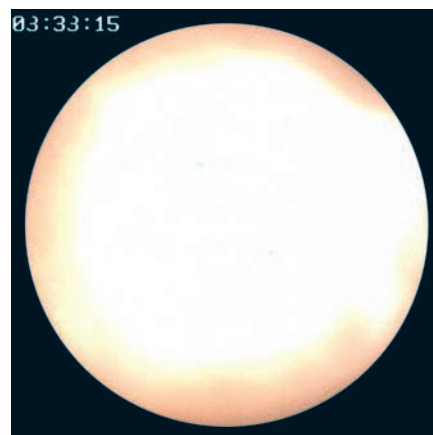
Figure 1 Capsule-endoscopic image, showing sunlight interfering with interpretation of the capsule video image.

On reviewing of the video data, at 4 h and with the capsule in the distal small bowel, strong interference by white light was observed in numerous segments of the small bowel, making interpretation of the video image impossible. External light was shining through the bowel wall, creating a whiteout on screen (Figure 1). When capsule transit occurred or there was an altered orientation, light was seen to transilluminate from one side of the bowel wall (Figure 2) or was observed in the distance (Figure 3). The capsule locator program indicated a right upper quadrant position. The total duration of intermittent interference was approximately 40 min. Capsule transit did not appear to be delayed, with normal peristalsis and no small-bowel dilation being observed [1]. In the last 2 h of recording, the CE image was not disturbed. On being questioned later, the patient recalled direct sunlight exposure corresponding to the time of the CE image whiteout.

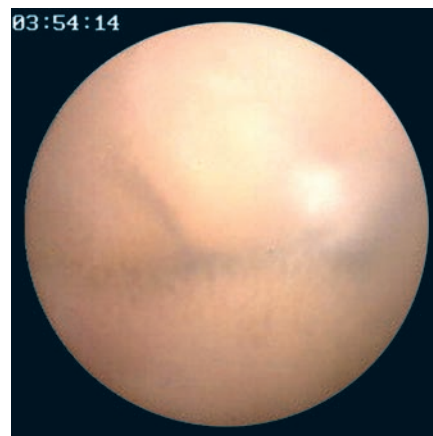
Figure 2 Sunlight shining through one side of the bowel wall.

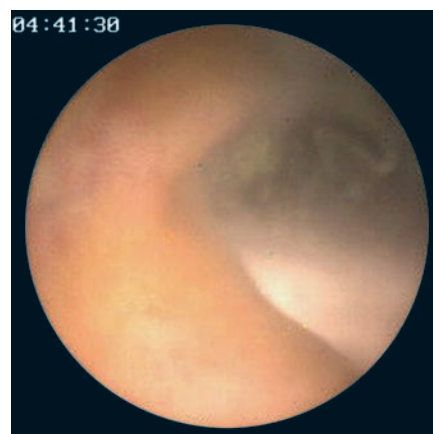
Figure 3 Sunlight shining in the distance.
