You Don't Have to Retrieve to Relieve: How and When to Trim a Self-Expanding Metal Biliary Stent

UCTN

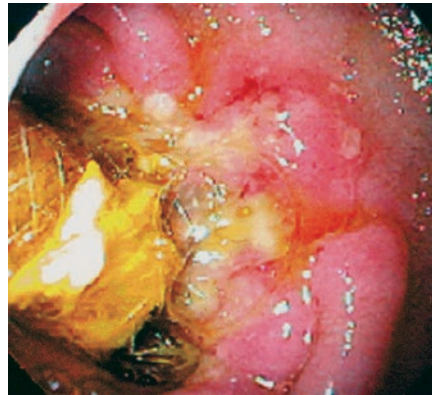
Figure 1 Endoscopic view of a self-expanding metallic stent (SEMS) impacted in the duodenal wall opposite to the papilla. The stent was occluded by biliary debris. Mucosal ulceration was seen.

A 62-year-old woman initially presented with obstructive jaundice due to a malignant common bile duct stricture. This was treated by placement of a SEMS. The patient presented 1 year later with abdominal pain and jaundice. Endoscopic retrograde cholangiopancreatography showed stent impaction in the opposite duodenal wall. This had led to extensive ulceration and mild hemorrhage (Figure 1). The stent lumen was filled with biliary debris. Using a neodymium-yttrium-aluminum-garnet (Nd:YAG) laser (power 60, pulse 0.6 s), the metal stent was trimmed until approximately 1 cm of stent protruded from the ampullary orifice (Figure 2). The shortened stent was then successfully cannulated and cleared with balloon sweeping, and the patient's jaundice resolved.

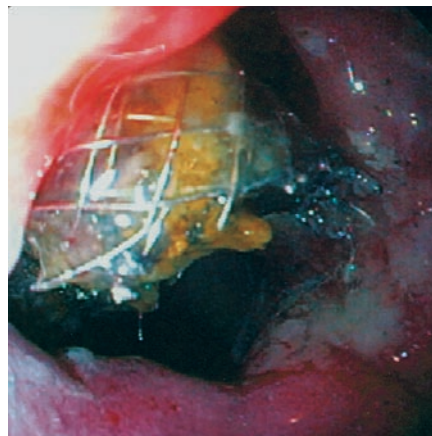
Figure 2 Laser trimming of the stent to an appropriate length relieved the impaction, thereby enabling cannulation.

It is our experience that a SEMS can be trimmed safely and effectively using the Nd:YAG laser. This technique was performed using standard equipment and was well tolerated by the patient. SEMS trimming may have a number of therapeutic applications. An obvious role is in the management of duodenal trauma or frank mucosal impaction. Another role might be to enable cannulation of stents that are difficult to reach. Shortening the stent to a more manageable length might allow easier access to the stent and facilitate endoscopic therapy.
