Hepatic Perforation: A Complication of Proximal Biliary Stent Migration

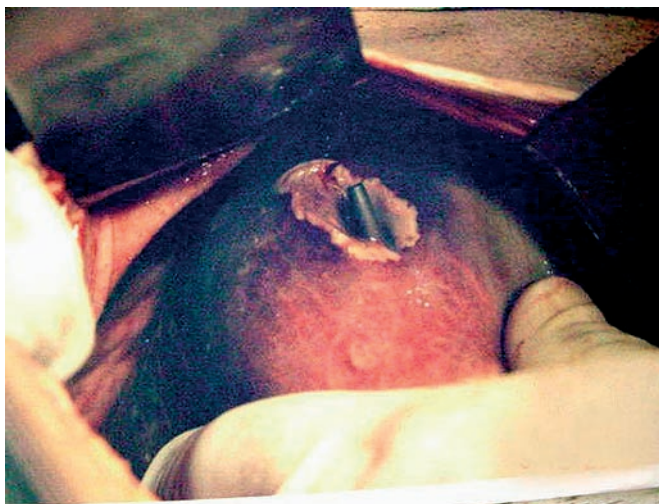
Figure 2 Peroperative photograph showing the hepatic perforation in the anterosuperior part of the right lobe of the liver caused by the migrated stent.
