Pictorial essay: Artifacts in cardiac CT: A practical system of understanding and correction

Hemant B. Telkar

Department of Radiology, Jupiter Heart Scan, Mumbai, India

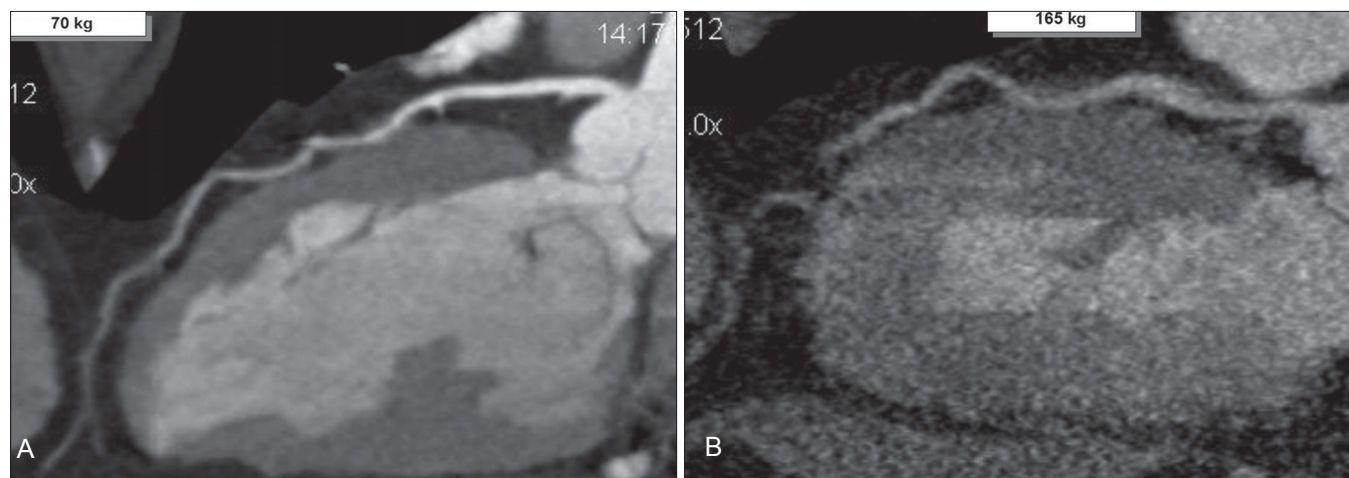
Figure 1 (A-B): 70 kg individual (A) shows a high signal-to-noise as against a grainy image due to low signal-to-noise in a 165 kg individual (B).

In patients weighing more than 80 kg or with large breasts, there is increased noise resulting in wall irregularity and difficulty in differentiating from plaques [Figures 1, 2].

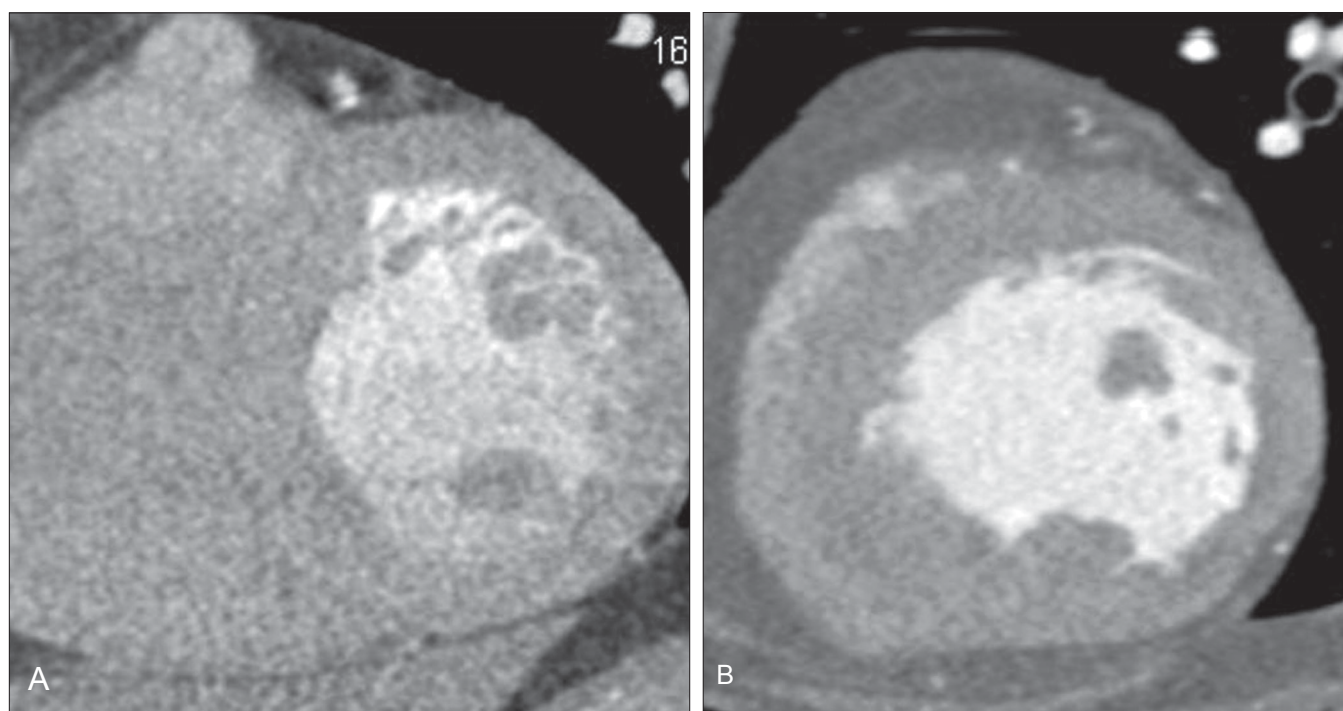
Figure 2 (A-B): Short axis images show a grainy image at 650 mAs (A) and a much smoother image at 850 mAs (B). This however means increased radiation.

- a. Try to scan the patient at a lower pitch, with overlapping images.
- b. Use a smoother kernel.
- c. Use a higher mAs [Figure 2].
- d. Use more contrast.

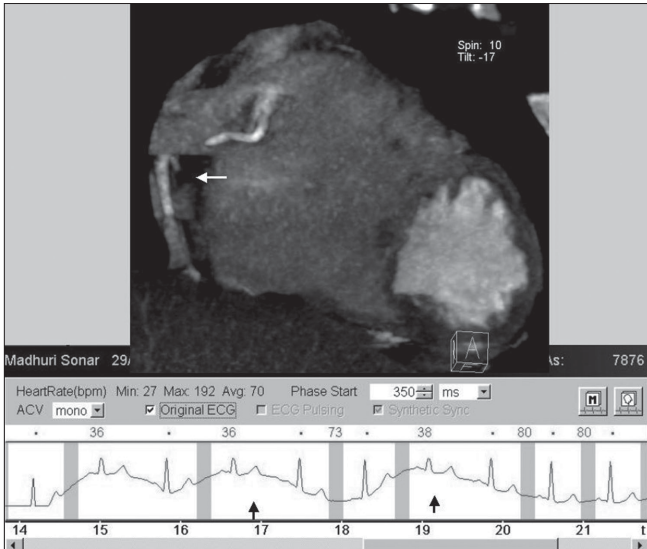
Figure 3: Free breathing during a study is seen as undulation in the baseline ECG resulting in an artifact (white arrow) along the RCA.

Holding one's breath for even as short as 8 to 10 seconds can be a problem for some patients [Figure 3]. To eliminate this problem, the patient must practice breath-holding before the procedure and if required an attendant can be placed in the room next to the patient's head for nose-holding. Slice collimations of 1.2mm can help reduce the scan time, while still maintaining adequate image quality [Figure 4].

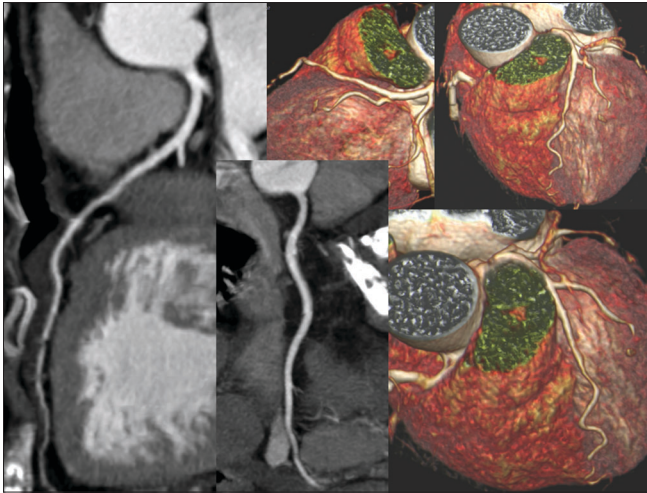
Figure 4: A good quality cardiac CT study done with 1.2 mm collimation, in a scan time of 6-8 seconds.

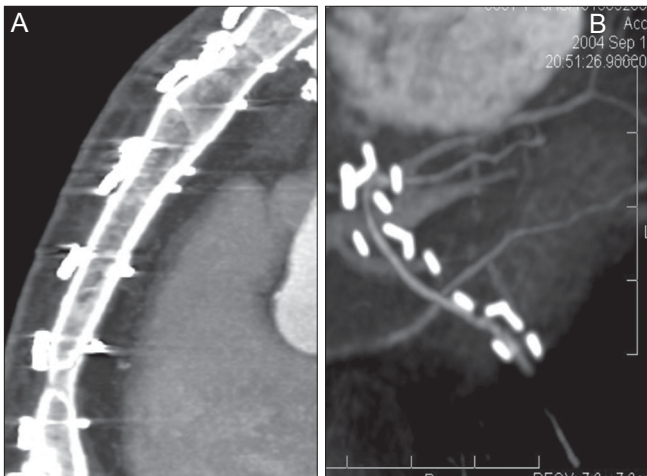
Figure 5: MIP images show streak artifacts from metal sutures (A), whereas those from the surgical clips (B) are minimal, in a patient who is post-bypass.

The presence of metal, especially after a bypass-surgery or dense calcium can lead to streak artifacts [Figure 5].

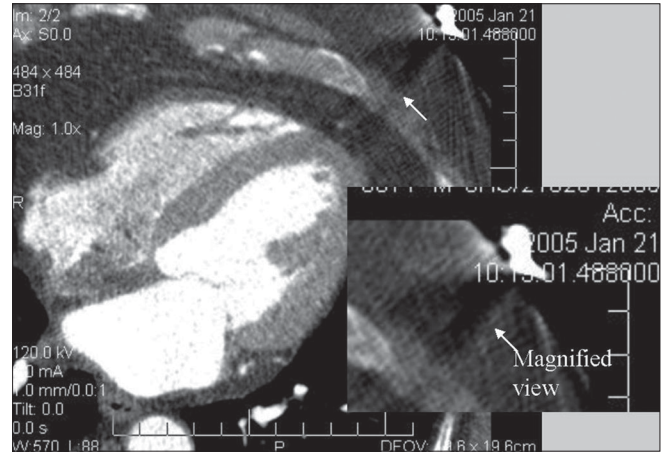
Figure 6: Axial image of a cardiac CT dataset shows streak artifacts (white arrow) from the metal in the ECG lead.

Due to immense improvement in the resolution of the scanners, streak artifacts due to metal in the ECG electrodes are not much of a problem on the 64-slice scanners [Figure 6].

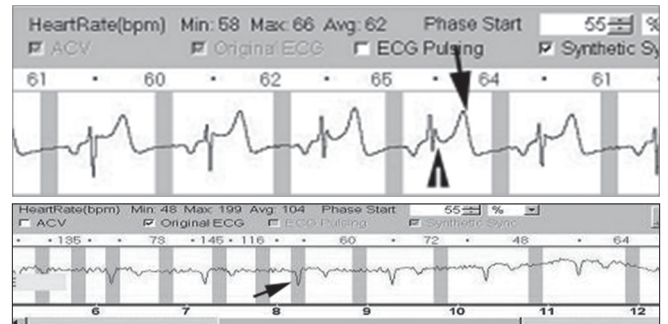
Figure 7: Abnormal amplitudes. The ECG trace (A) shows a T wave (arrow) of larger amplitude than the R wave (arrowhead). Another trace (B) shows very low amplitude R waves (arrow).

- a. Abnormal amplitudes [Figure 7]
- b. Baseline tremors [Figure 8]
- c. Wave-form artifact [Figure 9]

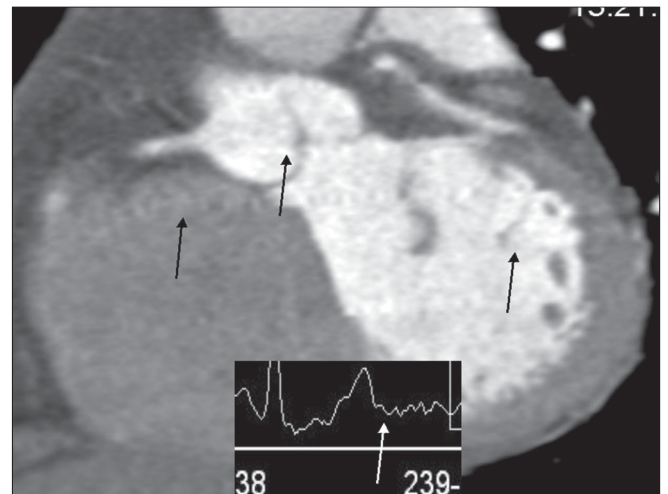
Figure 8: Baseline tremors. The reconstruction image shows fuzzy lines (arrows) in the image due to a poor baseline ECG trace (white arrow, see inset)

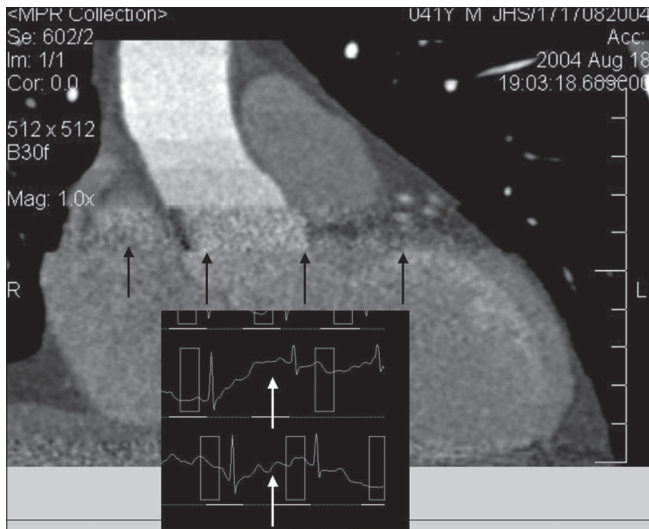
Figure 9: Waveform artifact. The poor ECG trace (white arrows in inset) is responsible for the step-artifacts (black arrows).

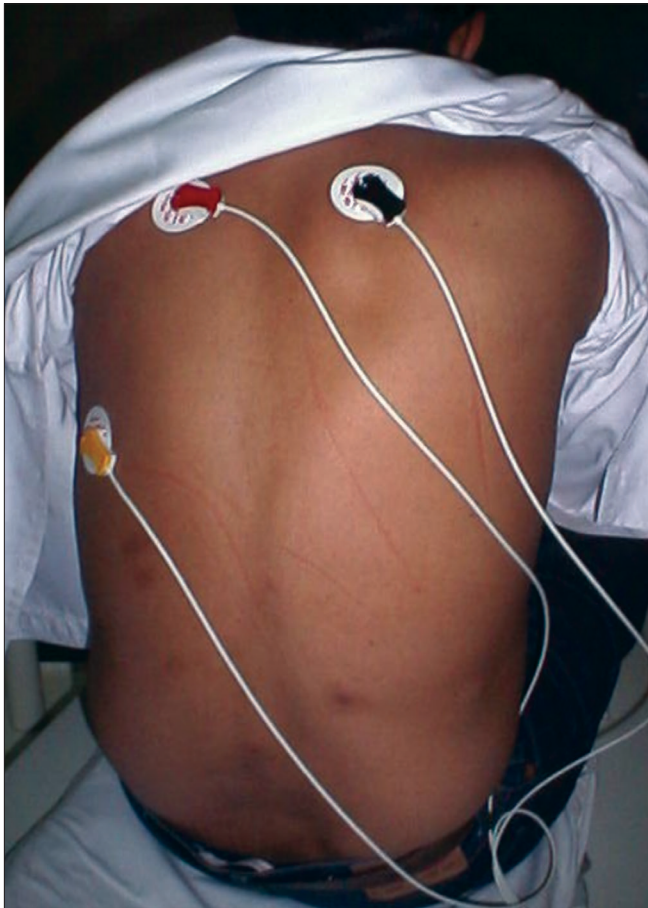
Figure 10: Alternate ECG lead placement. The photograph shows ECG leads placed on the back.

The above changes can be prevented by proper placement of electrodes, with good use of jelly for proper contact and to affix the leads after raising the patients' hands above their heads, so as to prevent creasing of the skin under the lead pads. Occasionally, we can change the position of the leads, such as, by putting them on the back [Figure 10]. Breasts can be strapped if they come in the way.

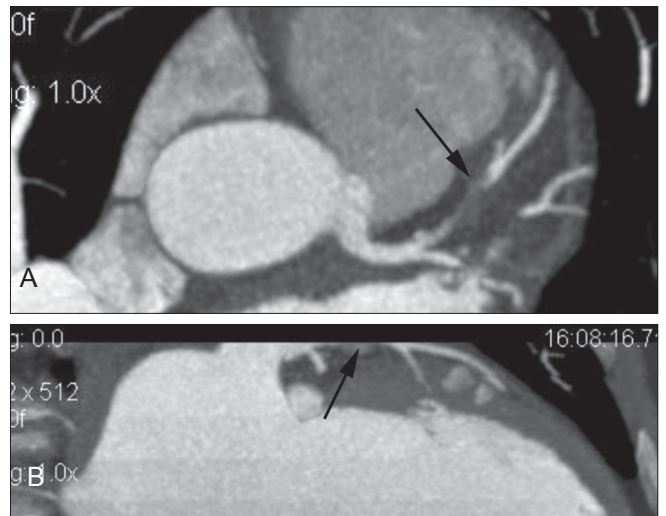
Figure 11 (A-B): Improper placement of the acquisition band leads to incomplete visualization of the LAD (arrow) in the axial (A) and coronal (B) planes.

Poor planning can generate unwanted artifacts and pseudo-stenosis [Figure 11]. To prevent this from happening, we should scan from the level of the inferior border of the arch of the aorta downwards. The calcium score axial data can be used to identify the left main (LM). We should then start higher than this level [Figure 12].

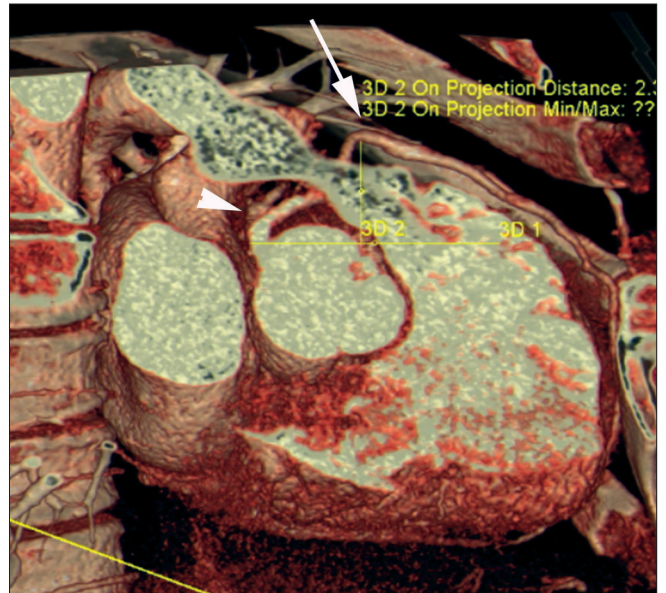
Figure 12: Volume rendered image shows that the LAD (arrow) is positioned 2.3 cms above the axial plane of the LM (arrowhead) origin.

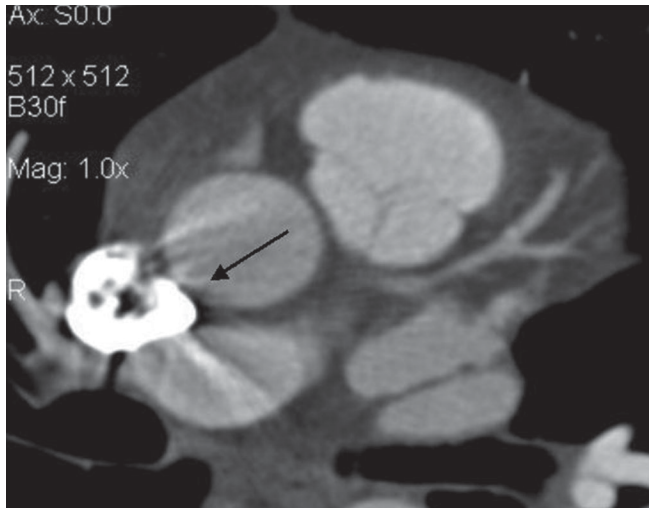
Figure 13: Axial image shows dense streak artifacts from the SVC (arrow).

Streak artifacts may occur due to contrast in the SVC, at the time of starting the scan. The SVC at this time is still filling with undiluted contrast from the veins and this may give rise to dense streak artifacts over the RCA

[Figure 13]. To avoid this, we can inject from the left arm and use a saline flush.

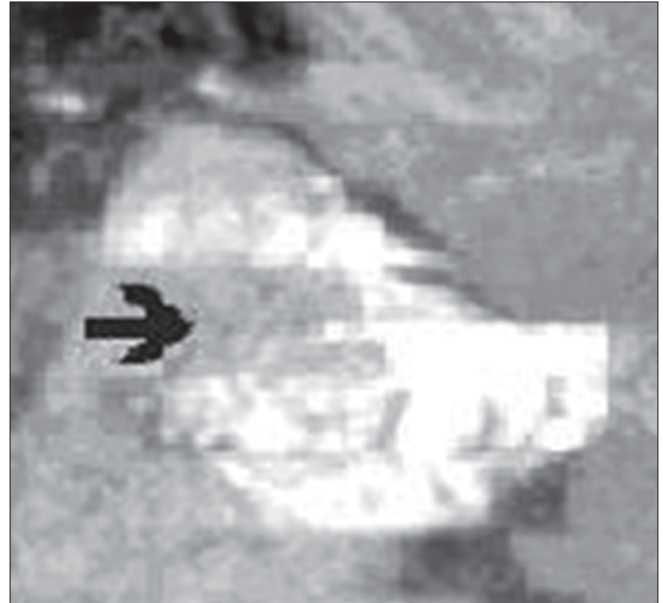
Figure 15: MIP image shows a "slab" artifact (arrow) due to differential contrast opacification.

These are caused by the improper use of contrast medium. Often, the concentration of contrast medium is locally too high or the contrast medium injection may have started too early. This gives rise to “contrast” slabs [Figure 15].

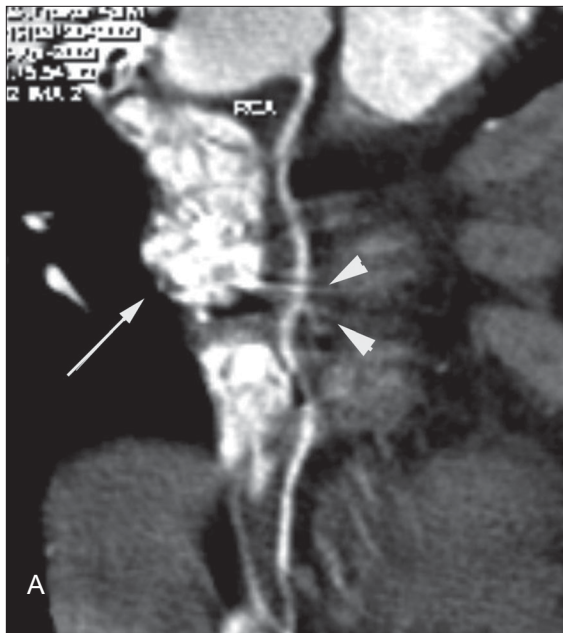
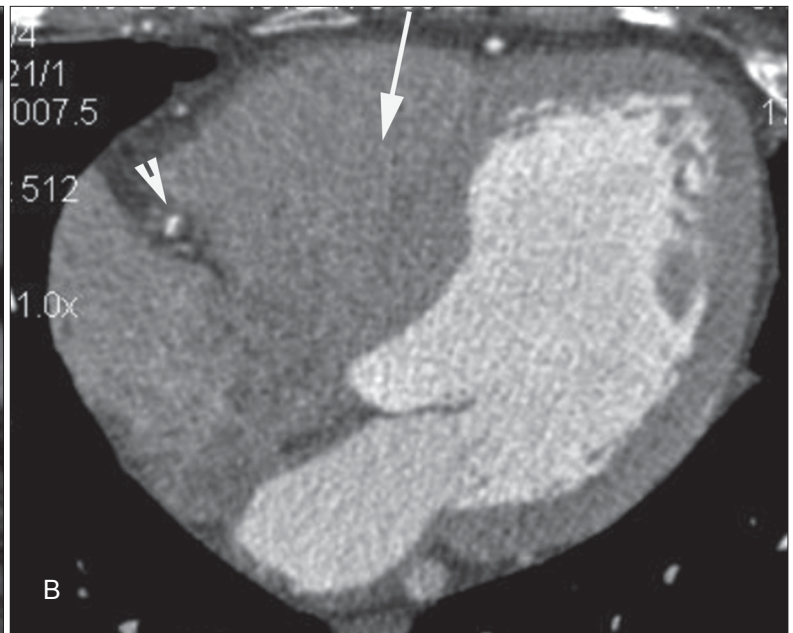
Figure 14 A-B: Contrast in RV (arrow) causes streak artifacts over the RCA (arrowhead), which are eliminated after the use of a saline flush (B), which results in markedly reduced contrast concentration in the RV (arrow). Note the RCA (arrowhead).

Contrast in the right ventricle (RV) [Figure 14A] also causes an artifact over the RCA, which can be eliminated by using a saline chaser [Figure 14B]. However in patients with a poor cardiac output, the RV opacification may still be dense and cause artifacts.

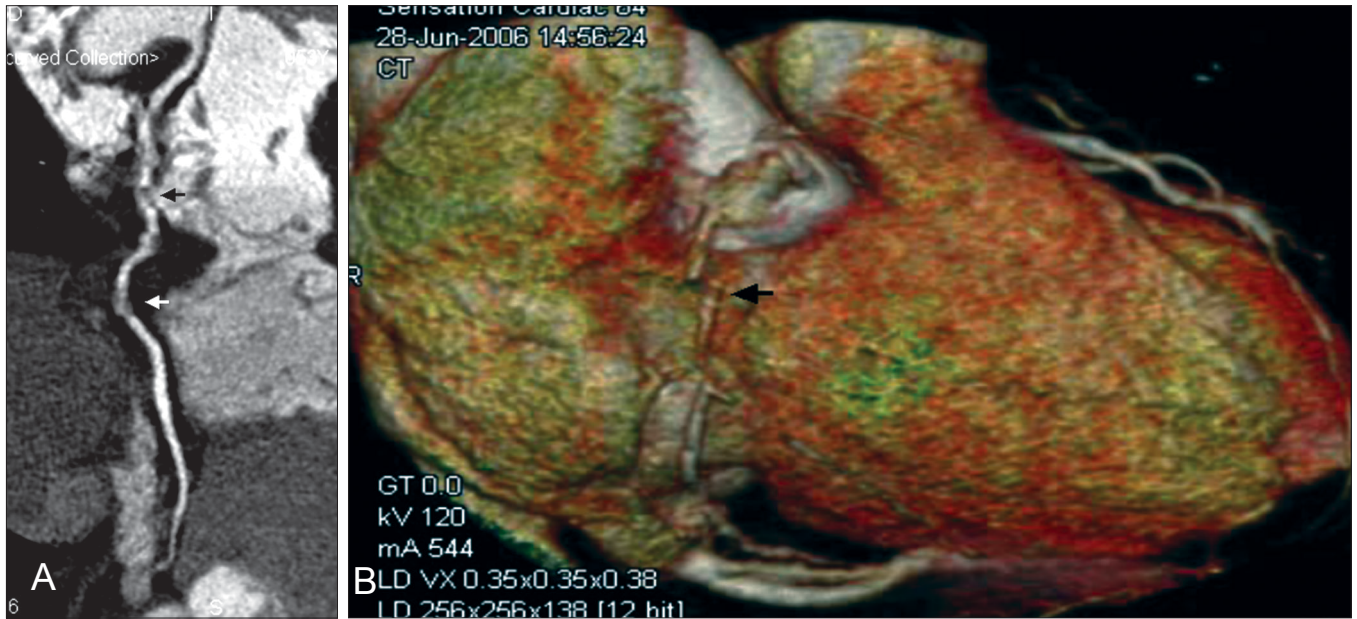
Figure 16 (A-B): MPR image (A) and volume rendered image (B) show step artifacts (arrows) due to RCA motion.

The RCA exhibits the highest velocity movement during the

cardiac cycle [Figure 16] and the greatest positional change in the x and y planes, followed by the circumflex branch of the left coronary artery, the left main coronary artery and the left anterior descending artery.

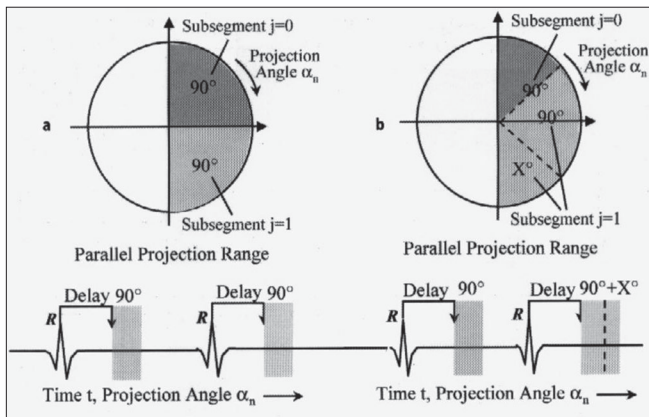
Figure 17: Diagram showing the concept of multi-sector reconstruction, using the ACV (Adaptive Cardio Volume TM) mode for Siemens scanners.

In dual-sector reconstruction, the temporal window can be reduced to a maximum of $1/4^{\text{th}}$ of the gantry rotation time [Figure 17]. This increases the flexibility and placement of the temporal window in the shortened R-R interval at high heart rates.

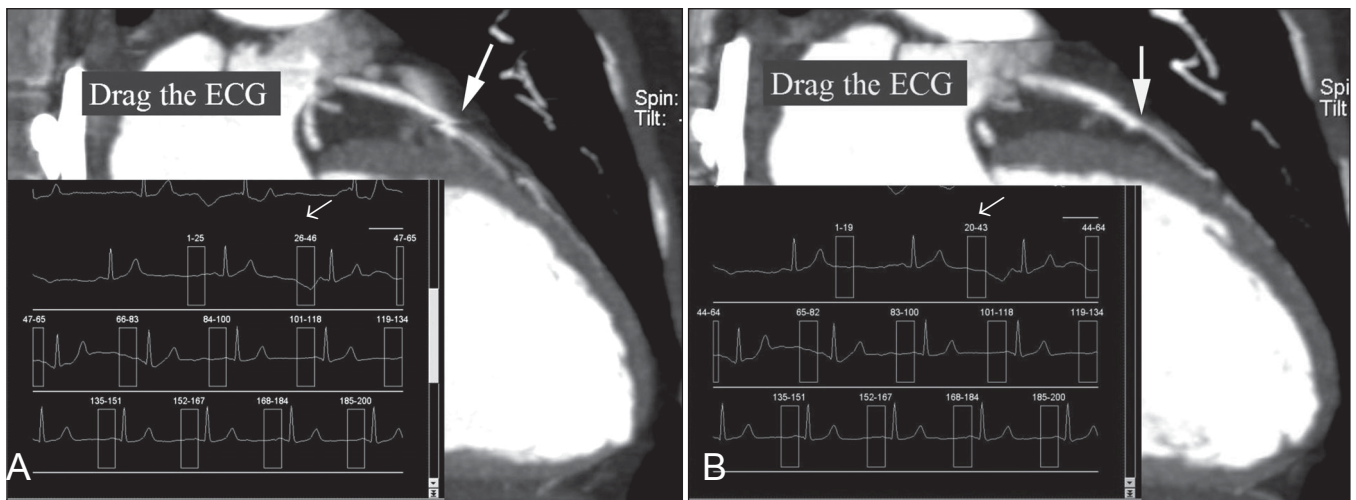
Figure 18 (A-B): The precorrection image (A) shows an artifact in the LAD (arrow) due to the acquisition band falling in late diastole/early systole. After dragging the ECG trace manually so that it lies in the middiastolic band the LAD artifact in the postcorrection image (B) is eliminated (arrow).

Step artifacts due to improper placement of syncs can be eliminated or reduced by changing the position of these syncs [Figure 18].

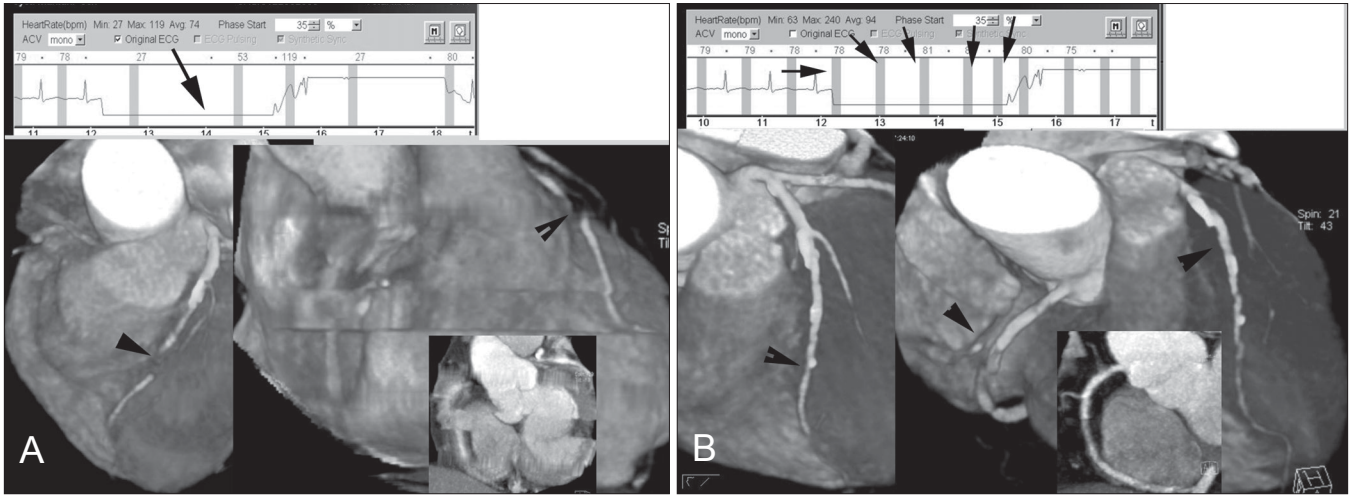
Figure 19 (A-B): The pre-correction image (A) shows a breathing artifact leading to a flat line (arrow) in the ECG trace and LAD artifacts (arrowheads). By inserting multiple syncs (arrows), the post-correction image (B) shows elimination of the LAD artifacts (arrowhead).

In cases where the difference between two adjacent heart beats is high, inserting an additional sync helps in averaging the ECG data and resultant uniformity in the trace pattern [Figure 19].

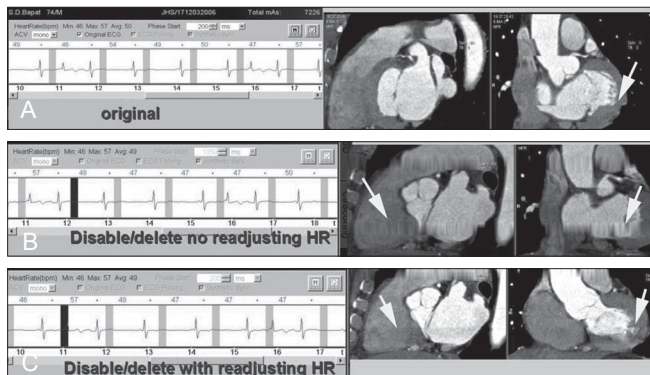
Figure 20 (A-C): The original image (A) shows a bad step artifact (arrow) across the LV cavity. Disabling the offending sync (B) without heart-rate adjustment leads to a blurring artifact (arrow), whereas both artifacts are eliminated (arrows) after readjusting the heart rate as well (C).

To overcome ectopic beats, the corresponding syncs can be disabled [Figure 20]. In this situation, the ectopic beat is not read during image reconstruction and the data from the previous heartbeat is used to fill in the image; this negates any image variation in the ECG pattern thereby removing the step in the final image. The disadvantage is that this leads to interpolation across the R-R interval thereby resulting in loss of information and blurring in the final reconstructed image.

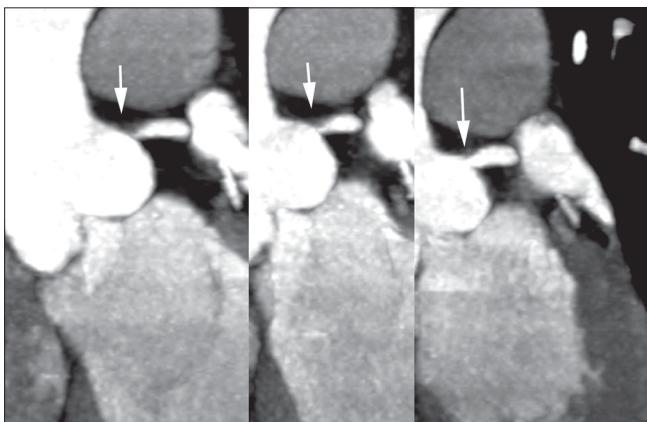
Figure 21: The LM shows different appearances in different phases, simulating narrowing (arrows).

The choice of an incorrect phase can give rise to artifacts [Figure 21]. Choosing the correct phase eliminates these artifacts [Figure 22].

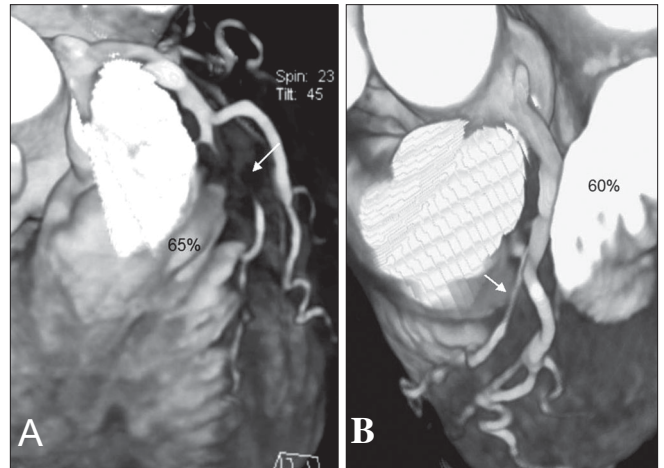
Figure 22 (A-B): A poor choice of phase shows an artifact (arrow) in the LAD at 65% reconstruction (A), which disappears (arrow) at 60% reconstruction (B).

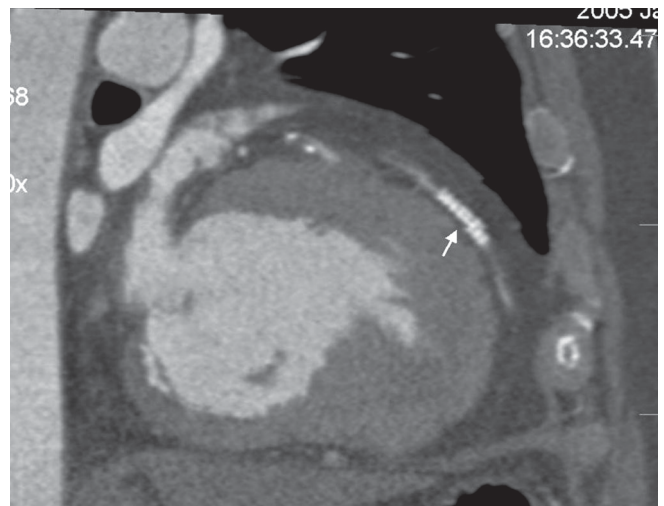
Figure 23: MIP image shows a mis-registration step artifact involving an LAD stent (arrow).

Step artifacts due to intrinsic mis-registration of data are known [Figures 23, 24]. These can be eliminated by using one or more of the following measures:

- i. Try more than one reconstruction phase
- ii. Try to edit the ECG trace
- iii. Sometimes a thicker reconstruction can be used, e.g. 1 mm instead of 0.75 mm
- iv. A multi-sectorial reconstruction may be used.

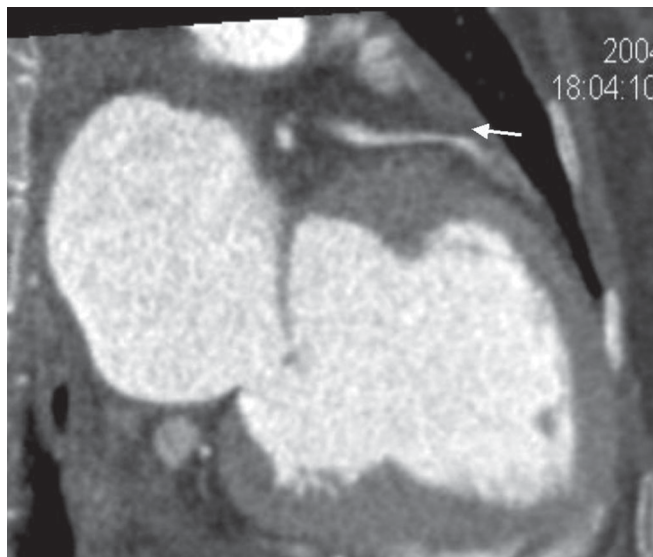
Figure 24: MIP image shows a mis-registration step artifact involving the proximal LAD (arrow).
