Dual-scan technique for the customization of zirconia computer-aided design/computer-aided manufacturing frameworks

Key words: Computer-aided design/computer-aided manufacturing, dual-scan technique, zirconia

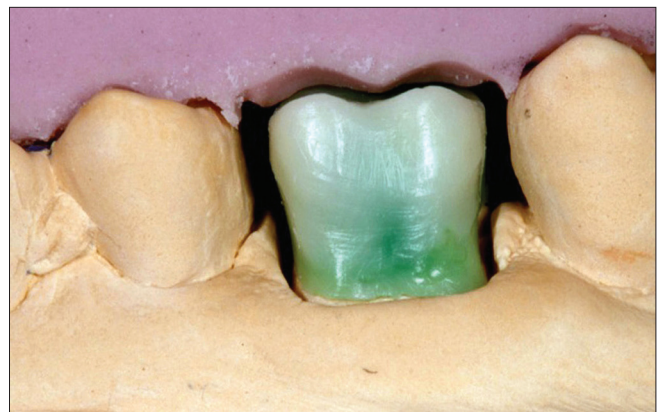
Figure 2: Waxed substructure

A dual-scan procedure was used to combine the datasets from the die with and without the waxed

substructure. First, the die was scanned. Then, the wax pattern was sealed to the die, which was scanned a second time. The scanner (Cercon Eye; Dentsply USA) used the sub marginal data points to orient the two scans and merge the data sets. It works as a subtraction of the images: The die with the waxed substructure minus the die with the tooth preparation. The result of this image subtraction is the personalized substructure for that specific case [Figure 3]. The merged file was transmitted to a milling facility and the coping was manufactured [Figure 4]. The porcelain veneering (Cercon Ceram, Dentsply, USA) was completed [Figure 5] and the crown cemented (RelyX Unicem, 3M ESPE, St. Paul, MN, USA) after surface treatment with sandblasting and alloy primer application. This particular restoration has been in service for over 1 year without clinical complications.

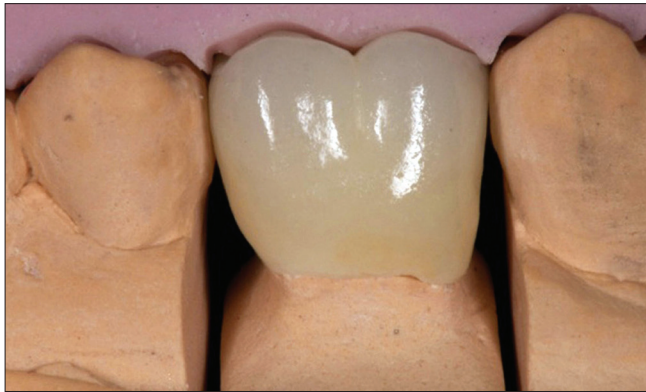
Figure 5: Ceramic crown after porcelain application

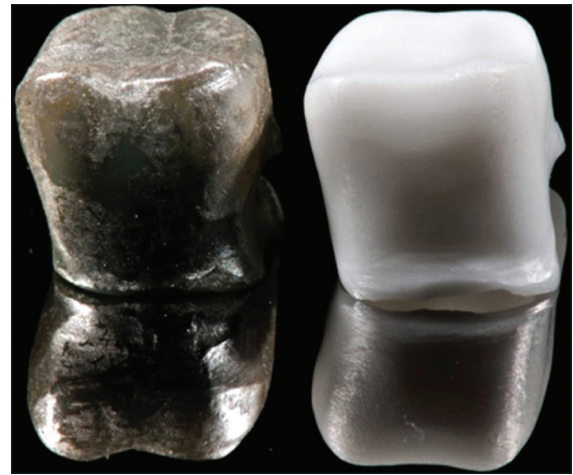
Figure 4: Milled zirconia substructure identical to the waxed substructure
