Dual-scan technique for the customization of zirconia computer-aided design/computer-aided manufacturing frameworks

Key words: Computer-aided design/computer-aided manufacturing, dual-scan technique, zirconia

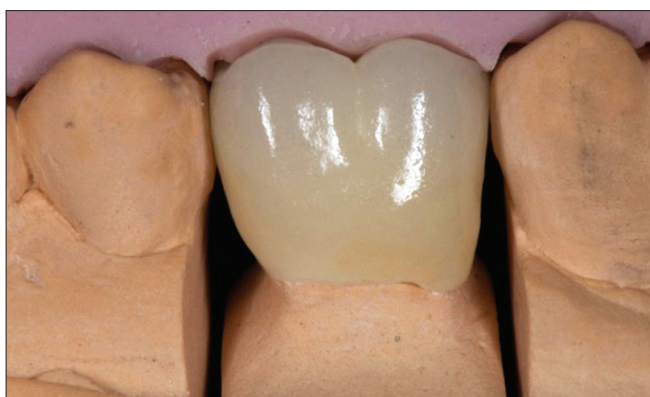
Figure 5: Ceramic crown after porcelain application

substructure. First, the die was scanned. Then, the wax pattern was sealed to the die, which was scanned a second time. The scanner (CERCON Eye; Dentsply USA) used the sub marginal data points to orient the two scans and merge the data sets. It works as a subtraction of the images: The die with the waxed substructure minus the die with the tooth preparation. The result of this image subtraction is the personalized substructure for that specific case [Figure 3]. The merged file was transmitted to a milling facility and the coping was manufactured [Figure 4]. The porcelain veneering (CERCON CERAM, Dentsply, USA) was completed [Figure 5] and the crown cemented (RelyX Unicem, 3M ESPE, St. Paul, MN, USA) after surface treatment with sandblasting and alloy primer application. This particular restoration has been in service for over 1 year without clinical complications.

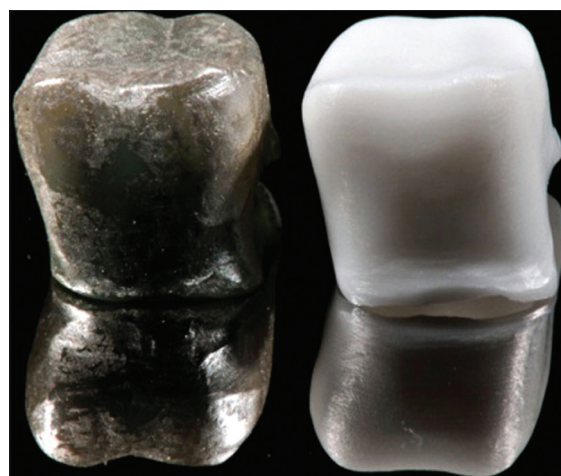
Figure 4: Milled zirconia substructure identical to the waxed substructure
