K-Wire Breakage During Metalware Removal Due to a Defective K-Wire Shaft

Seong Jae Hong, Hyun Jic Lee, Jin Young Kim,
Su Rak Eo, Sang Hun Cho

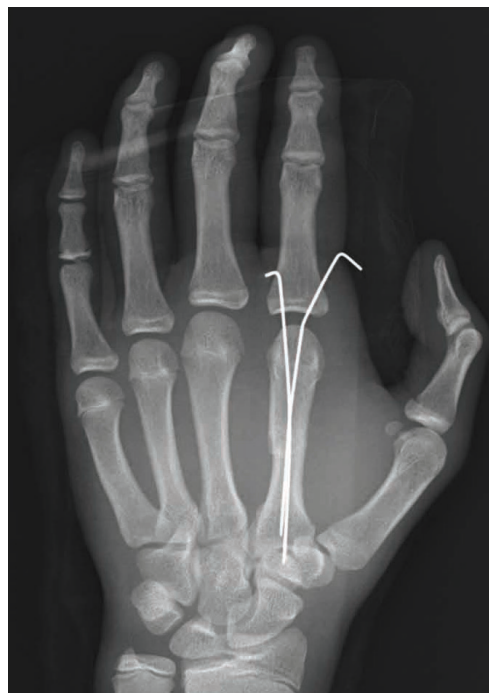
Fig. 1. A 15-year-old male had an oblique fracture on the shaft of the right second metacarpal. A plain radiograph taken 4 weeks after surgery shows the two K-wires placed after reduction of the right index metacarpal.

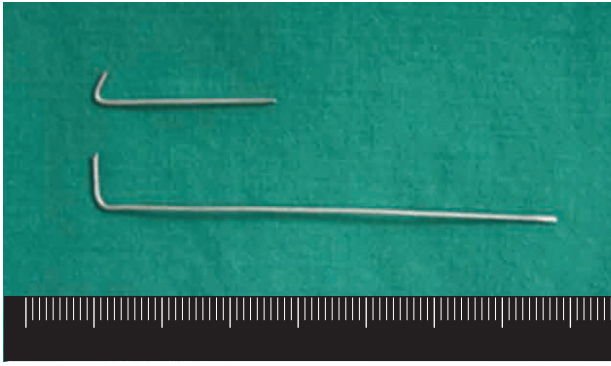
Fig. 2. The two extracted K-wires. The upper one is the broken K-wire and the lower one is the normal K-wire.

was allowed. At 6 weeks postoperatively, radiologic union was achieved using plain radiography, and we attempted to extract the two K-wires. One of the K-wires was completely removed but the other broke at its mid-shaft (Fig. 2), leaving the remnant proximal portion buried in the medullary cavity (Fig. 3). Subsequently, the patient was able to flex and extend the MP joint fully and no symptoms such as pain, bleeding, or swelling were encountered. We noticed that the tip of the broken K-wire resembled the tip of the intact extracted wire. To determine the cause of the breakage, both K-wires were sent to the head office of the manufacturer (Solco Biomedical Co., Ltd., Pyeongtaek, Korea). We observed that the broken tip resembled the end of a normal K-wire tip in magnified view ($40\times$ magnification) (Fig. 4), signifying that the breakage was caused by a manufacturing defect.

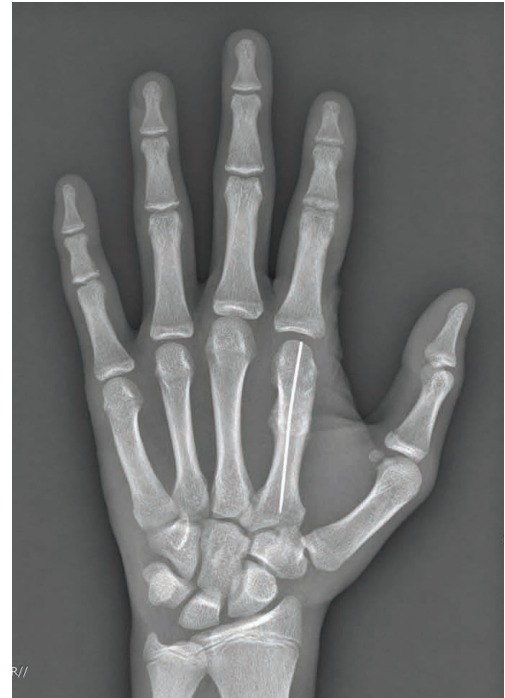
Fig. 3. Plain radiograph obtained at 6 weeks postoperatively, showing the residual K-wire portion in the medullary cavity.

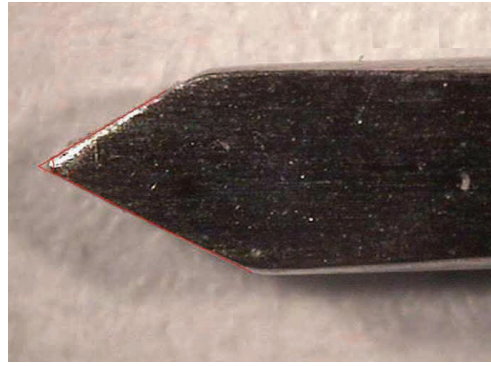
Fig. 4. The tip of the broken K-wire was relatively sharp and had the same angle as the normal K-wire (40× magnified).

This report is the first to document K-wire breakage due to a manufacturing defect. It was difficult to identify the shaft defect responsible intraoperatively because the broken wire had an appearance similar to the normal wire. In fact, the defect was noticed only after pin removal and close examination of the broken tip.
