Total Knee Arthroplasty Wrong Side Implant

Surg J 2018;4:e167-e169.

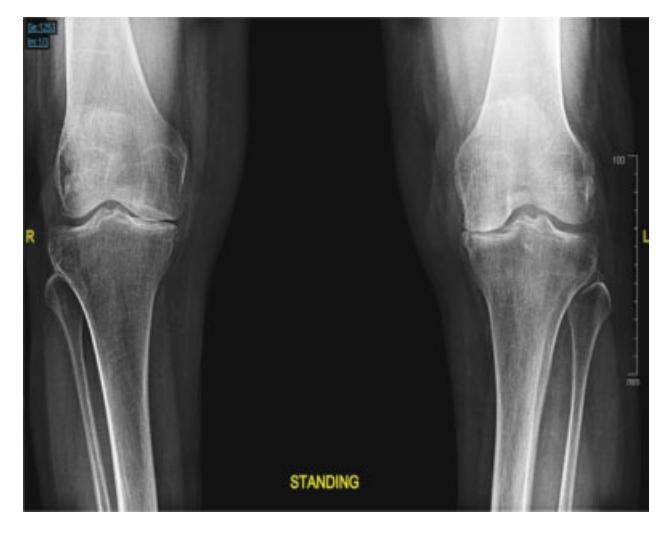
Fig. 1 Standing anteroposterior X-ray of both knees, showing severe bilateral tricompartmental osteoarthritis.

We report unique wrong implant error occurred during bilateral total knee replacement procedure in 71-year-old woman, known to have bilateral knee osteoarthritis that has failed conservative treatment. Patient reports severe pain in both knees with decreased walking distance. Examination showed full range of motion for both knees, preoperatively. X-ray showed severe bilateral tricompartmental osteoarthritis (**>Fig. 1**). Patient underwent bilateral sequential total knee replacement (PS, Sigma) in 2013. Postoperative radiographs showed well-fixed femoral, tibial, and patellar components;

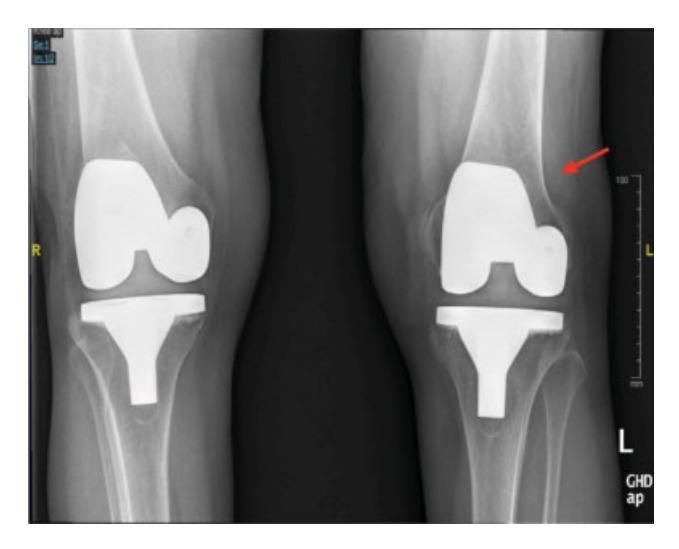
Fig. 2 Postoperative X-ray of both knees, showing right femoral implant was placed in the left knee (arrow).

however, right femoral implant was placed in the left knee instead of left femoral component (**-Fig. 2**). Postoperative examination showed painless full range of motion 0 to 125 degrees. There was no patellar maltracking. No popping was heard. The patient was informed about this error. She has been following up in the clinic for 5 years. She complains of mild occasional pain but otherwise is functioning well. Knee Society score was 75. Western Ontario and McMaster Universities Osteoarthritis Index (WOMAC) was 84 (**-Fig. 3**).

One case report has been found in the literature describing wrong-site femoral component in total knee arthroplasty that has ended up with symptomatic patellar maltracking.⁵ Sigma system is commercially available in the United Kingdom from August 1997. It has separate left and right femoral components. In our case, a right femoral component was correctly positioned in the right knee but a right femoral component was wrongly placed in the left knee (**-Fig. 2**). However, no complications have been observed in our reported case so far. During her follow-up in the clinic, WOMAC was shown to be 84 indicating very good result.

Several studies have shown that the root cause of such events is miscommunication among staff, surgical team members, ignoring members questioning the laterality of the procedure, or staff not speaking up when they notice wrongsite surgery. Other factors that may contribute are lack of timeout, lack of standardization, or lack of clear policies. It is of utmost importance to notice that proper communication inside and outside the operating room among all staff involved in the patients' care cannot be overemphasized.

the use of checklists, is critically important to keep the patients safe. The proper implant, including the correct side, size, and implant type, compatibility, and expiration date must be confirmed before being surgically implanted to avoid medical errors and wasted implants which can exhaust the health care system budget. Implants must be opened individually during the procedure and confirmed by the entire surgical team prior to opening the package by reading the implant package label directly from a distance that allows each one of the surgical team members to properly identify the implant type, laterality, size, and expiration date. The use of large size wall mounted monitors in the operating room can help overcome the distance problem between the person presenting the package and the confirming team member. Recent novel study has presented the use of electronic labeling system has shown to improve the identification of the implants in regard to type, size, site, expiration date, and resulted in less wasted implants and can reduce the chance of wrong-site surgeries.⁶

The surgeon should lead the process of procedure confirmation. If the planned surgery involves multiple surgical sites, procedures, and implants, each should be individually identified during the initial surgical "brief," the surgical "time-out," and the final "de-brief," as well as confirmed individually with a "time-out" before each planned separate site, procedure, and implant. The use of a separate implant "time-out" supports focused team communication and reduces surgical errors.

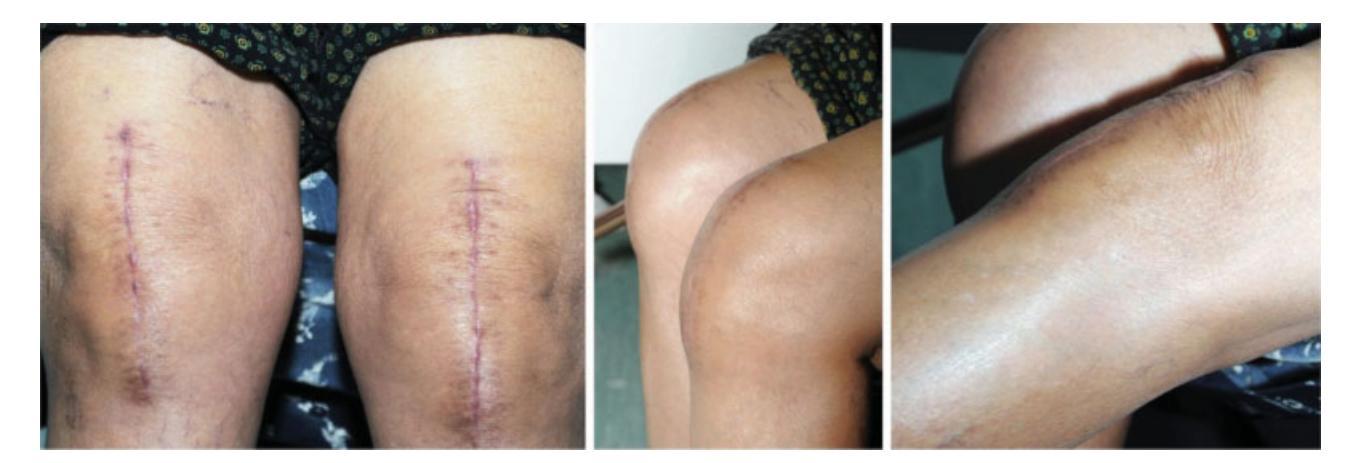
Fig. 3 Clinical pictures during follow-up showed healed scar and full functional range of motion of both knees.
