Endobronchial Malposition of Matthys Pleural Catheter: A Case Report

Thorac Cardiovasc Surg Rep 2015;4:14–17.

Case Description In our case, the positioning of the Matthys catheter was thought to be completely straightforward but an X-ray check nonetheless revealed malposition. The catheter had been advanced surprisingly over the left upper lobe bronchus across the carina into the right upper lobe bronchus. No thoracic bleeding occurred.

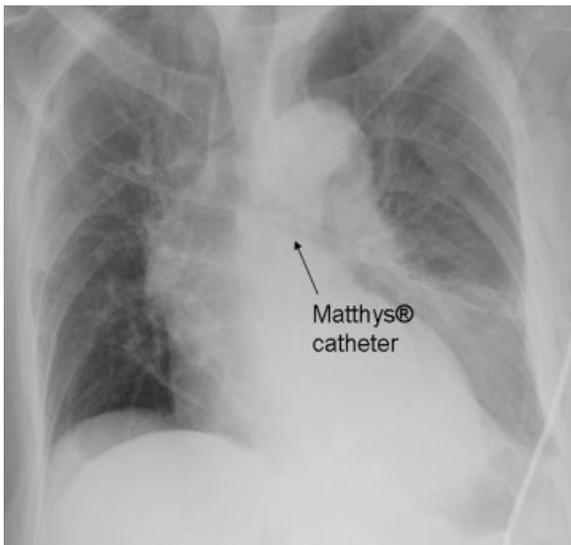
Fig. 1 X-ray of thorax directly after insertion of Matthys catheter.

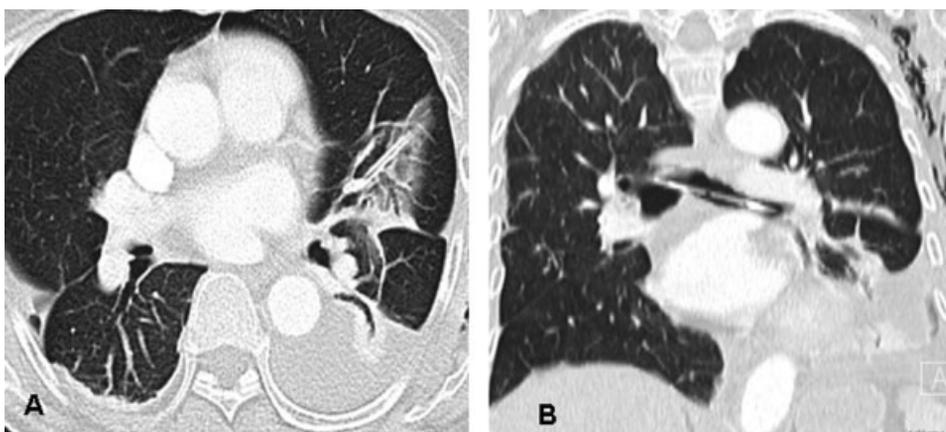
Fig. 2 Computed tomography of thorax: endobronchial malposition of the Matthys catheter: (A) bleeding of the lung parenchyma in segment 2 of the left upper lobe and persistent pleural effusion on the left side; (B) the catheter lies in the central bronchial system.

along the Matthys catheter which had been inserted through the upper lobe. The catheter entered the upper lobe bronchus via a left upper lobe segment and then progressed into the left main bronchus. It crossed into the right main bronchus and then the right upper lobe bronchus and lung parenchyma of the right upper lobe (see ►**Fig. 2**). Apart from a small apical pneumothorax on the left side, there was no soft tissue emphysema and no pneumothorax on the right side.

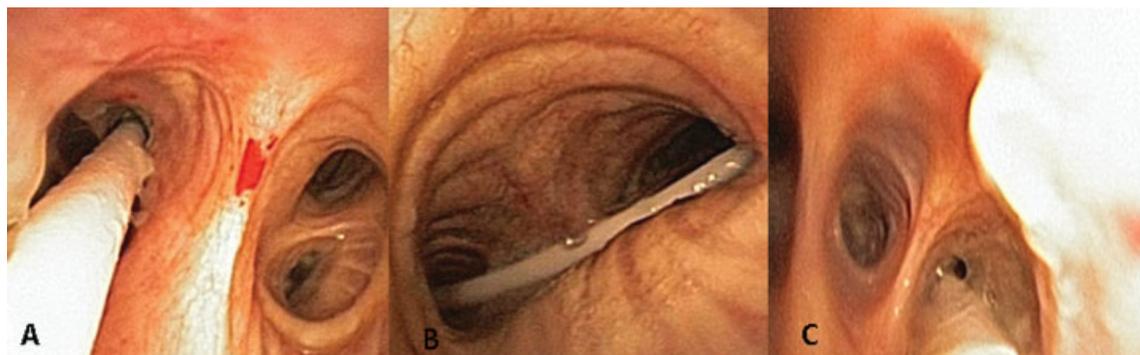
Fig. 3 Endoscopic view of the endobronchial malposition of the Matthys catheter. (A) Entrance of the Matthys catheter through the left upper lobe into the bronchial tree. (B) Bronchial bifurcation: catheter goes from the left to the right side. (C) The catheter runs into the right upper lobe.

We then performed a bronchoscopy to confirm the catheter's suspected position as suggested by computed tomography. The endoscopic examination was performed flexibly under analgosedation. Once the endoscope reached the distal trachea, the catheter immediately became visible. It ran from the left upper lobe through the bronchial system into the right upper lobe segment (see ►**Fig. 3**). The patient tolerated the catheter malposition without any problem. It is astonishing that there were no coughing attacks whatsoever.

First of all, an endoscopic evaluation of the situation inside the bronchi was indicated. Surprisingly, the patient tolerated the foreign body completely without coughing. The bronchoscopy confirmed the malposition of the catheter suggested by computed tomography. In the bronchi, no secretion or blood needed to be aspirated. It was clear that such malposition of the catheter could not be tolerated and the catheter needed to be removed immediately. In theory, bilateral pneumothorax can occur after removal. One option to consider would have been to fit the patient with prophylactic thoracic drainage on both sides to protect against bilateral tension pneumothorax. We decided against this, as the patient was awake and breathing spontaneously. We simply removed the catheter while carrying out intensive care monitoring. However, we had made preparations at the bedside for inserting thoracic drains on both sides. If respiratory insufficiency had occurred, it would have been possible to provide immediate bilateral relief even without an X-ray. If pronounced bronchopleural fistulas had been present on both sides and respiratory insufficiency had been a danger, intubation and ventilation would have been unavoidable. Ventilation with higher inspiratory pressures leads to worsening of the bronchopleural fistulas. Veno-venous extracorporeal membrane oxygenation is recommended to maintain gas exchange with implantation of cannulae via the groin.

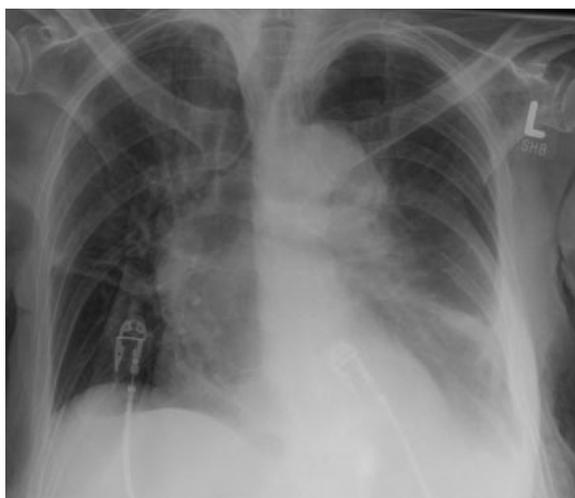
Fig. 4 Thoracic X-ray after removal of the Matthys catheter. No pneumothorax.

Because of the small size of the Matthys catheter, we decided simply to remove it while remaining prepared to place a thoracic drain if necessary. This was achieved without problems and without any occurrence of thoracic bleeding or pneumothorax. There was no occurrence of breathlessness. We prescribed absolute bedrest for the patient. A thorax X-ray showed no pneumothorax and no soft-tissue emphysema (see ►**Fig. 4**). The patient was transferred to the general ward 1 day later. As no lung problems occurred over the next few days, we were able to transfer the patient back to her original hospital on the 5th day of admission.
