# Cracked tooth diagnosis and treatment: An alternative paradigm

John S. Mamoun<sup>1</sup>, Donato Napoletano<sup>2</sup>

This article reviews the diagnosis and treatment of cracked teeth, and explores common clinical examples of cracked teeth, such as cusp fractures, fractures into tooth furcations, and root fractures. This article provides alternative definitions of terms such as cracked teeth, complete and incomplete fractures and crack lines, and explores the scientific rationale for dental terminology commonly used to describe cracked teeth, such as cracked tooth syndrome, structural versus nonstructural cracks, and vertical, horizontal, and oblique fractures. The article explains the advantages of high magnification loupes ( $\times 6-8$  or greater), or the surgical operating microscope, combined with co-axial or head-mounted illumination, when observing teeth for microscopic crack lines or enamel craze lines. The article explores what biomechanical factors help to facilitate the development of cracks in teeth, and under what circumstances a full coverage crown may be indicated for preventing further propagation of a fracture plane. Articles on cracked tooth phenomena wer

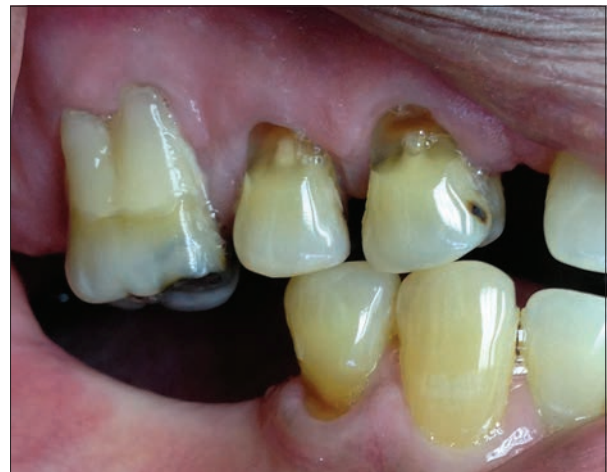
**Figure 1:** A lateral view of two premolars that experience heavy occlusal forces due to lack of molar occlusion, which also have abfraction lesions

protruding maxillary molar palatal cusps<sup>[12]</sup> occluding powerfully into the mandibular molar central grooves. Maxillary premolars, which often have steep inclines on nonfunctional cusps that result in torque forces during mastication, are more likely to crack than mandibular premolars, which experience mostly compression forces due to opposing teeth occluding into the mandibular premolar buccal cusps. A posterior tooth with a class II restoration may be the source of discomfort if it is the only remaining (or restored) posterior tooth in that quadrant, or if it shows signs of occlusal trauma or an abfraction lesion [Figures 1 and 2].

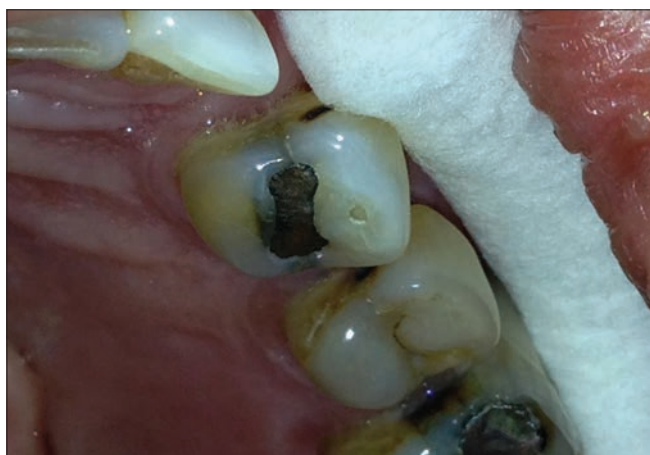
**Figure 2:** An occlusal view of the premolars from Figure 2 also shows marginal ridge fractures

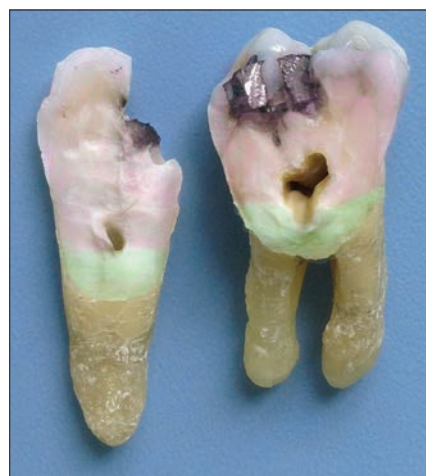
**Figure 3:** The palatal root (left) disconnected from the buccal roots (right) of this maxillary molar via a furcation fracture. Here, a stress plane superior to the pulp chamber floor (pink) and another stress plane between the pulp chamber floor and the external tooth surface between the roots (green) both fractured, resulting in complete palatal root disconnection

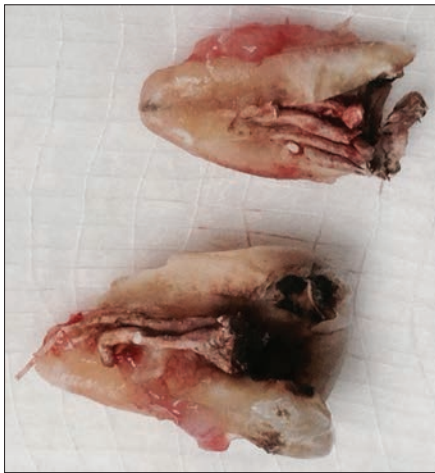
**Figure 4:** Hypothetically, the furcation fracture in this mandibular molar may have resulted partially from gutta-percha filling much of the pulp chamber, and increasing the flexibility of the pulp chamber walls and floor, compared to if the chamber was filled with a stiff core material

lingual aspects, and also binds the buccal aspects of the tooth structure that is occlusal and apical to the pulp chamber, respectively, with the lingual aspects. Any posterior tooth restorative preparation that involves removal of the mesial or distal marginal ridges (such as class II preparations), or the tooth structure occlusal to the pulp chamber roof (such as endodontic access openings<sup>[21-23]</sup> or deep class I preparations),<sup>[24,25]</sup> results in less tooth structure remaining to resist split-apart stresses.<sup>[26-34]</sup> Leaving too much soft gutta percha inside a pulp chamber after making a post/core or core build up, instead of filling the entire chamber with a strong core material, may increase the overall flexibility of a molar or premolar tooth, and the long-term rate of furcation fracture plane expansion [Figure 4].<sup>[35]</sup>

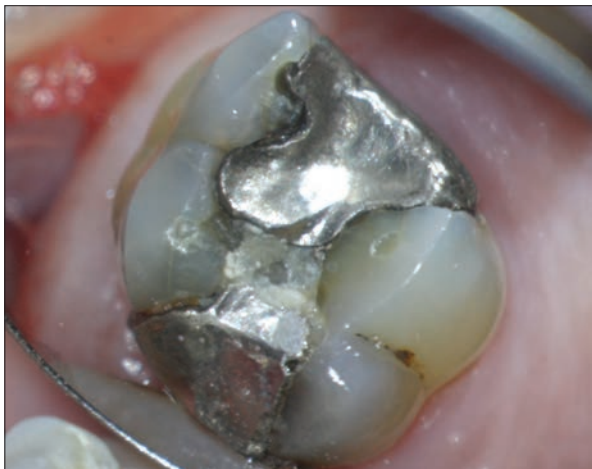
**Figure 6:** This maxillary molar with a class II restoration was sensitive

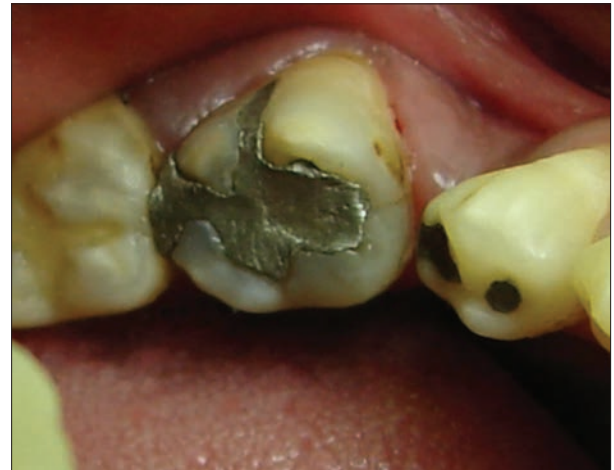
**Figure 5:** A molar with a class II restoration and a crack in the untouched marginal ridge

cracks [Figure 5]. Furthermore, if a tooth with a class II restoration is sensitive, a dentist may remove the restoration to observe if a crack line exists underneath the restoration [Figures 6 and 7]. If no crack line is observed, the dentist (conservatively) replaces the restoration. However, an observed crack line may be interpreted as a partial fracture of a furcation stress plane that is presumed to exist in that tooth, where the tooth has a missing marginal ridge on one side (due to the restoration), and a compromised marginal ridge on the other side (due to the crack). Here, a crown and possibly endodontic treatment may be needed.

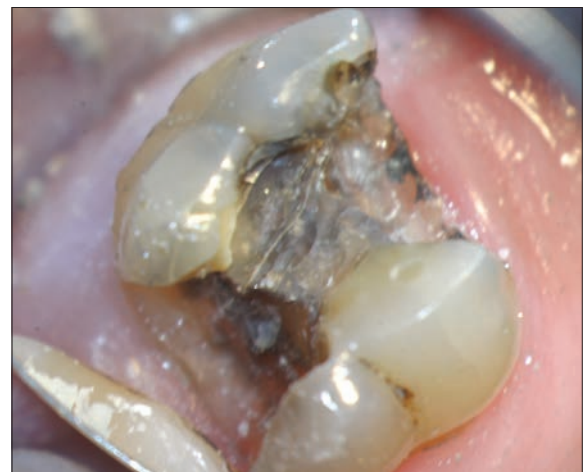
**Figure 7:** Removal of the amalgam reveals the crack lines of a cuspal fracture plane along the apical-axial aspect of the buccal cusps and a partially fractured furcation stress plane

Cuspal fractures can be caused by forces put on existing restorations during masticatory cycles; these forces stress the stress planes located apical to the cusps that retain the restorations.<sup>[32,40]</sup> With an amalgam, the preparation axial walls converge toward the occlusal, so occlusally directed forces on the restoration stress the cuspal stress planes. The walls of an inlay preparation diverge toward the occlusal, so apically directed forces stress the cuspal stress planes. If the dentist removes the restoration and observes the dried preparation surface, the dentist may observe a crack line located at what was previously the apical-lateral aspect of the restoration [Figure 7].

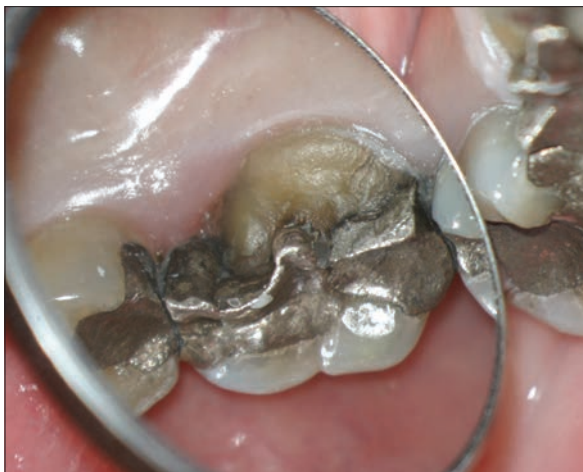
**Figure 8:** A complete fracture of a molar lingual cusp shows a void that is bounded axially by a large mesial-occlusal-distal amalgam that the cusp was helping to retain

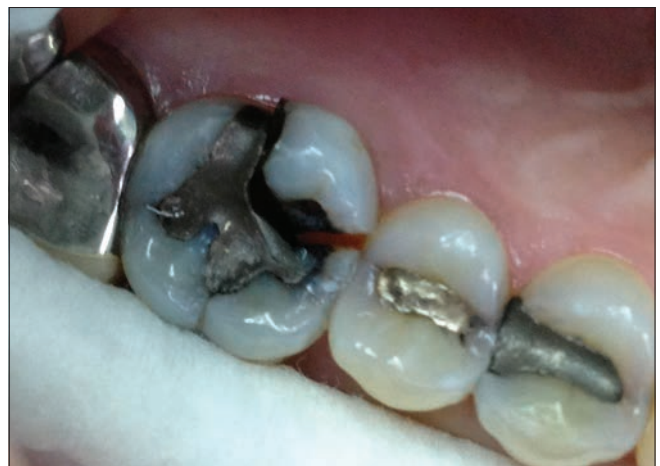
**Figure 9:** A complete fracture of the mesial-lingual cusp of a maxillary molar, retained only by gingival tissue

Cuspal fracture planes can develop inside a tooth without showing visible crack lines on the external surface of the tooth, if the fracture plane is subgingival, or if the fracture plane has not expanded enough in area to reach the external tooth surface [Figure 9].

A cusp may fracture off the tooth but be retained by gingival tissue [Figure 9]. When the patient occludes, the cracked piece may jab the gingiva but only cause soft tissue pain. Removing the loose piece may indefinitely relieve sensitivity, and with polishing the tooth may be indefinitely stable, without requiring further restoration. When restoring the tooth with a direct restoration, microscopes facilitate observing that an opposing pointy plunger cusp does not occlude into the restoration isthmus.

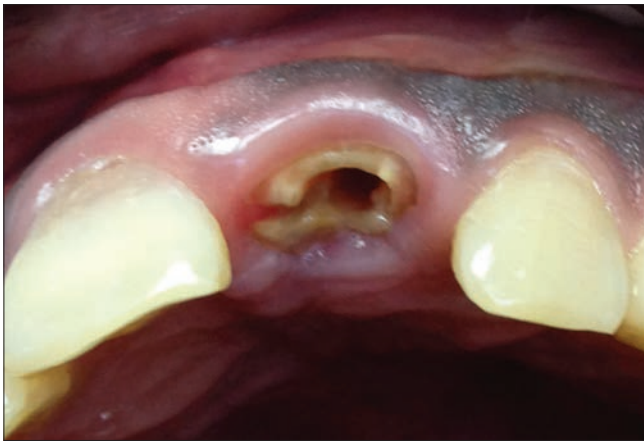
**Figure 10:** A maxillary central incisor showing a root fracture and a gingival interface fracture, due to a post and core that fractured the root due to lack of ferrule tooth structure

A root fracture is a fracture of a stress plane contained within only one root, such that complete fracture of the stress plane would not result in disconnection of one root from another [Figure 10]. Root fractures,<sup>[3,48]</sup> which are often catastrophic fractures,<sup>[49]</sup> can result from caries in root structure or from roots containing intra-canal retainers<sup>[2,50]</sup> where the tooth lacks ferrule tooth structure, which results in a post putting more stress on the root.<sup>[51,52]</sup> Roots can also be fractured via use of excessive pressure while obturating root canals;<sup>[53-56]</sup> using excessive vertical forces to push a peeso reamer into a root while making a postspace, particularly if the peeso reamer is too wide in diameter compared to the diameter of the canal; skipping sizes of peeso reamers while making a postspace, such as moving from a #1 peeso reamer directly to a #3 peeso reamer, particularly when preparing postspaces in thin roots, which are common with premolars or mandibular incisors; or radicular micro-cracks<sup>[45,57]</sup> created during apico-ectomy procedures using ultrasonic retro-tips. One study<sup>[53]</sup> showed that the

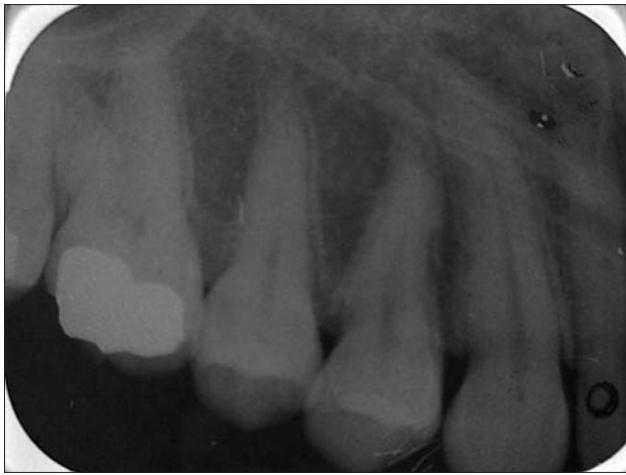
**Figure 11:** A radiograph of a maxillary molar that contains minimal remaining coronal tooth structure that can help to retain the large mesial-occlusal-distal restoration. The remaining tooth structure is under higher stress levels from retaining the restoration. Part of the distal aspect of the remaining tooth structure fractured, showing that the remaining tooth structure is not strong enough to retain this direct restoration without developing cracks

that is deep in an occlusal-to-apical direction [Figure 11], where there is minimal height of tooth structure from the gingival interface level of the tooth to the apical level of the restoration. A crown and possibly a post may be needed to retain the supra-gingival restoration. However, if the restoration has a buccal or lingual component that reaches the CEJ area of the tooth, then the restoration, on the radiograph, may appear deeper than it is in reality.

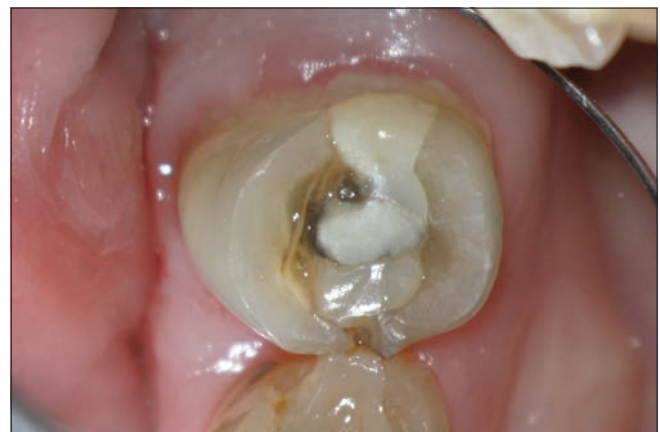
**Figure 12:** A sensitive premolar shows a cleft and a microscopically thin crack line, with a minimal color contrast with surrounding tooth structure

Microscopes facilitate observation of microscopic crack lines that may show minimal color contrasts against a desiccated tooth surface [Figure 12], without needing trans-illumination or dyes to observe crack lines. Microscopically precise tactile sensation permits verification of a crack by associating the tactile sensation of an explorer tip falling into a cleft with the microscopic point on a crack line where the tip is located. Microscopes permit detecting microscopic

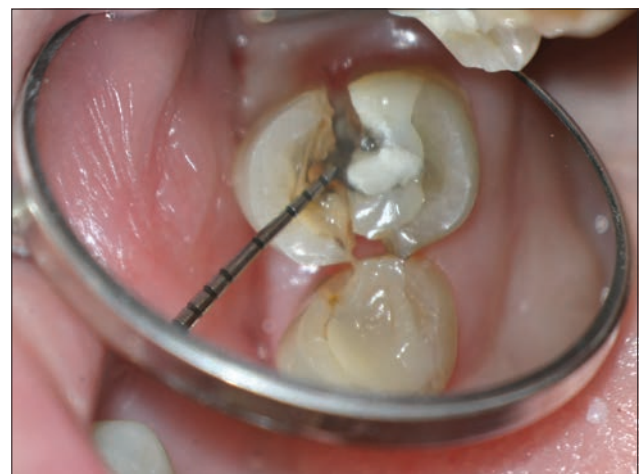
**Figure 13:** A periodontal probe in the premolar separates the cracked piece
