# Evaluation of dentinal defects during root canal preparation using thermomechanically processed nickel-titanium files

Bertan Kesim<sup>1</sup>, Burak Sagsen<sup>2</sup>, Tugrul Aslan<sup>2</sup>

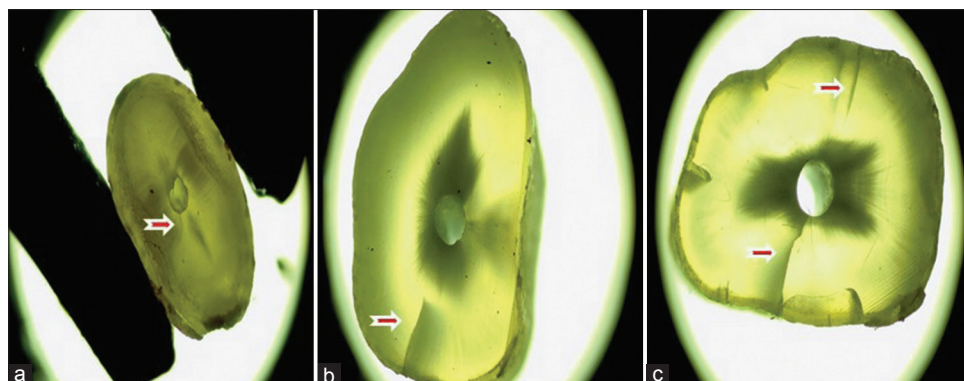
**Figure 1:** Representative images of (a) 3-mm, (b) 6-mm, and (c) 9-mm level horizontal root sections. Arrows indicate the cracks

All roots were sectioned horizontally at a distance of 3, 6, and 9 mm from the apex with a low-speed saw (Minitom; Struers, Denmark) under water-cooling. Two operators who were blinded to the technique examined sections by a stereomicroscope at  $\times 25$  magnification, and the images were captured with a digital camera (DP-70; Olympus, Tokyo, Japan) attached to the stereomicroscope. Images were classified as follows: “crack” or “no crack.” “Crack” was defined as any lines, microcracks, or fractures in the root dentin [Figure 1]. “No crack” was used if the root dentin was devoid of craze lines, microcracks on the external surface of the root, and microcracks on the internal surface of the root canal wall [Figure 2]. In each group, the number and percentage of cracks were recorded. Data were analyzed with the Chi-square

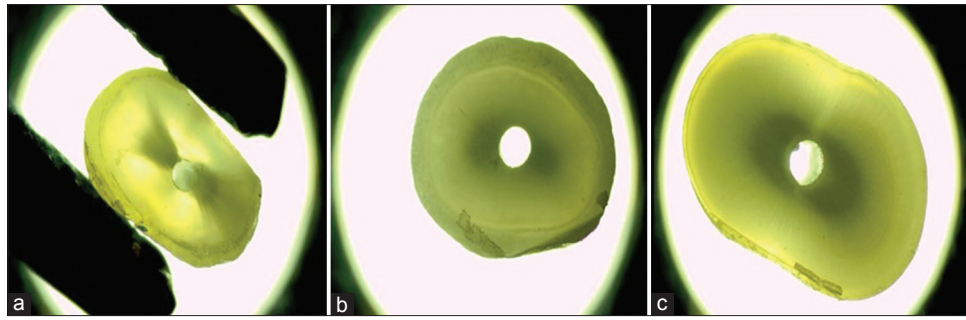
Figure 2: Representative images 9-mm level of (a) 3-mm, (b) 6-mm, and (c) horizontal root sections (without any cracks)
