Evaluation of dentinal defects during root canal preparation using thermomechanically processed nickel-titanium files

Bertan Kesim¹, Burak Sagsen², Tugrul Aslan²

¹Department of Endodontics, Faculty of Dentistry, Mersin University, Mersin, Turkiye,
²Department of Endodontics, Faculty of Dentistry, Erciyes University, Kayseri, Turkiye

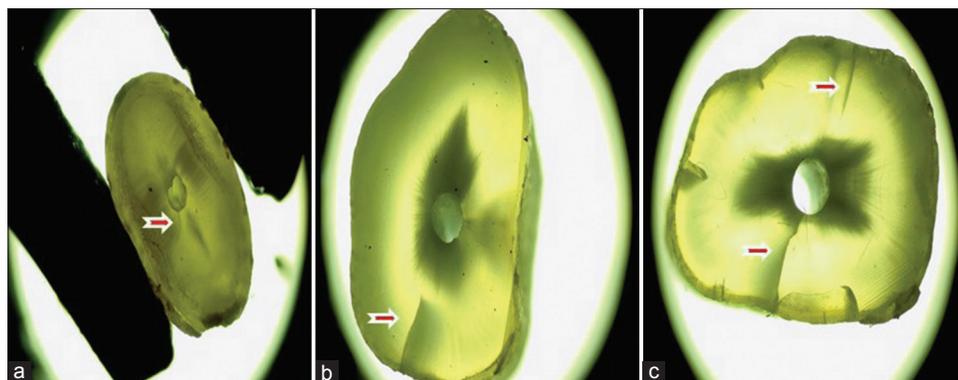
Figure 1: Representative images of (a) 3-mm, (b) 6-mm, and (c) 9-mm level horizontal root sections. Arrows indicate the cracks

All roots were sectioned horizontally at a distance of 3, 6, and 9 mm from the apex with a low-speed saw (Minitom; Struers, Denmark) under water-cooling. Two operators who were blinded to the technique examined sections by a stereomicroscope at $\times 25$ magnification, and the images were captured with a digital camera (DP-70; Olympus, Tokyo, Japan) attached to the stereomicroscope. Images were classified as follows: "crack" or "no crack." "Crack" was defined as any lines, microcracks, or fractures in the root dentin [Figure 1]. "No crack" was used if the root dentin was devoid of craze lines, microcracks on the external surface of the root, and microcracks on the internal surface of the root canal wall [Figure 2]. In each group, the number and percentage of cracks were recorded. Data were analyzed with the Chi-square
