Needle fracture during endoscopic ultrasound-guided fine needle aspiration using a needle with a side hole

Takashi Sasaki, Ryo Kanata, Naoki Sasahira

DOI <https://doi.org/10.1055/a-0587-4827> |
Endoscopy International Open 2018; 06: E553–E557
© Georg Thieme Verlag KG Stuttgart · New York
ISSN 2364-3722

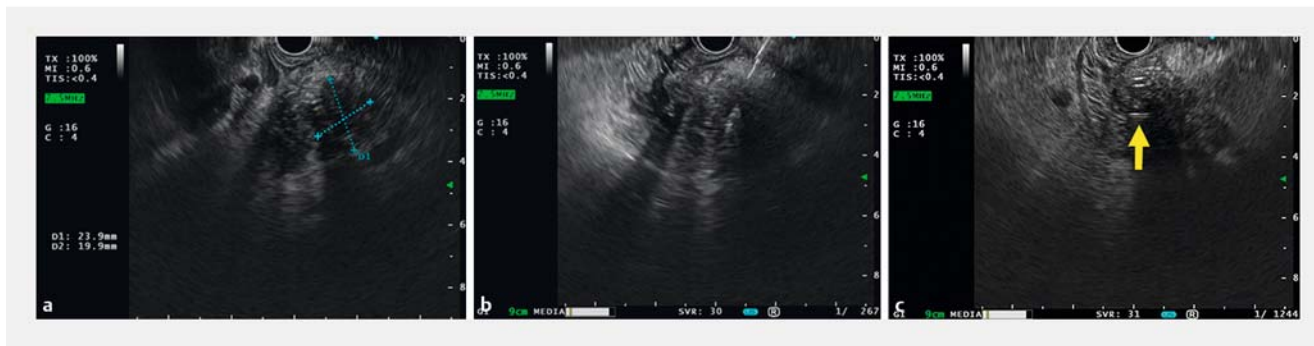
► **Fig. 2** a Endoscopic ultrasound revealed a 24 x 20-mm low echoic mass. b A 20-gauge needle was used to puncture the mass. c The fragment of fractured needle was visualized by EUS.

Under conscious sedation, an EUS (GF-UCT260, Olympus Medical) was performed to obtain a tissue sample from the pancreatic mass in the uncinate process. The mass was 24 × 20 mm (► **Fig. 2a**). A 20-gauge needle with forward bevel (Echo Tip ProCore HD Ultrasound Biopsy Needle, Cook Medical) was used to puncture the pancreatic mass from the first part of duodenum. The endoscope was angulated and the elevator was used a lot during needle passage, however, the endoscope did not need over-torquing to view the mass. Although the tumor had no calcification, it was slightly hard and light resistance was needed to puncture the tumor. A suf-

efficient specimen was not obtained from the first or second passage according to the rapid onsite evaluation of cytology. Therefore, a third puncture was performed using the same needle (► **Fig. 2b**). When removing the device from the endoscope, it was observed that the tip of the needle was not present. Endosonography confirmed that the tip of the fractured needle remained in the pancreas (► **Fig. 2c**). No needle was visible endoscopically from the duodenal wall, and it was impossible to remove the fragment endoscopically. Pathological confirmation of the specimen was achieved from the third puncture. The needle fractured at the side hole (► **Fig. 3**). The fragment was detected radiographically when introducing an expandable metallic stent for the malignant biliary obstruction (► **Fig. 4a**). Abdominal CT also showed an 8-mm-long needle fragment at the uncinus process of the pancreas (► **Fig. 4b**, ► **Fig. 4c**). Although the fragment of the fractured needle could not be removed from the pancreas, the patient exhibited no symptoms and no changes in vital signs after the procedure.

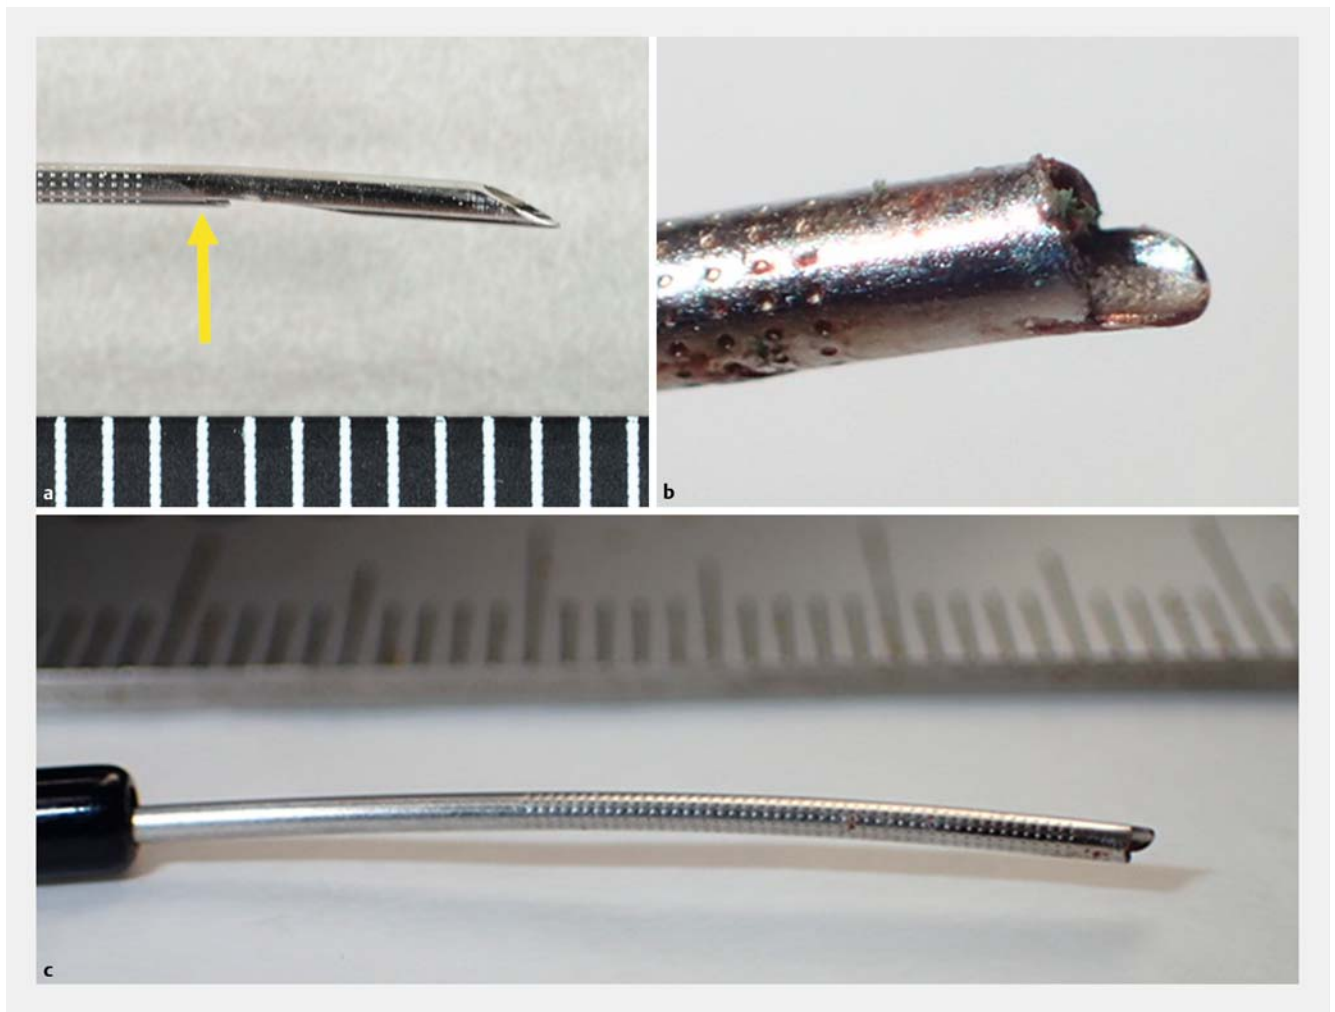
► **Fig. 3** a A 20-gauge needle with a forward bevel. **b, c** The needle was fractured at the site of the side hole.

we hypothesize that the side hole made the needle weaker and that in our case, the repeated passages led to for the needle fracture in our case.

This is the first report of a needle fracture that occurred at the side hole of an EUS-FNA needle. When repeatedly puncturing a rigid target, exchanging the needle may help to avoid needle fracture. It is important to inform clinicians about the potential risk for needle fracture, especially given the increased number of EUS-FNAs being performed.

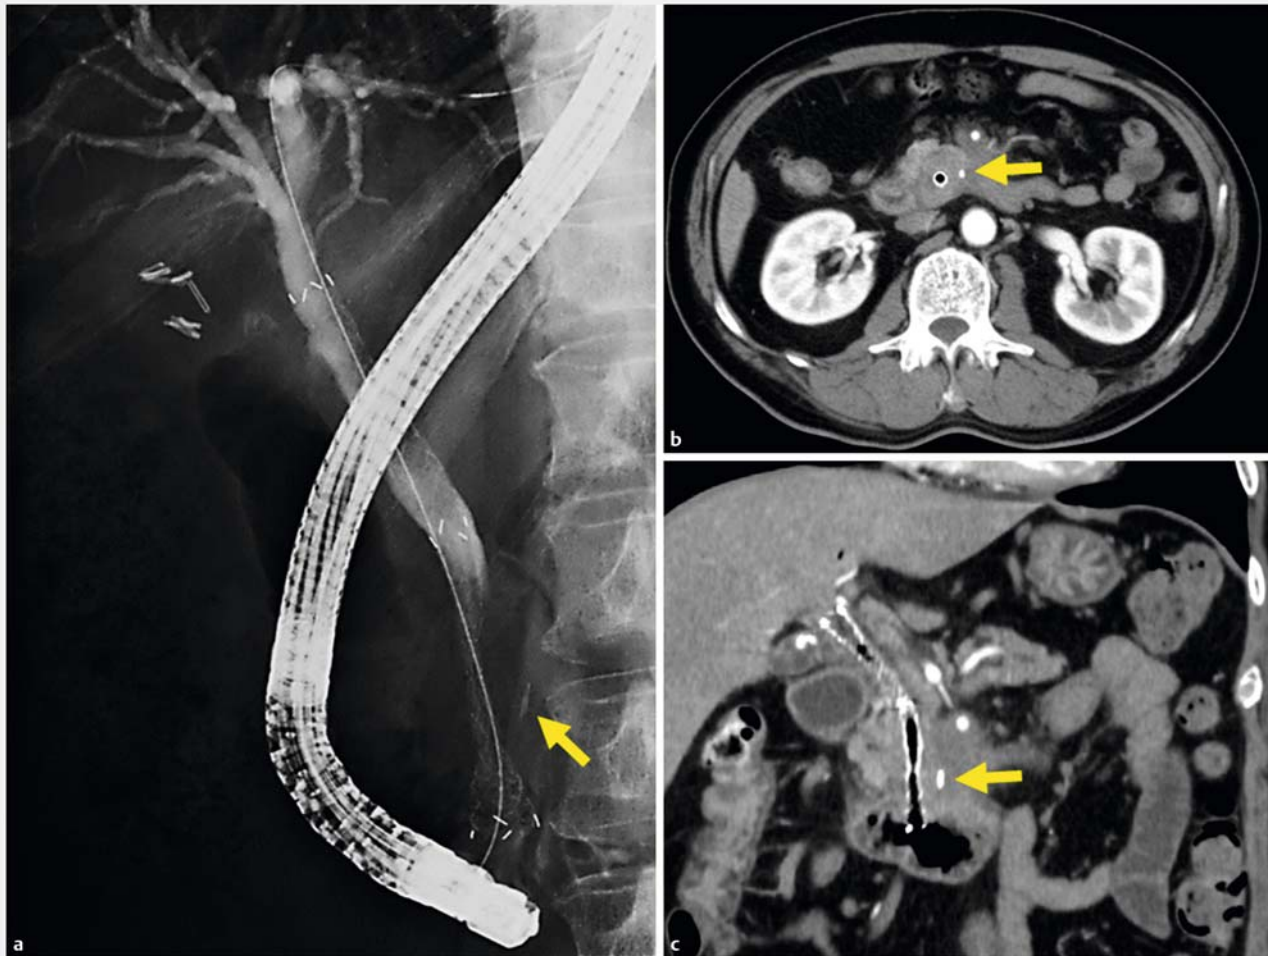
► **Fig. 4** **a** The fragment of the fractured needle was detected radiographically during endoscopic placement of a metallic stent. **b** Axial view of the abdominal computed tomography showing the fractured needle fragment. **c** Coronal view of the abdominal computed tomography showing the fractured needle fragment.

In our case, the fragment of fractured needle remained in the pancreas of the patient who was suffering from advanced pancreatic cancer. Surgical removal of the fragment was not attempted because it was considered too invasive for this patient. However, the fragment could have been removed if the patient had suffered from a benign disease and had a long life expect-

tancy. If the tip of the fractured needle remains inside the enteral lumen, a snare or forceps is useful for removing it. In the case of CT-guided biopsy of the thoracic spine, the needle-in-needle technique for percutaneous retrieval of a fractured needle was reported [10]. However, this technique is too difficult to perform in the case of EUS, and surgical removal is required when the fractured needle cannot be retrieved endoscopically.
