Endoscopic management of stent displacement after pancreatic pseudocyst drainage

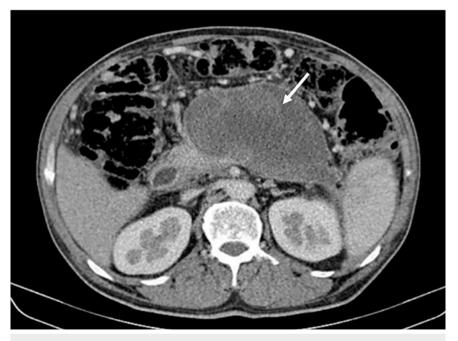
► Fig. 1 Abdominal computed tomography scan showing a well-defined cystic lesion (arrow), 16 × 8 cm in diameter, in the tail of the pancreas.

A 50-year-old man who had experienced acute alcoholic pancreatitis 2 years earlier presented with abdominal pain. An abdominal computed tomography (CT) scan revealed a pseudocyst, 16×8 cm in size, in the pancreatic tail (> Fig. 1). After multidisciplinary discussion, the patient was referred for endoscopic pseudocyst drainage.

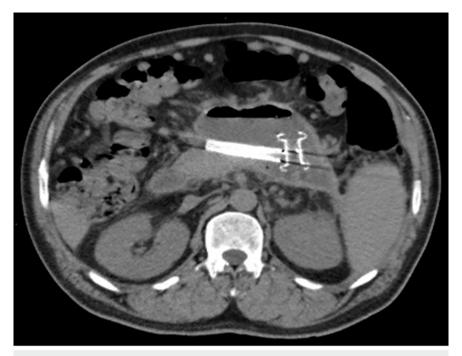
▶ Fig. 2 Abdominal computed tomography scan in axial view showing complete migration of the first two stents into the pseudocyst cavity.

Transgastric puncture of the pseudocyst was performed using a 19-gauge fineneedle aspiration needle, under endoscopic ultrasound (EUS) guidance. A 0.035-inch quidewire was advanced through the needle and the tract was dilated to 6 mm. A fully covered doubleflanged metal stent (40×14mm) was then deployed across the tract under endoscopic, EUS, and fluoroscopic guidance. The deployment was complicated by complete intracystic migration of the stent. We decided to place a fully covered biliary metal stent (60×10 mm) in an attempt to save the performed cystogastrostomy, and planned to retrieve the migrated stent at a later time. The patient was discharged with no symptoms. The patient was readmitted to our department 1 week later with fever and upper abdominal pain. Abdominal CT scan showed complete migration of the two stents into the pseudocyst cavity (12×6 cm) (► **Fig. 2**).

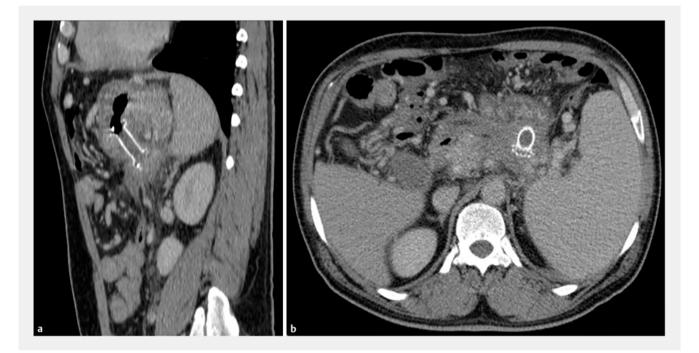
▶ Fig. 4 Abdominal computed tomography scan. a Coronal view, showing a correctly positioned fully covered double-flanged metal stent. b Axial view, showing complete resolution of the pancreatic pseudocyst.

Under endoscopic, EUS, and fluoroscopic guidance, we placed another fully covered double-flanged metal stent (40×14mm) through the patent cystogastrostomy (▶ Fig. 3). The two intracystic migrated stents were then removed through the third stent using a foreign body forceps. Effective drainage of the pseudocyst was observed and the patient became asymptomatic (▶ Video 1). At follow-up 1 month later, after an abdominal CT scan showed complete resolution of the pseudocyst (▶ Fig. 4), the stent was removed endoscopically (▶ Fig. 5).
