A Near Miss: Case Report and Literature Review

Am J Perinatol Rep 2012;2:23–24.

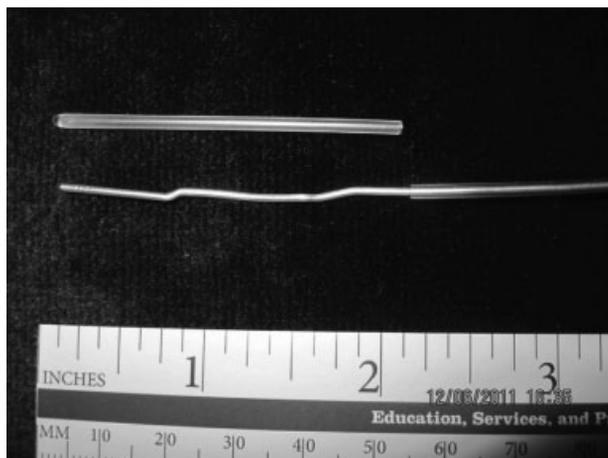
A 28 weeks gestation premature infant with birth weight of 970 g developed respiratory distress syndrome causing oxygen desaturation and respiratory acidosis in blood gas. The attending physician decided to perform endotracheal intubation for mechanical ventilation support. A 2.5 mm uncuffed ETT threaded with 6-French (2-mm) plastic-coated stylet (SMMP, Riyadh, Kingdom of Saudi Arabia) was used. After intubation the physician could not remove the stylet from the ETT. The stylet was stuck inside the ETT but eventually came out with force. The intubation attempt lasted more than 90 seconds and the infant experienced a period of desaturation without bradycardias. After removal, it was noticed that the distal part of the coated sheath is missing. The infant was extubated and ~5-cm long plastic piece found embedded distally inside the ETT (▶**Fig. 1**). The infant immediately reintubated with a new set of ETT and stylet.

Figure 1 A 5-cm long piece of the stylet sheath retrieved from the endotracheal tube lumen after extubation.

The plastic sheath is stretchable, pliable, and the malleable metal core should rotate easily inside it. It is unclear how does the plastic sheath shear off. We speculate that at different point of surface contact between the plastic sheath, the ETT externally and the metal core internally, the frictional force is variable. During forceful withdrawal of the stylet, the linear force created will be mounted at the point of maximum friction, such as an angulation's point at the stylet. These different points may be created by kinks and bends in the metal core caused by excessive handling of the stylet.¹⁰ Using a forceful withdrawal commonly attributed as a risk factor for the shearing.^{1–9}

Pulling the stylet forcefully should be avoided, instead, if the stylet stuck inside the ETT, we recommend to extubate the patient and reintubate with a new set of ETT and stylet. Fitting and rotating the stylet into the ETT before intubation may ease the stylet's withdrawal without using excessive force. A bigger size ETT may be used if indicated. Bending the stylet sharply to fit the ETT should be avoided because most of the reported severed point occurs at the angulation point and consistently reported as a risk factor.⁶ The practice of completely removing the plastic sheath from the stylet before fitting it inside ETT and seating the metal tip completely inside the ETT distally has been advocated but not commonly used.⁶

It is very important to carefully inspect the stylet's integrity after withdrawal and before using any positive pressure ventilation,³ to use a new stylet for each intubation attempts, to minimize bending and rebending the stylet, and to twist the stylet's proximal end around the ETT adaptor. High index of suspicion and vigilance will help in avoiding doing harm to patients.
