## Sigmoid perforation caused by a migrated biliary stent and closed with clips

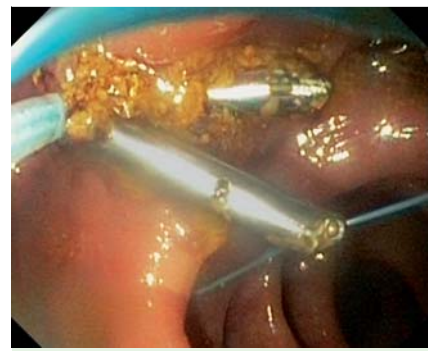
**Fig. 4** Completed closure was achieved with deployment of two clips and one endoloop.

A 73-year-old man was admitted with sharp tenderness in the left iliac fossa, peritonitis, fever, and leukocytosis. The patient had undergone an endoscopic retrograde cholangiography 15 days earlier, which showed choledocholithiasis and benign biliary stricture. The stones were extracted and a 10-Fr, 12-cm plastic biliary stent was inserted. A computed tomography (CT) scan revealed that the biliary stent had migrated and caused sigmoid colon perforation with mild pneumoperitoneum (Fig. 1). Sigmoidoscopy was carried out after colon preparation with enema. It showed extensive diverticulosis in the sigmoid colon and the stent was 30 cm from the anus. Its tip had perforated the wall of the sigmoid colon, near the diverticula (Fig. 2). The stent was atraumatically removed with foreign body forceps. A punctate perforation (Fig. 3) was closed with two through-scope clips and an endoloop (Fig. 4).

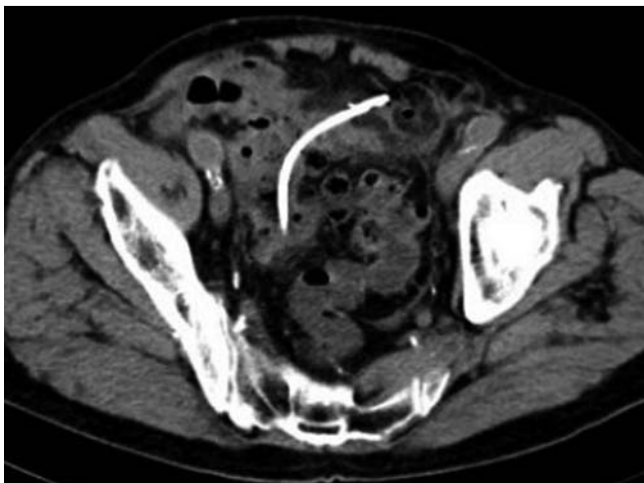
**Fig. 1** Computed tomography (CT) scan in a 73-year-old man with sharp tenderness in the left iliac fossa, peritonitis, fever, and leukocytosis following endoscopic retrograde cholangiography. The scan shows a biliary stent perforating the sigmoid colon.

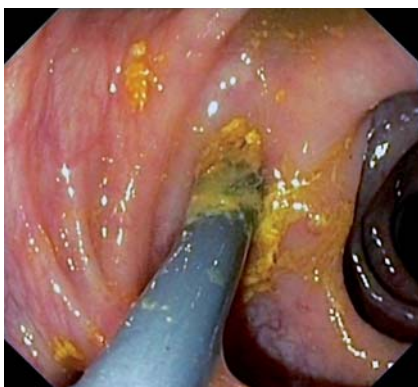
**Fig. 2** Endoscopic image of the biliary stent embedded in the wall of the sigmoid colon.

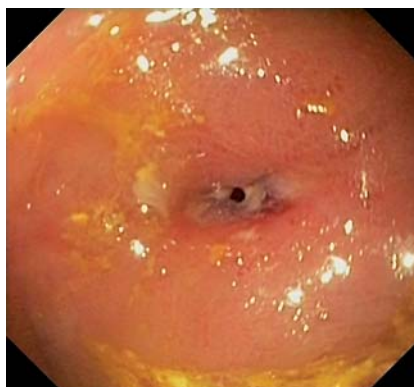
**Fig. 3** A small punctate perforation was seen after removal of the biliary stent.
