Internal Fixation of a Complicated Mandibular Fracture in a Filly Using a String-of-Pearls Locking Plate Assisted by a 3D Printed Model

VCOT Open 2020;3:e90–e95.

Study Design This is a case report.

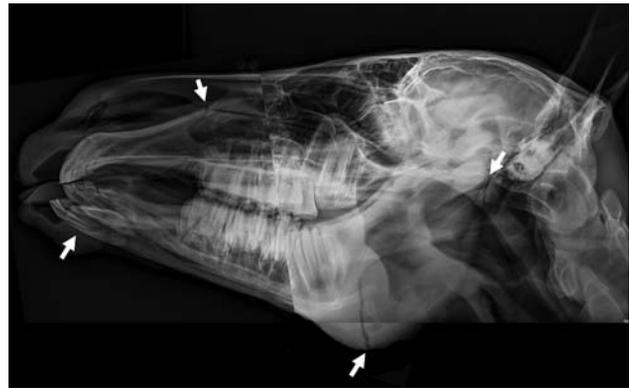
Fig. 1 Composite lateral radiograph several mandibular and maxillary fractures in a 5-month-old filly. From left to right, the white arrows indicate the mandibular symphyseal fracture, rostral maxillary fracture, cranioventral and caudal–ventral aspects of a displaced mandibular fracture.

Radiographic examination confirmed the presence of a unilateral symphysis fracture and identified a non-displaced fracture of the left vertical ramus, with a fracture line identified that appeared to extend to the temporomandibular joint (**► Fig. 1**). Bilateral rostral maxillary fractures were also identified at this time.

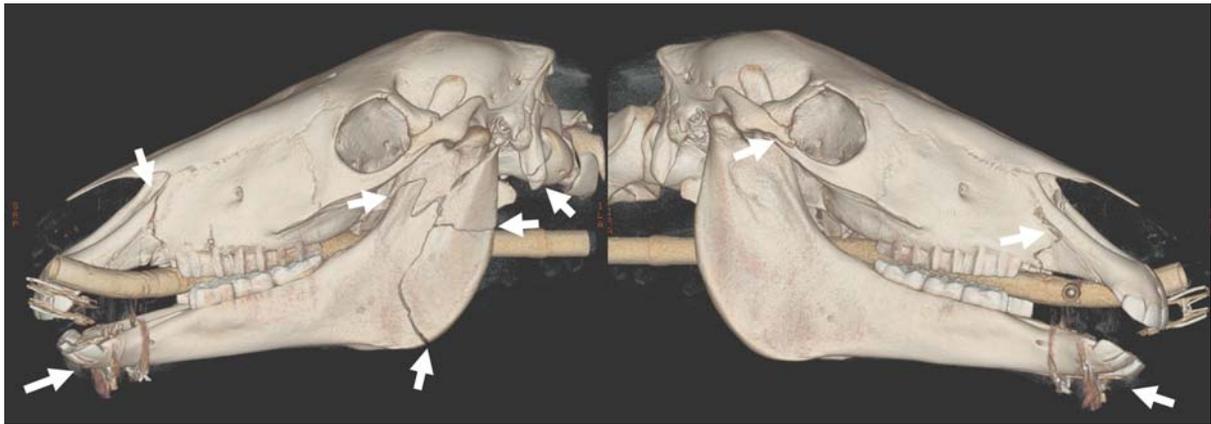
Fig. 2 Computed tomographic three-dimensional surface render of the skull. From left to right, the white arrows indicate the repaired mandibular symphyseal fracture, left maxilla fracture, comminution and displacement of the left mandibular fracture, left paracondylar process fracture, right zygomatic arch fracture, right maxilla fracture. Not pictured = left basisphenoid fracture.

The CT examination identified a fracture of the right wing of the basisphenoid bone, comminuted fracture of the left vertical ramus, minimally-displaced fractures of the left and right rostral maxilla, the right zygomatic arch and displaced fractures of the left paracondylar process, the lateral cortices of the mandible and the previously repaired symphysis

fracture (►Fig. 2). The temporomandibular joints appeared intact, thus the reason for the lateral malocclusion was determined to be the unstable fractures of the vertical ramus and the left paracondylar process. To further aid in the surgical planning of the repair, a scaled (1:4) three-dimensional (3D) printed model based on the CT reconstruction was made and was available during surgery (►Fig. 3).

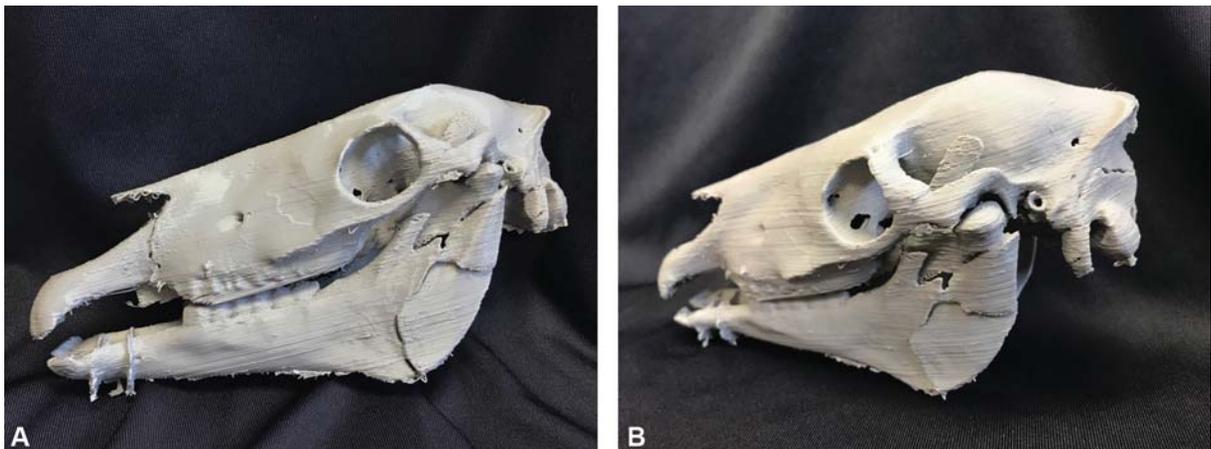
Fig. 3 (A) Three-dimensional (3D) model of the computed tomographic 3D surface render of the skull. The model was utilized pre- and intra-operative to aid in comprehension of the fracture, aid surgical planning, surgical resident training and for client education. (B) Close up of the 3D model highlighting the vertical ramus fracture.

The CT examination was performed to evaluate the filly's injuries more completely and to determine if there was disruption to the temporomandibular joint, which would have reduced the prognosis considerably.²³ The value of CT in pre-surgical planning in the repair of maxillofacial injuries is well established²⁴; the cranium is anatomically complex and the precise position and extent of fracture lines are difficult to infer from radiographs. However, even a reconstructed CT is a 2D representation of a 3D structure, which limits the complete understanding of spatial relationships and may impair decision making.²⁵ Recently, 3D printing has been utilized in small animal practice to aid in surgical planning for oral and maxillofacial surgery, as well as for enhancing resident training and for client education.²⁶ In this case, the availability of the 3D model during surgery helped the surgery team to fully appreciate the fracture margins and aided reduction without the need to pause the surgery to assess the CT. A 1:4 scaled model was utilized to cut back on production time; if a full size model had been produced, it would have had the added benefit of allowing for pre-contouring of the plate.

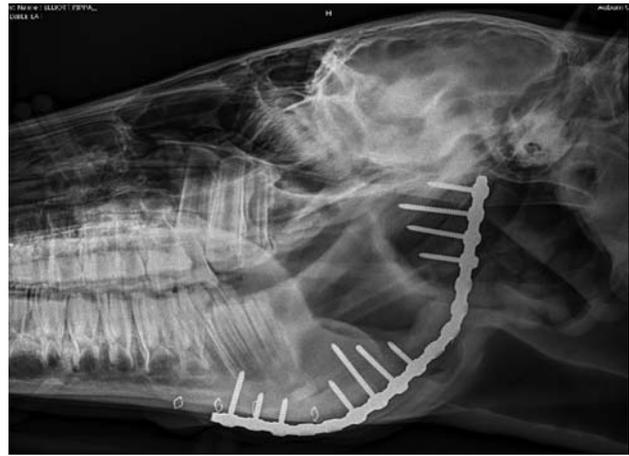
Fig. 4 Lateral radiograph of the caudal skull obtained 4 weeks postoperatively. The fracture is well reduced and healing appears appropriate.

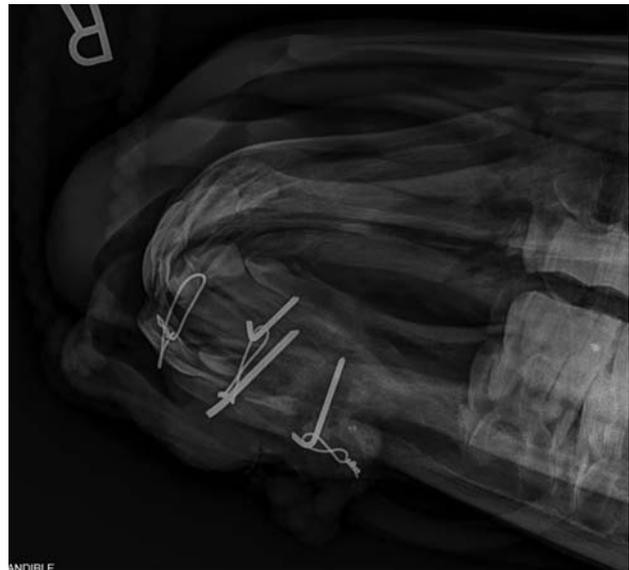
Fig. 5 Lateral ventral–medial dorsal oblique radiograph of the rostral skull 4 weeks postoperatively. There is abundant callus formation. The most caudal wire is associated with periosteal reaction, sclerosis and soft tissue proliferation.

The surgical staples were removed by the referring veterinarian 2 weeks after surgery, at which time the mild swelling of the mandibular incision had resolved. The filly maintained an excellent appetite. The filly was re-presented at 4 weeks postoperatively and radiographic examination revealed callus formation at the previously identified maxilla fractures. The mandibular fractures appeared to be healing well (► Fig. 4). There was peripheral sclerosis and periosteal reaction of the rostral right mandible associated with the symphyseal wire, indicative of focal osteomyelitis (► Fig. 5).
