## A forward-pulling technique for complicated Trapezoid basket impaction during retrieval of common bile duct stones

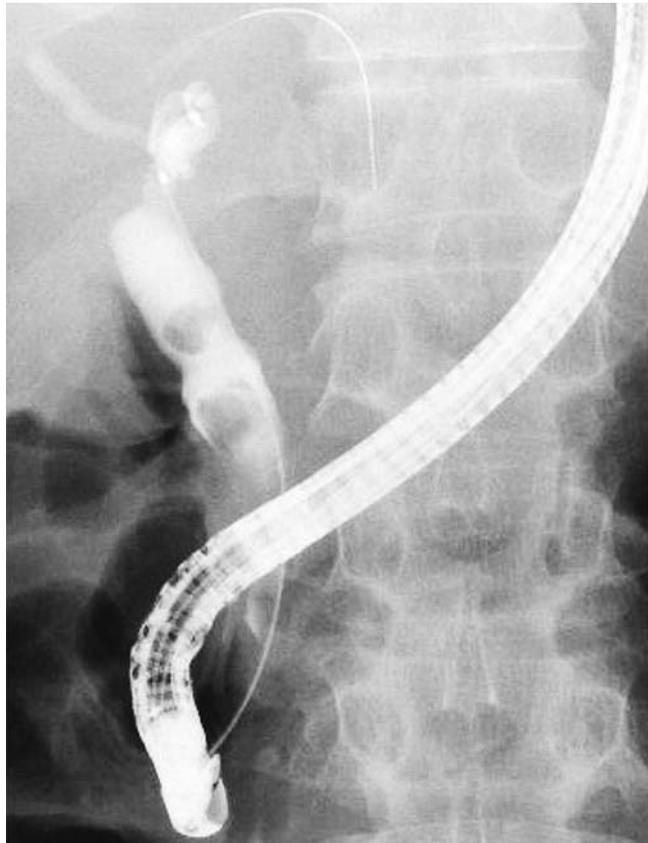
**Fig. 1** Endoscopic retrograde cholangiography revealing multiple common bile duct stones.

A man in his 50s was admitted with multiple common bile duct stones (● Fig. 1). After endoscopic sphincterotomy and endoscopic papillary large-balloon dilation, mechanical lithotripsy was attempted using a Trapezoid basket. However, basket impaction occurred because the stone was too hard and the tip of the Trapezoid failed to disengage.
