Unusual Pattern of Osteochondral Marginal Impaction in Acetabular Fractures. A Report of Two Cases

Bahaaeldin Ibrahim^{1,2} Mahmoud Badran¹ Ahmed A. Khalifa^{1,3} Hossam Abubeih¹
Osama Farouk¹

Rev Bras Ortop

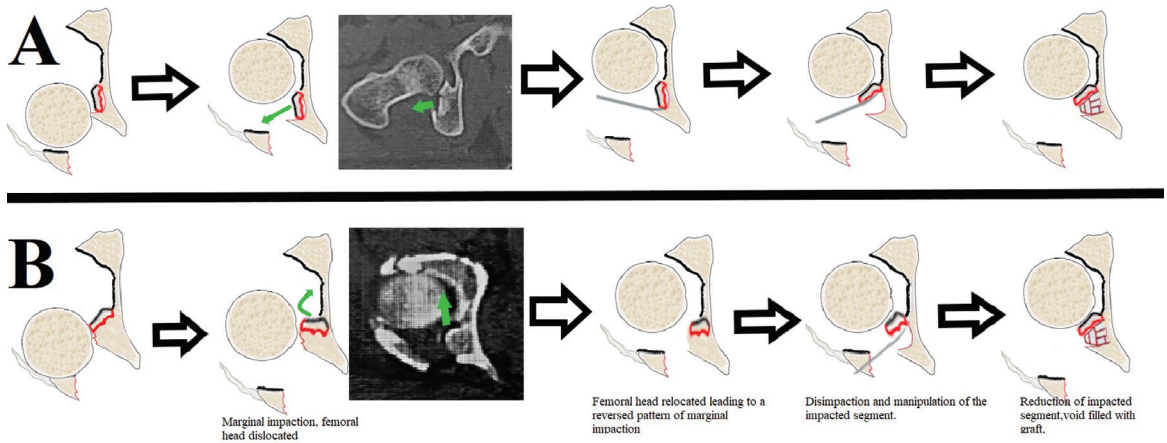
Fig. 1 A schematic diagram showing the differences between, (A) the commonly described marginal impaction pattern, and (B) the unusual pattern we described in the current report.

Open reduction and internal fixation through the Kocher-Langenbeck approach were performed intraoperatively after joint distraction; we noticed that the orientation of the impacted fragment is reversed compared with the usual marginal impaction appearance, meaning that, instead of having the articular surface of the impacted fragment presented enface (the surgeon having a clear look at the shining articular cartilage of the impacted segment [▶Fig. 1A]), it seemed reversed (the articular surface is looking toward the joint cavity hinged on its inner attachment to the acetabular articular cartilage and the surgeon is looking at the cancellous surface of the impacted segment [▶Fig. 1B]). After re-evaluating the preoperative CT of both patients, we found that the marginal osteochondral impacted fragment is looking toward the acetabulum articular cavity instead of the classic appearance description (▶Figs. 2 and 3).

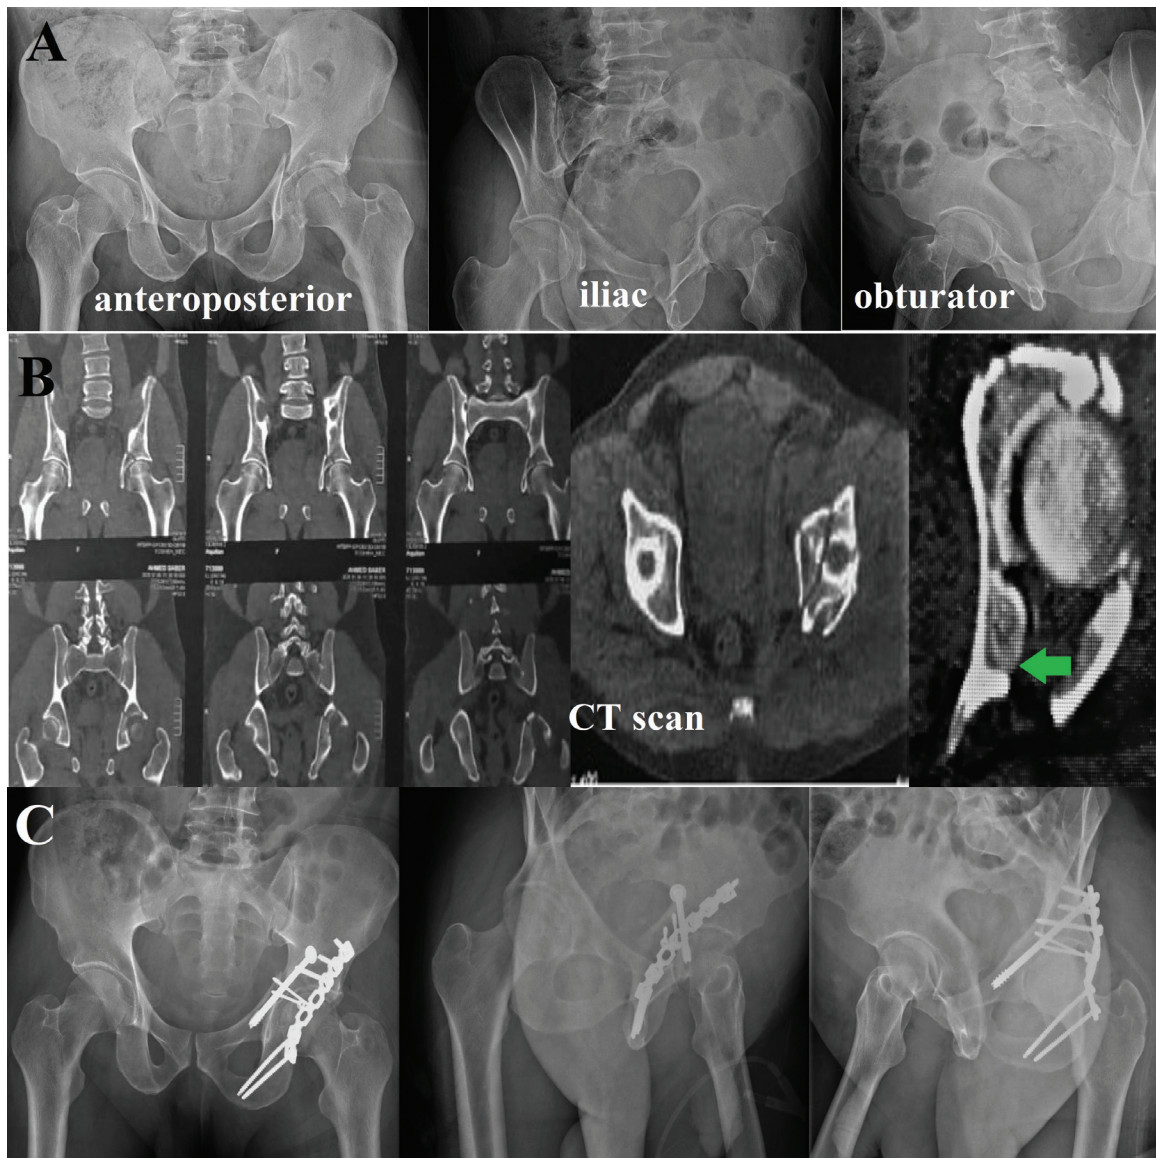
Fig. 2 Patient A: Diagnosed as transverse type acetabulum fracture with posterior wall fracture. (A and B) Preoperative plain radiographs and computed tomography scans (green arrowhead points to the impacted segment). (C) Postoperative pelvis plain radiographs.

The impacted fragment was first disimpacted using an osteotome; then, it was manipulated to its bed, keeping its inner hinge as intact as possible and using the femoral head as a template to ensure perfect reduction. Autogenous bone graft from the greater trochanter was used to support the reduced fragment and to fill the void created by the impaction. Lastly, reduction of the main fracture element and fixation using plate and screws were performed (▶Fig. 2 and 3).

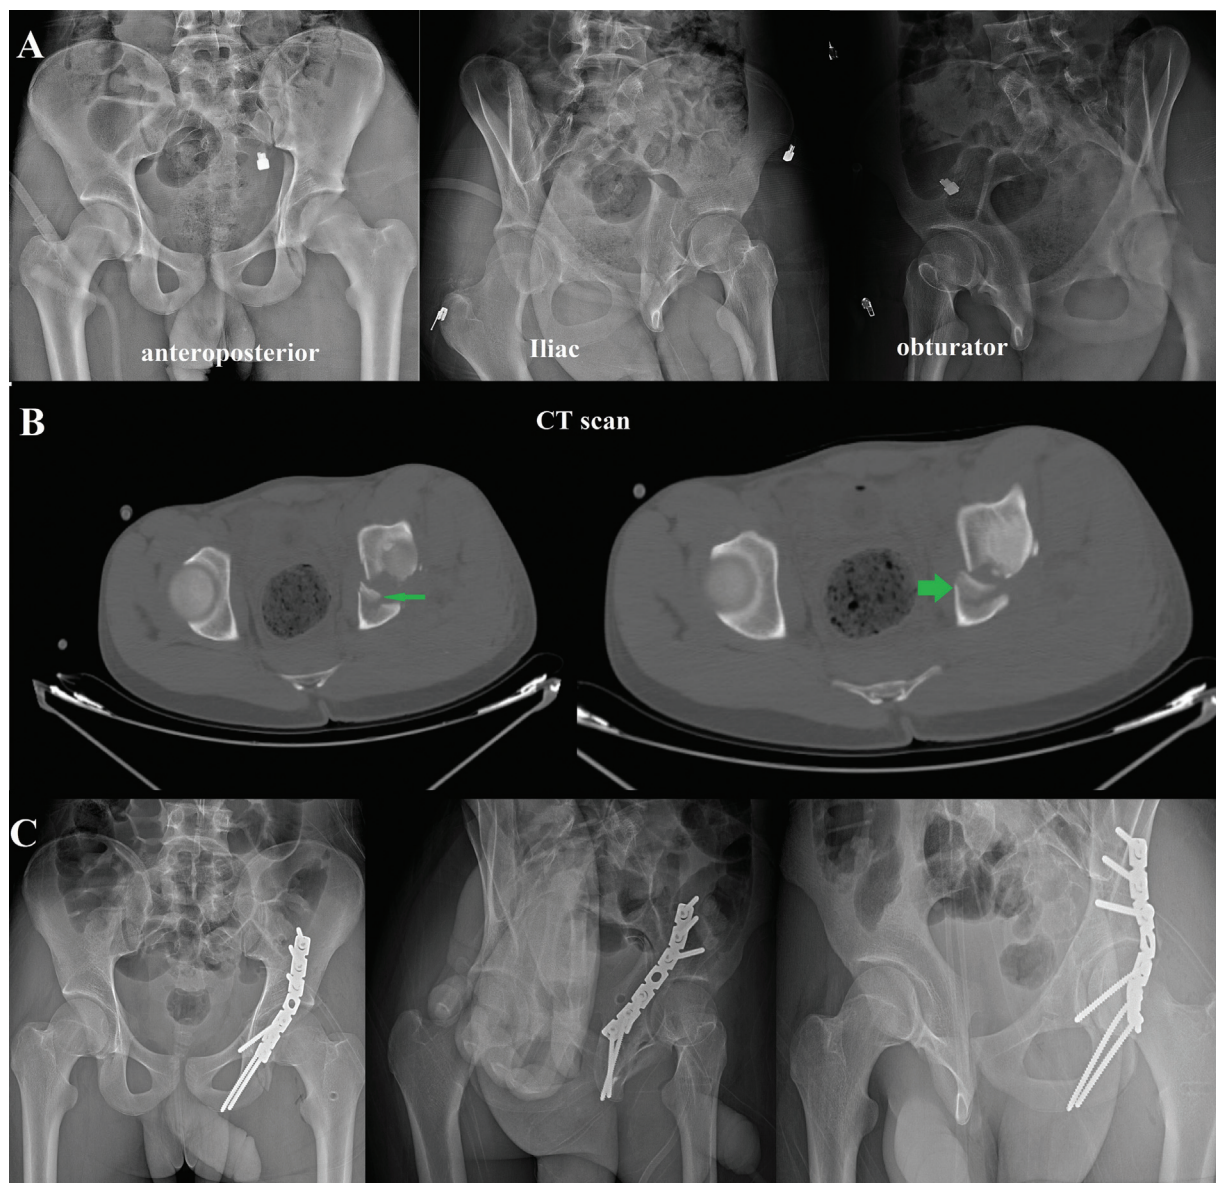
Fig. 3 Patient B: Diagnosed as a posterior column fracture. (A and B) Preoperative plain radiographs and computed tomography scans (green arrowhead points to the impacted segment). (C) Postoperative pelvis plain radiographs.

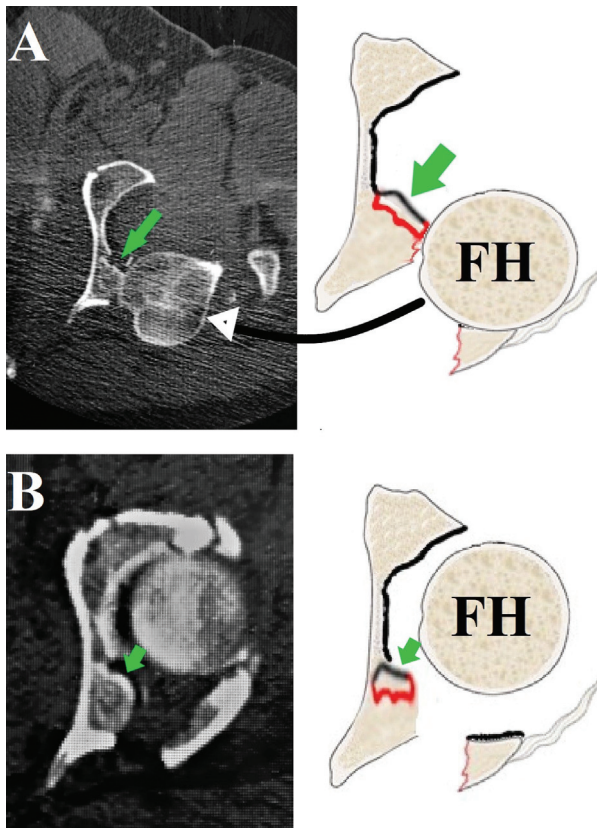
Fig. 4 Schematic diagram and computed tomography scan images showing the probable mechanism of injury leading to this unusual pattern of marginal impaction injury. (A) The head is dislocated, which pushes the marginal impaction segment (green arrowhead) while it is being relocated. (B) The final picture after relocating the femoral head with the articular surface of the marginally impacted segment facing the joint cavity.

Patient-A was transferred to our hospital after failed closed reduction attempts in another center; the patient presented a CT scan while the hip was dislocated. Based on the appearance of the injury in the CT scan, we hypothesized that this pattern could occur while reducing the hip since the femoral head could hit the outer edge of the impacted fragment, leading to its elevation from its bed and with further femoral head reduction into the joint cavity leading to the flipping of the fragment to be located toward the joint cavity (→ Fig. 4).
