A 72-year-old woman with known liver metastases was admitted to our Institute with an acute malignant colorectal obstruction. Colonoscopy revealed a serrated neoplastic stenosis at the splenic flexure and left-sided diverticular disease, with a narrowed, fixed and acute-angled sigmoid colon. An uncovered Wallstent Enteral endoprosthesis (Boston Scientific, Galway, Ireland) was successfully placed (Figure 1), which led to immediate relief of the patient's obstructive symptoms. A radiological control was performed 24 hours later which confirmed satisfactory stent placement.

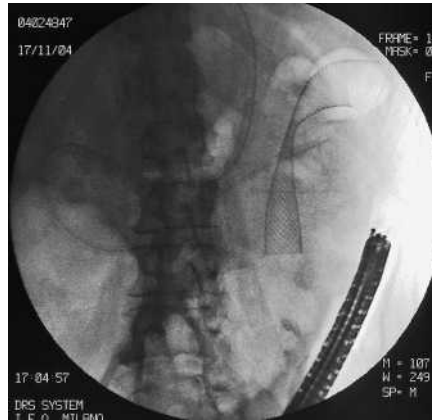
Figure 1 Radiograph showing the stent successfully placed in a stricture at the splenic flexure.
