## Endoscopic Therapy Using Monopolar and Bipolar Snare with a High-Frequency Current in Patients with a Pacemaker

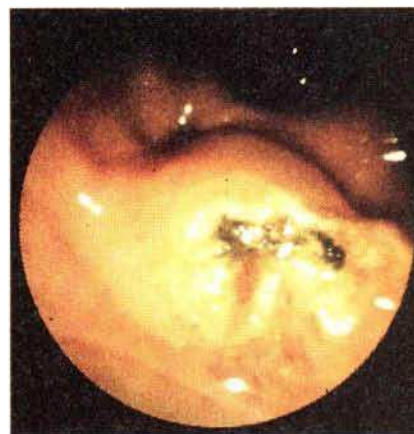
**Figure 1** Endoscopic image following endoscopic sphincterectomy. As the distance between the duodenal papilla and the electrode was only about 15 cm, the place of attachment for the return electrode was shifted to the right lumbar region to reduce the effect of the high-frequency current on the pacemaker as much as possible.

**Case 1:** A 58-year-old woman. An endoscopic image of case 1 is shown in Figure 1. The calculi were removed by lithotripter after electro-shock therapy by making a small incision.
