AORTA, February 2015, Volume 3, Issue 1: 41-45 DOI: http://dx.doi.org/10.12945/j.aorta.2015.14-044

# U-Shape Kissing Chimney Thoracic Endovascular Aneurysm Repair for a Traumatic Arch Rupture in a Polytraumatized Patient

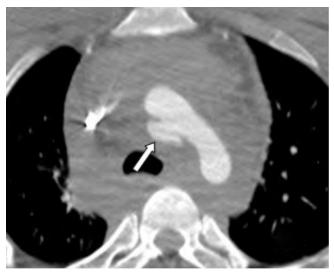
**Figure 1.** Mediastinal bleeding caused by a rupture of the aortic arch. White arrow: Posterior wall pseudoaneurysm.

to a posteriorly located rupture of the aortic arch with formation of a pseudoaneurysm (Figure 1).

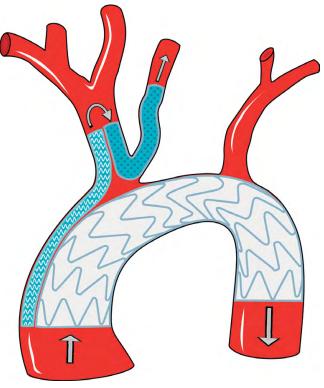
**Figure 3.** Schematic diagram of the construction used in this patient: Large waved area: 2 subsequent endoprostheses (Valiant Captivia, Medtronic, Minneapolis, Minnesota, USA) overriding the brachiocephalic trunk. Small waved area: 2 Advanta V12 stents from the ascending aorta, entering the brachiocephalic trunk. Dotted area: U-shaped Viabahn stent allowing blood to enter the LCCA from the brachiocephalic trunk. Arrows: blood

Therefore a more complex option was chosen: This began with an elongation of the endoprosthesis with a second Valiant Captivia placed more distally and overriding the brachiocephalic trunk, which meant placing kissing chimney stents. At the most proximal part of this "kissing chimney" configuration were two Advanta V12 10x38mm and 10x59mm stents (Maguet Cardiovascular, Wayne, New Jersey, USA) introduced via the right brachial and subclavian arteries. This allowed for blood from the ascending aorta to enter the trunk and proceed through the right subclavian artery and the right common carotid artery. The second portion of the chimney allowed blood to enter the LCCA from the trunk in a retrograde manner. This part consisted of a 7x100mm Viabahn stent (Gore Medical, Flagstaff, Arizona, USA) introduced after puncture of the LCCA and wiring of this vessel back and upwards,

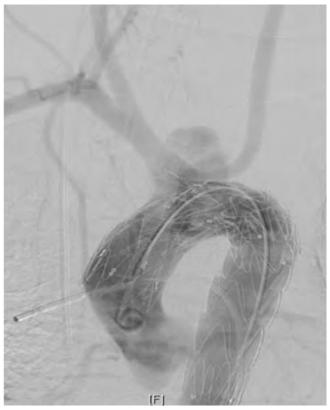
**Figure 4.** Post procedure visualization of Type 1A endoleak with filling of the pseudoaneurysm.

Although the procedure went well, immediate control comparison revealed a type IA endoleak (Figure 4) which was treated additionally by direct suprasternal puncture of the pseudoaneurysm. Once the correct position of the sheath was verified, filling of the space with Gianturco coils (Cook Medical, Bloomington, Indiana, USA) and Glubran glue (GEM S.R.L., Lu, Italy) resulted in immediate success (Figure 5).

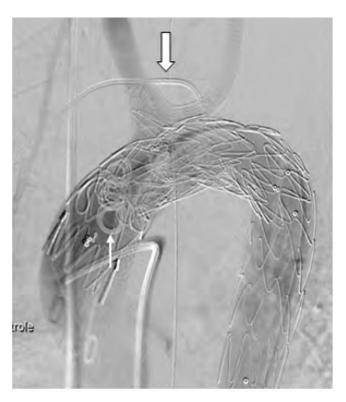
**Figure 5.** Post-treatment of the endoleak. Large white arrow: suprasternal sheath; Thin white arrow: coils.

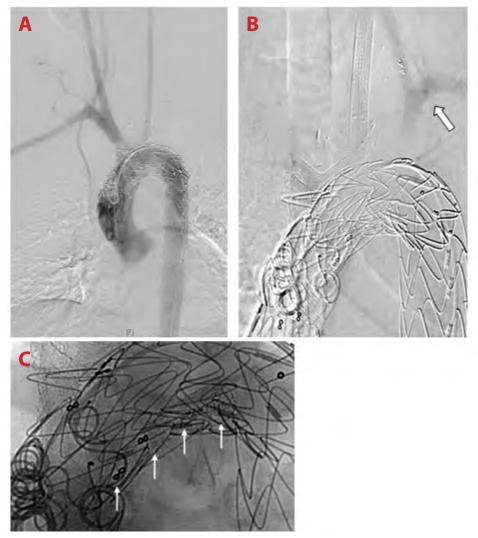
**Figure 6.** Stable control at 1 year. A) frontal view, early contrast phase. B) frontal view, late contrast phase. C) enhanced image. Note the subclavian steal to the left upper extremity (large arrow) and the luxated V12 stent still in situ (small white arrows).

Today, the patient is in perfect clinical condition without any problems regarding the extensive endovascular repair of his aortic arch and supraaortic vessels. A control CT scan and intraarterial angiogram 1 year later showed a good construction with patent chimneys and no type I or II leakage (Figure 6).
