# Coping in a calamity: Radiology during the cloudburst at Leh

## Abstract

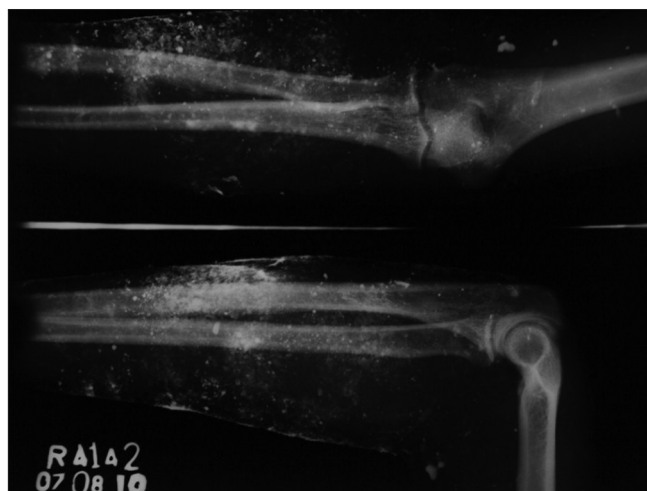
**Figure 1:** Radiograph of the elbow showing the bones obscured by mud and grit on the body surface

The wet and mud-caked clothing presented a hindrance to imaging and their removal was a time-consuming process. The X-ray tables required frequent cleaning due to the mud and dirt shed from the clothing and bodies of the patients. Precious time was again lost cleaning the abdominal surface of all mud and grit before FAST. The presence of mud on the body surfaces and scalp hair made the radiographic interpretation difficult and often impossible [Figure 1]. CT scans presented a similar problem due to the omnipresent mud. The gantry and table had to be vacuum-cleaned after each scan. The problem was partially circumvented by seeking the assistance of attendants/volunteers in removing clothing and cleaning the body parts.

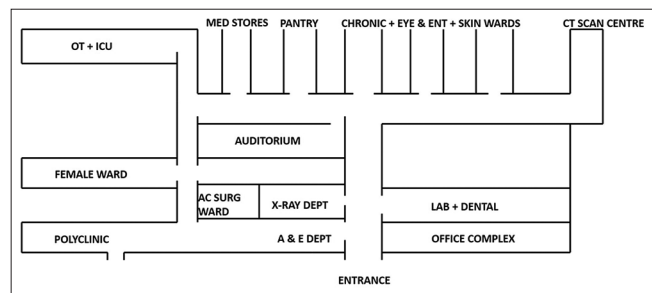
**Figure 2:** Line diagram showing the layout of the hospital. The CT scan center, radiography units, A and E Dept, and OT are at a considerable distance from each other

The distance between the Accident and Emergency (A and E) Department, operation theatres, surgical wards, and the radiology and CT wings was considerable (50 m) and valuable time was lost in transit [Figure 2] due to this design flaw. To avoid patient inconvenience and wastage of time, a portable ultrasound machine was stationed in the intensive care unit (ICU) to enable ultrasound examinations to be performed there itself.

It is important to have the Radiology Department with all its subsections like CT scan centre, Magnetic Resonance Imaging (MRI) centre, Digital Subtraction Angiography (DSA) lab as close to one another and to the Accident and Emergency Department and the Operation Theatres so that patients can be quickly triaged and sent for the appropriate medical imaging and subsequently for surgery if required. The department should have broad corridors to allow easy passage of trolleys and stretchers and large waiting areas to prevent crowding. Separate entrance and exits would allow unidirectional flow of patients and also prevent congestion and crowding.<sup>[5]</sup> Being an equipment-heavy department, which is prone to damage due to dust, moisture, and water, the department should preferably be located on the first floor of a building to avoid the danger of flooding. Adequate provision for electrical power points, piped oxygen, and suction and devices for hanging infusion sets should be present.<sup>[5]</sup>

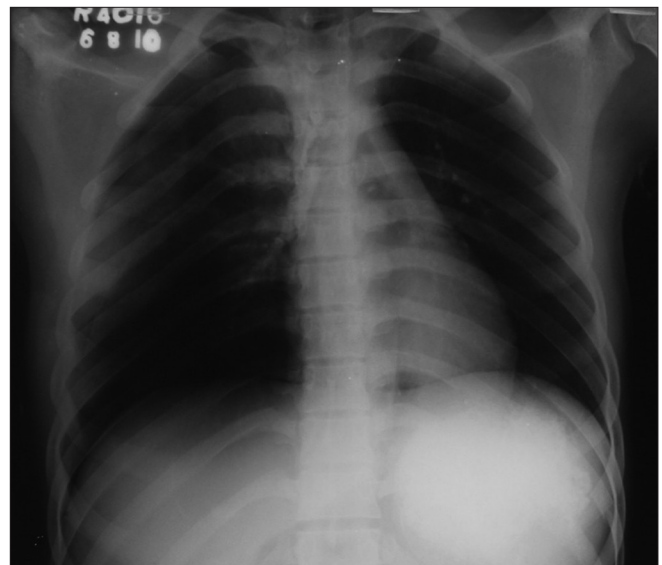
**Figure 3:** Radiograph Chest (PA view) showing aspirated mud outlining the trachea and bronchi (mud-bronchogram)

during non-emergency routines) in the form of fractures and aspiration of mud (mud-bronchogram) [Figure 3]. Intra-abdominal fluid was noted in four of the eight patients suspected to have abdominal trauma. Deep venous thrombosis of a lower limb was noted in one patient on color Doppler. Of the patients who underwent CT scans, 11 had skull fractures with signs of brain injury. Three patients had multiple vertebral and pelvic fractures. The presence of a radiologist during triage led to better decision making in terms of requirement of imaging for a particular patient, the modality that would best serve the purpose under the given circumstances, the urgency of imaging, and judicious and even usage of all available radiology resources. This contributed to a high yield of positive findings as is evident from Table 2. By helping reach a definite diagnosis and its severity, imaging was critical not only in deciding the appropriate course of action to be followed for a particular patient but also helped in the judicious and timely utilization of resources. Simple innovations like usage of serial numbers for all patients during initial documentation and imaging, pending confirmation of identity, helped obviate confusion and saved much valuable time. Other innovations like taking radiographs on the floor/stretchers obviated crowding within the department, excessive patient movement and reduced the requirement of manpower and increased patient through-put. Placing portable ultrasound machines and x-ray machines at critical areas apart from the radiology department also helped. Recruiting attendants and volunteers to help clean up the body parts and remove soiled clothing and also the radiography tables before imaging saved precious time and reduced distractions for the staff.
