Eagle syndrome

Deepika Raina, Rajesh Gothi, Sriram Rajan

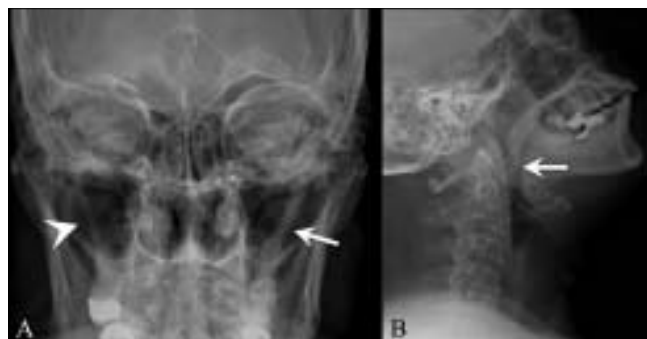
Figure 1 (A, B): Antero-posterior (A) and lateral (B) radiographs of the skull show elongated styloid processes on both sides; there is a completely calcified stylohyoid ligament on the left side (arrow) and a partially calcified one on the right side (arrowhead)

A 62-year-old male presented with 6 months' history of pain in the throat, radiating to the head and neck; the pain was more on the left side, especially on turning the head towards the left. Anterior and posterior radiographs of the skull showed elongated, excessively ossified styloid processes on both sides, with the left being more affected than the right [Figure 1]. There was also calcification of the stylohyoid ligaments on both sides, the right being partially calcified and the left completely calcified.

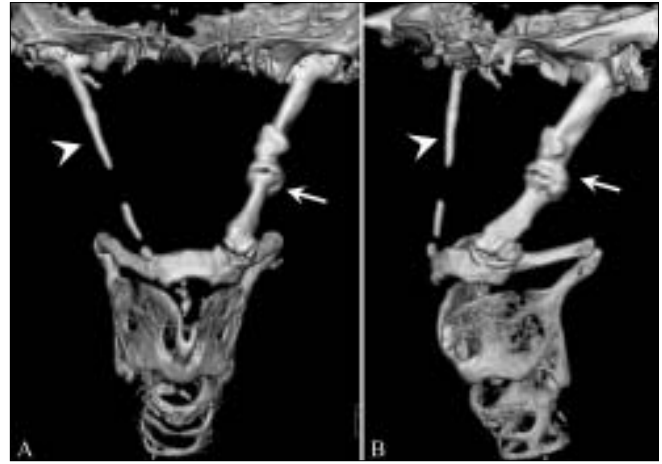
Figure 2 (A, B): Antero-posterior (A) and oblique (B) 3DCT images show the stylohyoid chain apparatus, with elongated styloid processes on both sides; there is a completely calcified stylohyoid ligament on the left side (arrow) and a partially calcified one on the right side (arrowhead)

The patient also underwent a CT scan (Sensation 64, Siemens, Erlangen, Germany) of the head and neck; images were obtained in the axial, coronal, and sagittal planes and three-dimensional (3D) reconstructions were done. The CT scan showed excessive ossification of both styloid processes leading to an increase in their length and thickness; the left styloid was more affected than the right. There was calcification of both stylohyoid ligaments, which was partial on the right and complete on the left side [Figure 2].

ES can be diagnosed radiologically and by physical examination. The elongated styloid process can be felt in the tonsillar fossa, and palpation can lead to an increase in symptoms. This elongation can be confirmed radiologically using conventional radiographs or CT scan.^[4] 3DCT helps in surgical planning and allows the physician to better explain the lesion and the surgical details to patient. It also helps to

obtain measurements in three dimensions, along the plane of the styloid process being measured; in contrast there is underestimation of the length of the styloid process with two-dimensional cross-sectional imaging, where even in the coronal plane, the images are usually not parallel to the styloid process.
